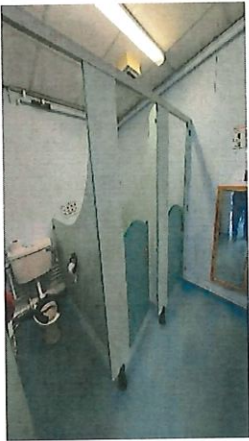
Material Assessment Ref	S213 –	
Building	Main	
Floor	Ground	
Room	N004 Toilets	
Position	Ceiling, Walls & Floor	
Component	Ceiling, Walls & Floor	
Accessibility	N/A	
Lab	In-House Database	
Next Inspection	No further action required	
Material Risk	0 (VL)	
Priority Risk	N/A	
Quantity	Num	
Survey Type	Management	
Action	No further action required	
Product Type	Not Selected	
Asbestos Type	Non suspect material	
Surface Treatment	Not Selected	
Condition	Not Selected	
Recommendations	No further action required	
Comments	Timber roof decking boards above suspended ceiling, plaster skim to block walls and concrete floor beneath modern vinyl. Ceramic toilet cisterns and modern seats.

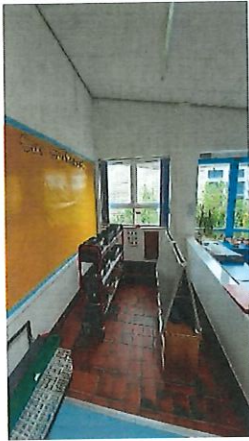
Material Assessment Ref	S214 –	
Building	Main	
Floor	Ground	
Room	N005 Sand Pit	
Position	Ceiling, Walls & Floor	
Component	Ceiling, Walls & Floor	
Accessibility	N/A	
Lab	In-House Database	
Next Inspection	No further action required	
Material Risk	0 (VL)	
Priority Risk	N/A	
Quantity	Num	
Survey Type	Management	
Action	No further action required	
Product Type	Not Selected	
Asbestos Type	Non suspect material	
Surface Treatment	Not Selected	
Condition	Not Selected	
Recommendations	No further action required	
Comments	Timber roof decking boards above suspended ceiling, plaster skim to block walls and concrete floor beneath ceramic floor tiles.

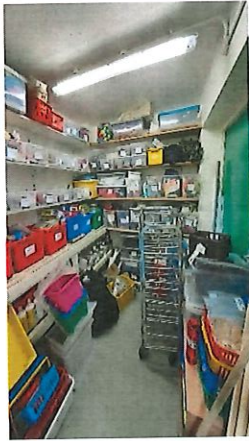
Material Assessment Ref	S215 –	
Building	Main	
Floor	Ground	
Room	N006 Store Room	
Position	Ceiling, Walls & Floor	
Component	Ceiling, Walls & Floor	
Accessibility	N/A	
Lab	In-House Database	
Next Inspection	No further action required	
Material Risk	0 (VL)	
Priority Risk	N/A	
Quantity	Num	
Survey Type	Management	
Action	No further action required	
Product Type	Not Selected	
Asbestos Type	Non suspect material	
Surface Treatment	Not Selected	
Condition	Not Selected	
Recommendations	No further action required	
Comments	Timber panels to ceiling, plaster skim to block walls and concrete floor beneath modern vinyl.

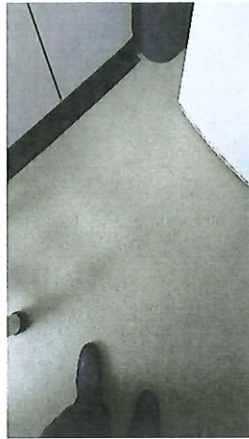
Material Assessment Ref	S219 –	
Building	Main	
Floor	Ground	
Room	N007 Laundry	
Position	Below Floor Covering	
Component	Below Floor Covering	
Accessibility	N/A	
Lab	In-House Database	
Next Inspection	No Access	
Material Risk	12 (H)	
Priority Risk	N/A	
Quantity	Num	
Survey Type	Management	
Action	Further investigation may be required.	
Product Type	No Access	
Asbestos Type	No Access	
Surface Treatment	No Access	
Condition	No Access	
Recommendations	Access was denied on the day of survey – see Inspection Comments (Material & Priority Assessment Records) for details.	
Comments	No access was possible beneath the modern vinyl without causing unnecessary damage.

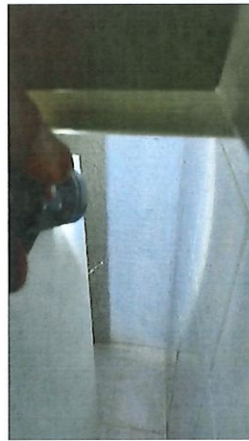
Material Assessment Ref	S220 – (As S204)	
Building	Main	
Floor	Ground	
Room	N007A Laundry Store	
Position	Ceiling	
Component	Textured Coating To Ceiling	
Accessibility	Medium	
Lab	In-House Database	
Next Inspection	17/08/2023	
Material Risk	3 (VL)	
Priority Risk	N/A	
Quantity	1 Sqr Mtrs	
Survey Type	Management	
Action	Manage	
Product Type	Textured Coating	
Asbestos Type	Strongly Presumed Chrysotile	
Surface Treatment	Composite materials containing asbestos: reinforced plastics, resins, mastics, vinyl tiles, semi rigid paints or decorative finishes.	
Condition	Low damage: a few scratches or surface marks, broken edges on boards, tiles etc.	
Recommendations	Manage	
Comments	Textured coating to plasterboard ceiling.

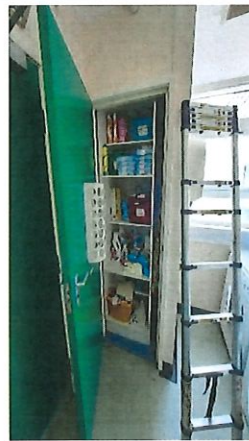
Material Assessment Ref	S221 –	
Building	Main	
Floor	Ground	
Room	N007A Laundry Store	
Position	Walls Internal	
Component	Walls Internal	
Accessibility	N/A	
Lab	In-House Database	
Next Inspection	No further action required	
Material Risk	0 (VL)	
Priority Risk	N/A	
Quantity	Num	
Survey Type	Management	
Action	No further action required	
Product Type	Not Selected	
Asbestos Type	Non suspect material	
Surface Treatment	Not Selected	
Condition	Not Selected	
Recommendations	No further action required	
Comments	Plaster skim to brick walls.

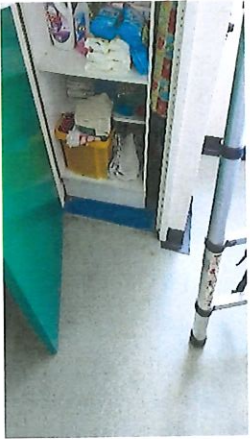
Material Assessment Ref	S222 –	
Building	Main	
Floor	Ground	
Room	N007A Laundry Store	
Position	Below Floor Covering	
Component	Below Floor Covering	
Accessibility	N/A	
Lab	In-House Database	
Next Inspection	No Access	
Material Risk	12 (H)	
Priority Risk	N/A	
Quantity	Num	
Survey Type	Management	
Action	Further investigation may be required.	
Product Type	No Access	
Asbestos Type	No Access	
Surface Treatment	No Access	
Condition	No Access	
Recommendations	Access was denied on the day of survey – see Inspection Comments (Material & Priority Assessment Records) for details.	
Comments	No access was possible beneath the modern vinyl without causing unnecessary damage.

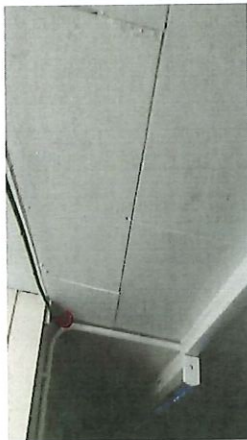
Material Assessment Ref	S223 –	
Building	Main	
Floor	First	
Room	101 Stairwells	
Position	Ceiling	
Component	Ceiling	
Accessibility	N/A	
Lab	The Testing Lab PLC	
Next Inspection	No Further Action Required	
Material Risk	0 (VL)	
Priority Risk	N/A	
Quantity	6 Sqr Mtrs	
Survey Type	Management	
Action	No Further Action Required	
Product Type	Not Selected	
Asbestos Type	NADIS	
Surface Treatment	Not Selected	
Condition	Not Selected	
Recommendations	No further action required	
Comments	Insulating boards to the ceiling.

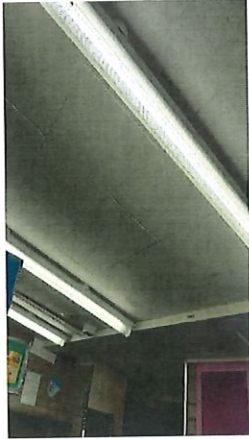
Material Assessment Ref	S225 – (As S223)	
Building	Main	
Floor	First	
Room	102 Lobby / Cloaks	
Position	Ceiling	
Component	Ceiling	
Accessibility	N/A	
Lab	In-House Database	
Next Inspection	No Further Action Required	
Material Risk	0 (VL)	
Priority Risk	N/A	
Quantity	10 Sqr Mtrs	
Survey Type	Management	
Action	No Further Action Required	
Product Type	Not Selected	
Asbestos Type	Non suspect material	
Surface Treatment	Not Selected	
Condition	Not Selected	
Recommendations	No further action required	
Comments	Insulating boards to the ceiling.

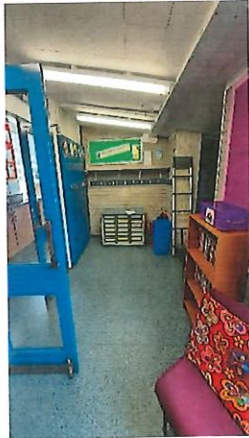
Material Assessment Ref	S226 –	
Building	Main	
Floor	First	
Room	102 Lobby / Cloaks	
Position	Walls Internal	
Component	Walls Internal	
Accessibility	N/A	
Lab	In-House Database	
Next Inspection	No further action required	
Material Risk	0 (VL)	
Priority Risk	N/A	
Quantity	Num	
Survey Type	Management	
Action	No further action required	
Product Type	Not Selected	
Asbestos Type	Non suspect material	
Surface Treatment	Not Selected	
Condition	Not Selected	
Recommendations	No further action required	
Comments	Plaster skim to plasterboard or brick walls. Glass door head panels.

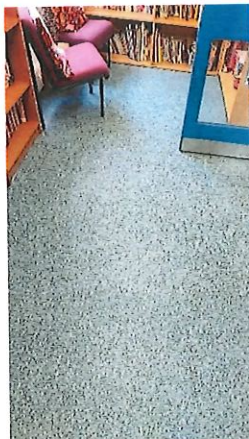
Material Assessment Ref	S227 –	
Building	Main	
Floor	First	
Room	102 Lobby / Cloaks	
Position	Below Floor Covering	
Component	Below Floor Covering	
Accessibility	N/A	
Lab	In-House Database	
Next Inspection	No Access	
Material Risk	12 (H)	
Priority Risk	N/A	
Quantity	Num	
Survey Type	Management	
Action	Further investigation may be required.	
Product Type	No Access	
Asbestos Type	No Access	
Surface Treatment	No Access	
Condition	No Access	
Recommendations	Access was denied on the day of survey – see Inspection Comments (Material & Priority Assessment Records) for details.	
Comments	No access was possible beneath the modern vinyl without causing unnecessary damage.

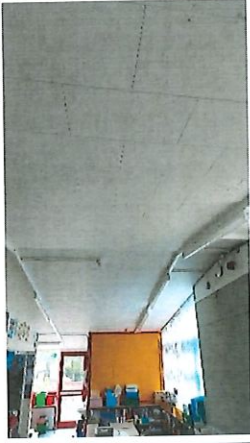
Material Assessment Ref	S231 – (As S223)	
Building	Main	
Floor	First	
Room	104 Resource Area	
Position	Ceiling	
Component	Ceiling	
Accessibility	N/A	
Lab	In-House Database	
Next Inspection	No Further Action Required	
Material Risk	0 (VL)	
Priority Risk	N/A	
Quantity	60 Sqr Mtrs	
Survey Type	Management	
Action	No Further Action Required	
Product Type	Not Selected	
Asbestos Type	Non suspect material	
Surface Treatment	Not Selected	
Condition	Not Selected	
Recommendations	No further action required	
Comments	Insulating boards to the ceiling.

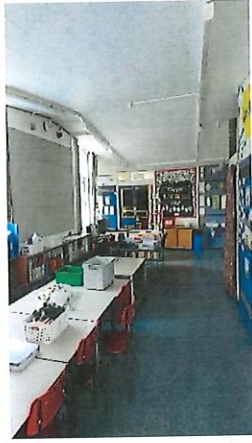
Material Assessment Ref	S232 –	
Building	Main	
Floor	First	
Room	104 Resource Area	
Position	Walls Internal	
Component	Walls Internal	
Accessibility	N/A	
Lab	In-House Database	
Next Inspection	No further action required	
Material Risk	0 (VL)	
Priority Risk	N/A	
Quantity	Num	
Survey Type	Management	
Action	No further action required	
Product Type	Not Selected	
Asbestos Type	Non suspect material	
Surface Treatment	Not Selected	
Condition	Not Selected	
Recommendations	No further action required	
Comments	Plaster skim to plasterboard or brick walls.

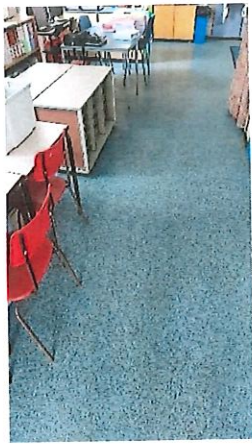
Material Assessment Ref	S233 –	
Building	Main	
Floor	First	
Room	104 Resource Area	
Position	Below Floor Covering	
Component	Below Floor Covering	
Accessibility	N/A	
Lab	In-House Database	
Next Inspection	No Access	
Material Risk	12 (H)	
Priority Risk	N/A	
Quantity	Num	
Survey Type	Management	
Action	Further investigation may be required.	
Product Type	No Access	
Asbestos Type	No Access	
Surface Treatment	No Access	
Condition	No Access	
Recommendations	Access was denied on the day of survey – see Inspection Comments (Material & Priority Assessment Records) for details.	
Comments	No access was possible beneath the modern vinyl without causing unnecessary damage.

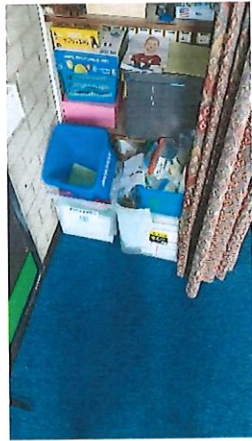
Material Assessment Ref	S239 –	
Building	Main	
Floor	First	
Room	106 Classroom Store	
Position	Below Floor Covering	
Component	Floor Tiles & Adhesive	
Accessibility	Difficult	
Lab	The Testing Lab PLC	
Next Inspection	17/08/2023	
Material Risk	3 (VL)	
Priority Risk	N/A	
Quantity	1 Sqr Mtrs	
Survey Type	Management	
Action	Manage	
Product Type	Thermo Plastic Floor Tiles	
Asbestos Type	Chrysotile	
Surface Treatment	Composite materials containing asbestos: reinforced plastics, resins, mastics, vinyl tiles, semi rigid paints or decorative finishes.	
Condition	Low damage: a few scratches or surface marks, broken edges on boards, tiles etc.	
Recommendations	Manage	
Comments	Green floor tiles and bitumen adhesive to concrete floor beneath carpet.

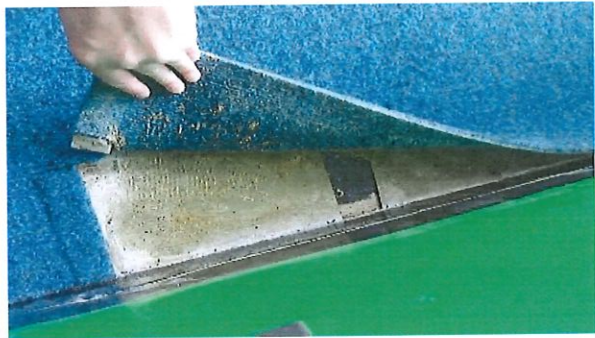
Material Assessment Ref	S242 – (As S239)	
Building	Main	
Floor	First	
Room	107 Classroom	
Position	Below Floor Covering	
Component	Floor Tiles & Adhesive	
Accessibility	Difficult	
Lab	In-House Database	
Next Inspection	17/08/2023	
Material Risk	3 (VL)	
Priority Risk	N/A	
Quantity	60 Sqr Mtrs	
Survey Type	Management	
Action	Manage	
Product Type	Thermo Plastic Floor Tiles	
Asbestos Type	Strongly Presumed Chrysotile	
Surface Treatment	Composite materials containing asbestos: reinforced plastics, resins, mastics, vinyl tiles, semi rigid paints or decorative finishes.	
Condition	Low damage: a few scratches or surface marks, broken edges on boards, tiles etc.	
Recommendations	Manage	
Comments	Green floor tiles and bitumen adhesive to concrete floor beneath carpet.

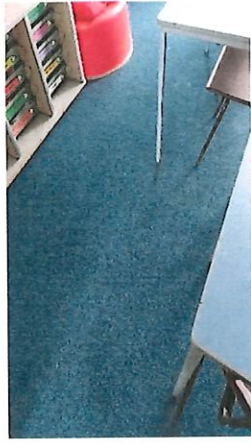
Material Assessment Ref	S245 – (As S239)	
Building	Main	
Floor	First	
Room	108 Classroom	
Position	Below Floor Covering	
Component	Floor Tiles & Adhesive	
Accessibility	Difficult	
Lab	In-House Database	
Next Inspection	17/08/2023	
Material Risk	3 (VL)	
Priority Risk	N/A	
Quantity	60 Sqr Mtrs	
Survey Type	Management	
Action	Manage	
Product Type	Thermo Plastic Floor Tiles	
Asbestos Type	Strongly Presumed Chrysotile	
Surface Treatment	Composite materials containing asbestos: reinforced plastics, resins, mastics, vinyl tiles, semi rigid paints or decorative finishes.	
Condition	Low damage: a few scratches or surface marks, broken edges on boards, tiles etc.	
Recommendations	Manage	
Comments	Green floor tiles and bitumen adhesive to concrete floor beneath carpet.

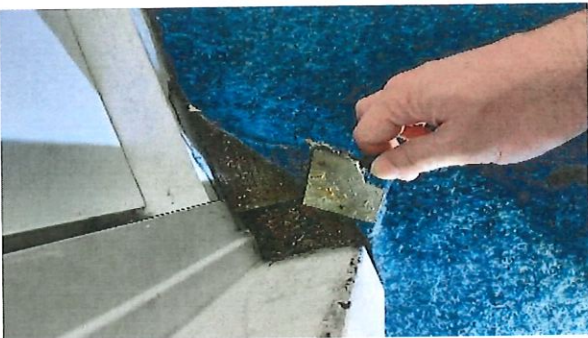
Material Assessment Ref	S275 – (As S239)	
Building	Main	
Floor	First	
Room	121 Classroom	
Position	Below Floor Covering	
Component	Floor Tiles & Adhesive	
Accessibility	Difficult	
Lab	In-House Database	
Next Inspection	17/08/2023	
Material Risk	3 (VL)	
Priority Risk	N/A	
Quantity	60 Sqr Mtrs	
Survey Type	Management	
Action	Manage	
Product Type	Thermo Plastic Floor Tiles	
Asbestos Type	Strongly Presumed Chrysotile	
Surface Treatment	Composite materials containing asbestos: reinforced plastics, resins, mastics, vinyl tiles, semi rigid paints or decorative finishes.	
Condition	Low damage: a few scratches or surface marks, broken edges on boards, tiles etc.	
Recommendations	Manage	
Comments	Green floor tiles and bitumen adhesive to concrete floor beneath carpet.

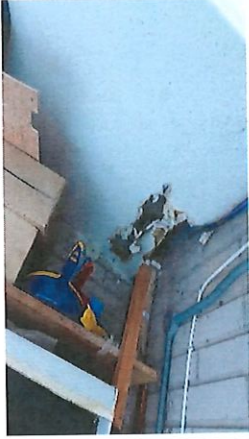
Material Assessment Ref	S285 –	
Building	Main	
Floor	Ground	
Room	007 Gas Meter Cupboard	
Position	Ceiling	
Component	Textured Coating To Ceiling	
Accessibility	Medium	
Lab	The Testing Lab PLC	
Next Inspection	17/08/2023	
Material Risk	4 (VL)	
Priority Risk	N/A	
Quantity	2 Sqr Mtrs	
Survey Type	Management	
Action	Encapsulate/Repair	
Product Type	Textured Coating	
Asbestos Type	Chrysotile	
Surface Treatment	Composite materials containing asbestos: reinforced plastics, resins, mastics, vinyl tiles, semi rigid paints or decorative finishes.	
Condition	Medium damage: significant breakage or materials or several small areas where material has been damaged revealing loose asbestos fibres.	
Recommendations	Encapsulate/ Repair	
Comments	Textured coating to plasterboard ceiling.

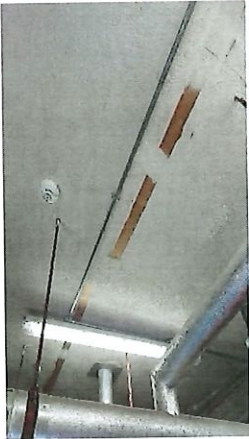
Material Assessment Ref	S287 – (As S285)	
Building	Main	
Floor	Ground	
Room	008 Boiler Room	
Position	Ceiling	
Component	Textured Coating To Ceiling	
Accessibility	Medium	
Lab	In-House Database	
Next Inspection	17/08/2023	
Material Risk	3 (VL)	
Priority Risk	N/A	
Quantity	20 Sqr Mtrs	
Survey Type	Management	
Action	Manage	
Product Type	Textured Coating	
Asbestos Type	Strongly Presumed Chrysotile	
Surface Treatment	Composite materials containing asbestos: reinforced plastics, resins, mastics, vinyl tiles, semi rigid paints or decorative finishes.	
Condition	Low damage: a few scratches or surface marks, broken edges on boards, tiles etc.	
Recommendations	Manage	
Comments	Textured coating to plasterboard ceiling.

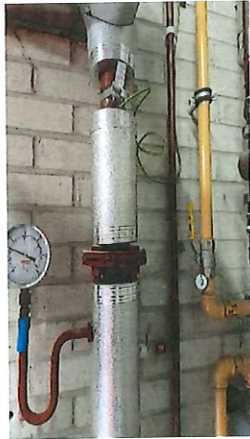
Material Assessment Ref	S289 –	
Building	Main	
Floor	Ground	
Room	008 Boiler Room	
Position	Pipework	
Component	Gaskets	
Accessibility	N/A	
Lab	The Testing Lab PLC	
Next Inspection	No Further Action Required	
Material Risk	0 (VL)	
Priority Risk	N/A	
Quantity	4 Num	
Survey Type	Management	
Action	No Further Action Required	
Product Type	Not Selected	
Asbestos Type	NADIS	
Surface Treatment	Not Selected	
Condition	Not Selected	
Recommendations	No further action required	
Comments	Gaskets to pipework.

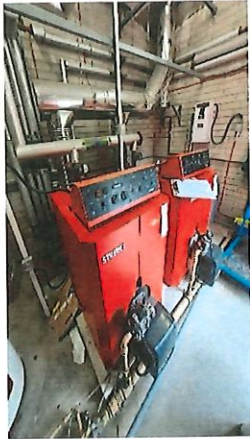
Material Assessment Ref	S290 –	
Building	Main	
Floor	Ground	
Room	008 Boiler Room	
Position	Live Plant	
Component	Plant Equipment	
Accessibility	N/A	
Lab	In-House Database	
Next Inspection	No further action required	
Material Risk	0 (VL)	
Priority Risk	N/A	
Quantity	Num	
Survey Type	Management	
Action	No further action required	
Product Type	Not Selected	
Asbestos Type	Non suspect material	
Surface Treatment	Not Selected	
Condition	Not Selected	
Recommendations	No further action required	
Comments	Modern boilers x 2 and mmmf insulation to pipework beneath metal cladding. Modern metal flue pipe.
