Section 3 – Survey Information [◀ Back](#)

Summary of Areas Included within this Survey Chapel End School – For site specific details see Section 3 – Site Specific Information.

This survey was a management asbestos survey.

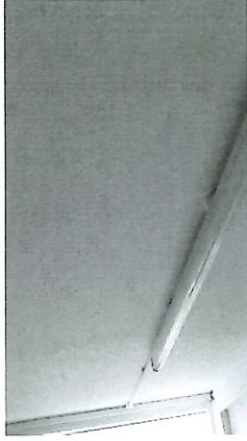
Material Assessment Ref	S001 –	
Building	Main	
Floor	Ground	
Room	001 Main Entrance Lobby	
Position	Ceiling	
Component	Textured Coating To Ceiling	
Accessibility	Medium	
Lab	The Testing Lab PLC	
Next Inspection	16/08/2023	
Material Risk	3 (VL)	
Priority Risk	N/A	
Quantity	8 Sqr Mtrs	
Survey Type	Management	
Action	Manage	
Product Type	Textured Coating	
Asbestos Type	Chrysotile	
Surface Treatment	Composite materials containing asbestos: reinforced plastics, resins, mastics, vinyl tiles, semi rigid paints or decorative finishes.	
Condition	Low damage: a few scratches or surface marks, broken edges on boards, tiles etc.	
Recommendations	Manage	
Comments	Textured coating to plasterboard ceiling.

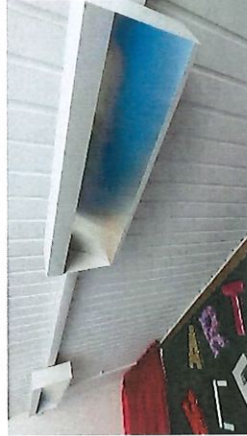
Material Assessment Ref	S002 –	
Building	Main	
Floor	Ground	
Room	001 Main Entrance Lobby	
Position	Behind Cladding	
Component	Behind Cladding	
Accessibility	N/A	
Lab	In-House Database	
Next Inspection	No Access	
Material Risk	12 (H)	
Priority Risk	N/A	
Quantity	Num	
Survey Type	Management	
Action	Further investigation may be required.	
Product Type	No Access	
Asbestos Type	No Access	
Surface Treatment	No Access	
Condition	No Access	
Recommendations	Access was denied on the day of survey – see Inspection Comments (Material & Priority Assessment Records) for details.	
Comments	No access was possible behind the wooden cladding to part of the ceiling without causing unnecessary damage.

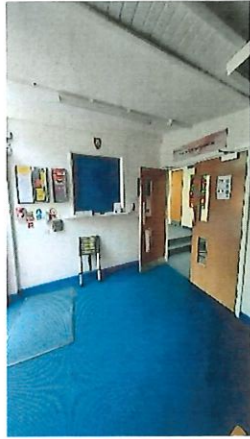
Material Assessment Ref	S003 –	
Building	Main	
Floor	Ground	
Room	001 Main Entrance Lobby	
Position	Walls & Floor	
Component	Walls & Floor	
Accessibility	N/A	
Lab	In-House Database	
Next Inspection	No further action required	
Material Risk	0 (VL)	
Priority Risk	N/A	
Quantity	Num	
Survey Type	Management	
Action	No further action required	
Product Type	Not Selected	
Asbestos Type	Non suspect material	
Surface Treatment	Not Selected	
Condition	Not Selected	
Recommendations	No further action required	
Comments	Plaster skim to plasterboard and brick walls or timber panels and concrete floor beneath carpet. Plastic downpipe.

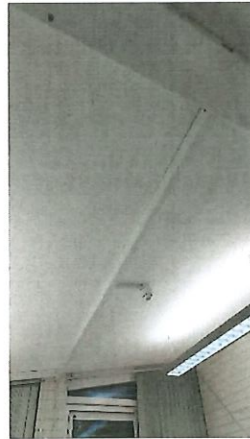
Material Assessment Ref	S004 – (As S001)	
Building	Main	
Floor	Ground	
Room	002 & 003 School Office	
Position	Ceiling	
Component	Textured Coating To Ceiling	
Accessibility	Medium	
Lab	In-House Database	
Next Inspection	16/08/2023	
Material Risk	3 (VL)	
Priority Risk	N/A	
Quantity	16 Sqr Mtrs	
Survey Type	Management	
Action	Manage	
Product Type	Textured Coating	
Asbestos Type	Strongly Presumed Chrysotile	
Surface Treatment	Composite materials containing asbestos: reinforced plastics, resins, mastics, vinyl tiles, semi rigid paints or decorative finishes.	
Condition	Low damage: a few scratches or surface marks, broken edges on boards, tiles etc.	
Recommendations	Manage	
Comments	Textured coating to plasterboard ceiling.

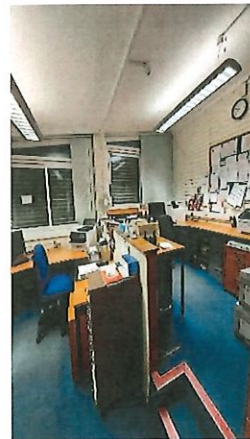
Material Assessment Ref	S005 –	
Building	Main	
Floor	Ground	
Room	002 & 003 School Office	
Position	Walls & Floor	
Component	Walls & Floor	
Accessibility	N/A	
Lab	In-House Database	
Next Inspection	No further action required	
Material Risk	0 (VL)	
Priority Risk	N/A	
Quantity	Num	
Survey Type	Management	
Action	No further action required	
Product Type	Not Selected	
Asbestos Type	Non suspect material	
Surface Treatment	Not Selected	
Condition	Not Selected	
Recommendations	No further action required	
Comments	Brick walls and concrete floor beneath carpet. Rubber stair nosing strips to steps. Modern safe unit.

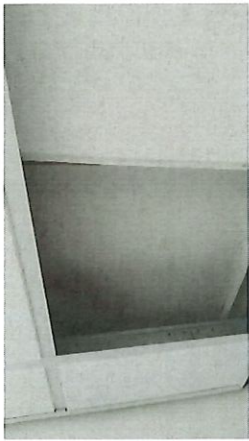
Material Assessment Ref	S006 – (As S001)	
Building	Main	
Floor	Ground	
Room	004 Corridor	
Position	Ceiling	
Component	Textured Coating To Ceiling	
Accessibility	Difficult	
Lab	In-House Database	
Next Inspection	16/08/2023	
Material Risk	3 (VL)	
Priority Risk	N/A	
Quantity	20 Sqr Mtrs	
Survey Type	Management	
Action	Manage	
Product Type	Textured Coating	
Asbestos Type	Strongly Presumed Chrysotile	
Surface Treatment	Composite materials containing asbestos: reinforced plastics, resins, mastics, vinyl tiles, semi rigid paints or decorative finishes.	
Condition	Low damage: a few scratches or surface marks, broken edges on boards, tiles etc.	
Recommendations	Manage	
Comments	Textured coating to plasterboard ceiling.

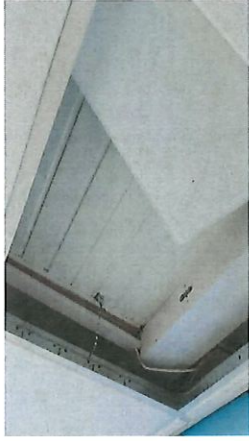
Material Assessment Ref	S007 –	
Building	Main	
Floor	Ground	
Room	004 Corridor	
Position	Behind Cladding	
Component	Behind Cladding	
Accessibility	N/A	
Lab	In-House Database	
Next Inspection	No Access	
Material Risk	12 (H)	
Priority Risk	N/A	
Quantity	Num	
Survey Type	Management	
Action	Further investigation may be required.	
Product Type	No Access	
Asbestos Type	No Access	
Surface Treatment	No Access	
Condition	No Access	
Recommendations	Access was denied on the day of survey – see Inspection Comments (Material & Priority Assessment Records) for details.	
Comments	No access was possible behind the wooden cladding to part of the ceiling above the suspended ceiling without causing unnecessary damage.

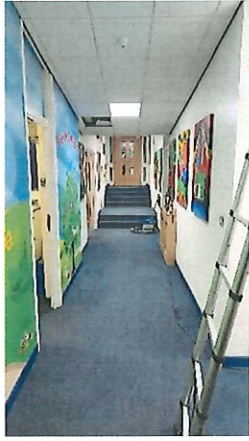
Material Assessment Ref	S008 –	
Building	Main	
Floor	Ground	
Room	004 Corridor	
Position	Walls Internal	
Component	Walls Internal	
Accessibility	N/A	
Lab	In-House Database	
Next Inspection	No further action required	
Material Risk	0 (VL)	
Priority Risk	N/A	
Quantity	Num	
Survey Type	Management	
Action	No further action required	
Product Type	Not Selected	
Asbestos Type	Non suspect material	
Surface Treatment	Not Selected	
Condition	Not Selected	
Recommendations	No further action required	
Comments	Plaster skim to plasterboard and brick walls. Rubber stair nosing strips to steps. Glass door head panels.

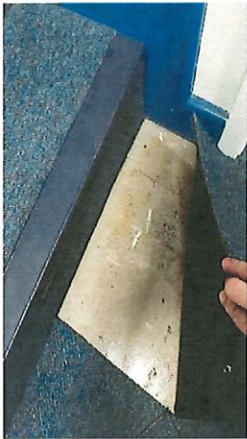
Material Assessment Ref	S009 –	
Building	Main	
Floor	Ground	
Room	004 Corridor	
Position	Below Floor Covering	
Component	Floor Tiles & Adhesive	
Accessibility	Difficult	
Lab	The Testing Lab PLC	
Next Inspection	16/08/2023	
Material Risk	2 (VL)	
Priority Risk	N/A	
Quantity	20 Sqr Mtrs	
Survey Type	Management	
Action	Manage	
Product Type	Thermo Plastic Floor Tiles	
Asbestos Type	Chrysotile	
Surface Treatment	Composite materials containing asbestos: reinforced plastics, resins, mastics, vinyl tiles, semi rigid paints or decorative finishes.	
Condition	Good condition: no visible damage.	
Recommendations	Manage	
Comments	Beige floor tiles and bitumen adhesive to concrete floor beneath carpet.

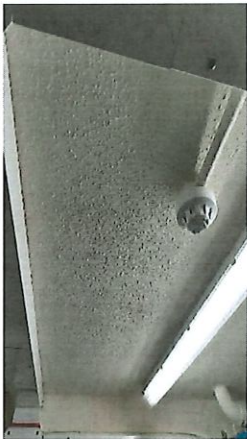
Material Assessment Ref	S010 –	
Building	Main	
Floor	Ground	
Room	006 Switch Room 1	
Position	Ceiling	
Component	Textured Coating To Ceiling	
Accessibility	Medium	
Lab	The Testing Lab PLC	
Next Inspection	16/08/2023	
Material Risk	3 (VL)	
Priority Risk	N/A	
Quantity	4 Sqr Mtrs	
Survey Type	Management	
Action	Manage	
Product Type	Textured Coating	
Asbestos Type	Chrysotile	
Surface Treatment	Composite materials containing asbestos: reinforced plastics, resins, mastics, vinyl tiles, semi rigid paints or decorative finishes.	
Condition	Low damage: a few scratches or surface marks, broken edges on boards, tiles etc.	
Recommendations	Manage	
Comments	Textured coating to plasterboard ceiling.

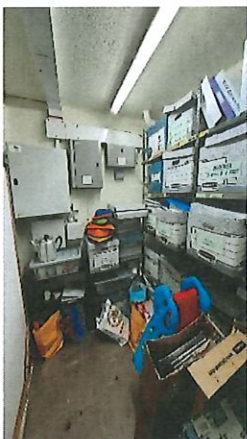
Material Assessment Ref	S011 –	
Building	Main	
Floor	Ground	
Room	006 Switch Room 1	
Position	Walls Internal	
Component	Walls Internal	
Accessibility	N/A	
Lab	In-House Database	
Next Inspection	No further action required	
Material Risk	0 (VL)	
Priority Risk	N/A	
Quantity	Num	
Survey Type	Management	
Action	No further action required	
Product Type	Not Selected	
Asbestos Type	Non suspect material	
Surface Treatment	Not Selected	
Condition	Not Selected	
Recommendations	No further action required	
Comments	Plaster skim to brick walls. Glass door head panel.

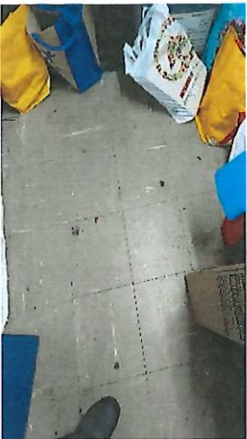
Material Assessment Ref	S012 – (As S009)	
Building	Main	
Floor	Ground	
Room	006 Switch Room 1	
Position	Floor	
Component	Floor Tiles & Adhesive	
Accessibility	Easy	
Lab	In-House Database	
Next Inspection	16/08/2023	
Material Risk	2 (VL)	
Priority Risk	N/A	
Quantity	4 Sqr Mtrs	
Survey Type	Management	
Action	Manage	
Product Type	Thermo Plastic Floor Tiles	
Asbestos Type	Strongly Presumed Chrysotile	
Surface Treatment	Composite materials containing asbestos: reinforced plastics, resins, mastics, vinyl tiles, semi rigid paints or decorative finishes.	
Condition	Good condition: no visible damage.	
Recommendations	Manage	
Comments	Beige floor tiles and bitumen adhesive to concrete floor.

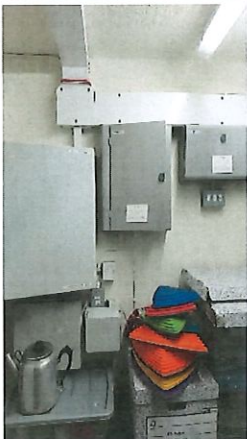
Material Assessment Ref	S013 –	
Building	Main	
Floor	Ground	
Room	006 Switch Room 1	
Position	Electrics	
Component	Electrics	
Accessibility	N/A	
Lab	In-House Database	
Next Inspection	No further action required	
Material Risk	0 (VL)	
Priority Risk	N/A	
Quantity	Num	
Survey Type	Management	
Action	No further action required	
Product Type	Not Selected	
Asbestos Type	Non suspect material	
Surface Treatment	Not Selected	
Condition	Not Selected	
Recommendations	No further action required	
Comments	Modern electrics.

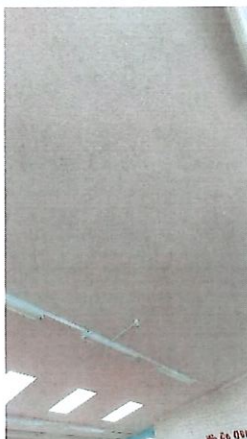
Material Assessment Ref	S014 – (As S010)	
Building	Main	
Floor	Ground	
Room	005 Infants Hall	
Position	Ceiling	
Component	Textured Coating To Ceiling	
Accessibility	Difficult	
Lab	In-House Database	
Next Inspection	16/08/2023	
Material Risk	3 (VL)	
Priority Risk	N/A	
Quantity	120 Sqr Mtrs	
Survey Type	Management	
Action	Manage	
Product Type	Textured Coating	
Asbestos Type	Strongly Presumed Chrysotile	
Surface Treatment	Composite materials containing asbestos: reinforced plastics, resins, mastics, vinyl tiles, semi rigid paints or decorative finishes.	
Condition	Low damage: a few scratches or surface marks, broken edges on boards, tiles etc.	
Recommendations	Manage	
Comments	Textured coating to plasterboard ceiling.

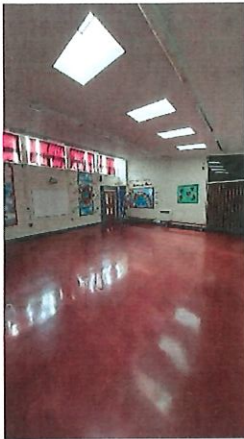
Material Assessment Ref	S015 –	
Building	Main	
Floor	Ground	
Room	005 Infants Hall	
Position	Walls Internal	
Component	Walls Internal	
Accessibility	N/A	
Lab	In-House Database	
Next Inspection	No further action required	
Material Risk	0 (VL)	
Priority Risk	N/A	
Quantity	Num	
Survey Type	Management	
Action	No further action required	
Product Type	Not Selected	
Asbestos Type	Non suspect material	
Surface Treatment	Not Selected	
Condition	Not Selected	
Recommendations	No further action required	
Comments	Brick walls. Glass door head panels.

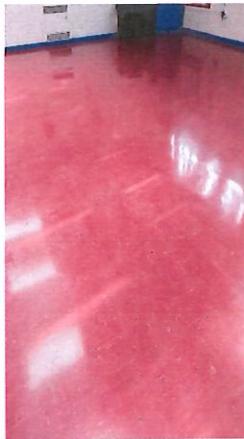
Material Assessment Ref	S016 –	
Building	Main	
Floor	Ground	
Room	005 Infants Hall	
Position	Floor	
Component	Floor Tiles & Adhesive	
Accessibility	Easy	
Lab	The Testing Lab PLC	
Next Inspection	No further action required	
Material Risk	3 (VL)	
Priority Risk	N/A	
Quantity	110 Sqr Mtrs	
Survey Type	Management	
Action	Manage	
Product Type	Thermo Plastic Floor Tiles	
Asbestos Type	Chrysotile	
Surface Treatment	Composite materials containing asbestos: reinforced plastics, resins, mastics, vinyl tiles, semi rigid paints or decorative finishes.	
Condition	Low damage: a few scratches or surface marks, broken edges on boards, tiles etc.	
Recommendations	Manage	
Comments	Red floor tiles and bitumen adhesive to concrete floor.

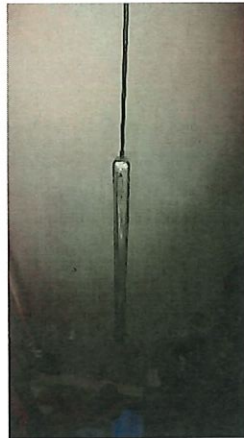
Material Assessment Ref	S017 – (As S010)	
Building	Main	
Floor	Ground	
Room	009 PE Store	
Position	Ceiling	
Component	Textured Coating To Ceiling	
Accessibility	Medium	
Lab	In-House Database	
Next Inspection	16/08/2023	
Material Risk	3 (VL)	
Priority Risk	N/A	
Quantity	10 Sqr Mtrs	
Survey Type	Management	
Action	Manage	
Product Type	Textured Coating	
Asbestos Type	Strongly Presumed Chrysotile	
Surface Treatment	Composite materials containing asbestos: reinforced plastics, resins, mastics, vinyl tiles, semi rigid paints or decorative finishes.	
Condition	Low damage: a few scratches or surface marks, broken edges on boards, tiles etc.	
Recommendations	Manage	
Comments	Textured coating to plasterboard ceiling.

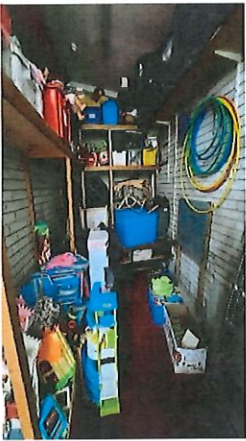
Material Assessment Ref	S018 –	
Building	Main	
Floor	Ground	
Room	009 PE Store	
Position	Walls Internal	
Component	Walls Internal	
Accessibility	N/A	
Lab	In-House Database	
Next Inspection	No further action required	
Material Risk	0 (VL)	
Priority Risk	N/A	
Quantity	Num	
Survey Type	Management	
Action	No further action required	
Product Type	Not Selected	
Asbestos Type	Non suspect material	
Surface Treatment	Not Selected	
Condition	Not Selected	
Recommendations	No further action required	
Comments	Brick walls. Glass door head panels.

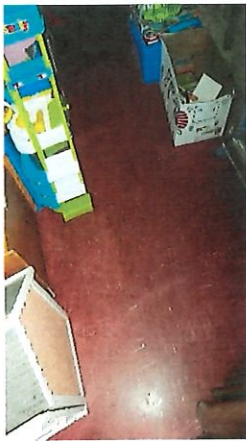
Material Assessment Ref	S019 – (As S016)	
Building	Main	
Floor	Ground	
Room	009 PE Store	
Position	Floor	
Component	Floor Tiles & Adhesive	
Accessibility	Easy	
Lab	In-House Database	
Next Inspection	No further action required	
Material Risk	3 (VL)	
Priority Risk	N/A	
Quantity	10 Sqr Mtrs	
Survey Type	Management	
Action	Manage	
Product Type	Thermo Plastic Floor Tiles	
Asbestos Type	Strongly Presumed Chrysotile	
Surface Treatment	Composite materials containing asbestos: reinforced plastics, resins, mastics, vinyl tiles, semi rigid paints or decorative finishes.	
Condition	Low damage: a few scratches or surface marks, broken edges on boards, tiles etc.	
Recommendations	Manage	
Comments	Red floor tiles and bitumen adhesive to concrete floor.

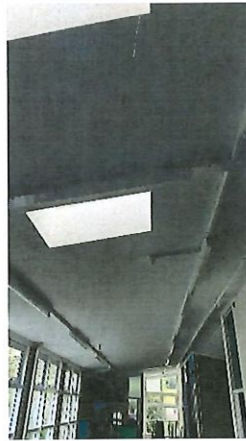
Material Assessment Ref	S020 –	
Building	Main	
Floor	Ground	
Room	010 Resource Area	
Position	Ceiling	
Component	Textured Coating To Ceiling	
Accessibility	Medium	
Lab	The Testing Lab PLC	
Next Inspection	16/08/2023	
Material Risk	3 (VL)	
Priority Risk	N/A	
Quantity	300 Sqr Mtrs	
Survey Type	Management	
Action	Manage	
Product Type	Textured Coating	
Asbestos Type	Chrysotile	
Surface Treatment	Composite materials containing asbestos: reinforced plastics, resins, mastics, vinyl tiles, semi rigid paints or decorative finishes.	
Condition	Low damage: a few scratches or surface marks, broken edges on boards, tiles etc.	
Recommendations	Manage	
Comments	Textured coating to plasterboard ceiling.

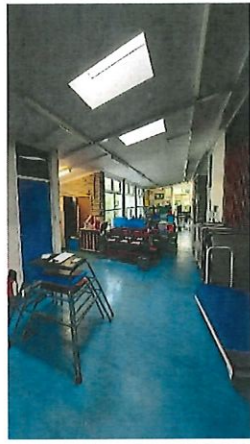
Material Assessment Ref	S021 –	
Building	Main	
Floor	Ground	
Room	010 Resource Area	
Position	Walls Internal	
Component	Walls Internal	
Accessibility	N/A	
Lab	In-House Database	
Next Inspection	No further action required	
Material Risk	0 (VL)	
Priority Risk	N/A	
Quantity	Num	
Survey Type	Management	
Action	No further action required	
Product Type	Not Selected	
Asbestos Type	Non suspect material	
Surface Treatment	Not Selected	
Condition	Not Selected	
Recommendations	No further action required	
Comments	Brick walls or plaster skim to plasterboard walls. Glass door head panels. Plastic downpipes.

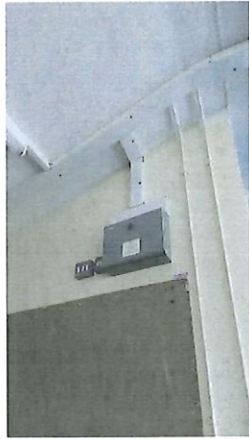
Material Assessment Ref	S023 –	
Building	Main	
Floor	Ground	
Room	010 Resource Area	
Position	Electrics	
Component	Electrics	
Accessibility	N/A	
Lab	In-House Database	
Next Inspection	No further action required	
Material Risk	0 (VL)	
Priority Risk	N/A	
Quantity	Num	
Survey Type	Management	
Action	No further action required	
Product Type	Not Selected	
Asbestos Type	Non suspect material	
Surface Treatment	Not Selected	
Condition	Not Selected	
Recommendations	No further action required	
Comments	Modern electrics.

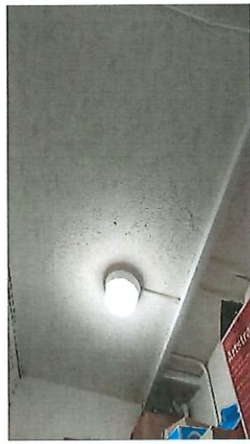
Material Assessment Ref	S024 – (As S020)	
Building	Main	
Floor	Ground	
Room	010A Art Store	
Position	Ceiling	
Component	Textured Coating To Ceiling	
Accessibility	Medium	
Lab	In-House Database	
Next Inspection	16/08/2023	
Material Risk	3 (VL)	
Priority Risk	N/A	
Quantity	3 Sqr Mtrs	
Survey Type	Management	
Action	Manage	
Product Type	Textured Coating	
Asbestos Type	Strongly Presumed Chrysotile	
Surface Treatment	Composite materials containing asbestos: reinforced plastics, resins, mastics, vinyl tiles, semi rigid paints or decorative finishes.	
Condition	Low damage: a few scratches or surface marks, broken edges on boards, tiles etc.	
Recommendations	Manage	
Comments	Textured coating to plasterboard ceiling.

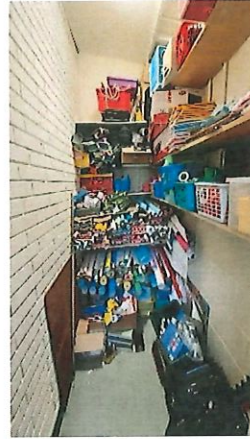
Material Assessment Ref	S025 –	
Building	Main	
Floor	Ground	
Room	010A Art Store	
Position	Walls Internal	
Component	Walls Internal	
Accessibility	N/A	
Lab	In-House Database	
Next Inspection	No further action required	
Material Risk	0 (VL)	
Priority Risk	N/A	
Quantity	Num	
Survey Type	Management	
Action	No further action required	
Product Type	Not Selected	
Asbestos Type	Non suspect material	
Surface Treatment	Not Selected	
Condition	Not Selected	
Recommendations	No further action required	
Comments	Brick walls.

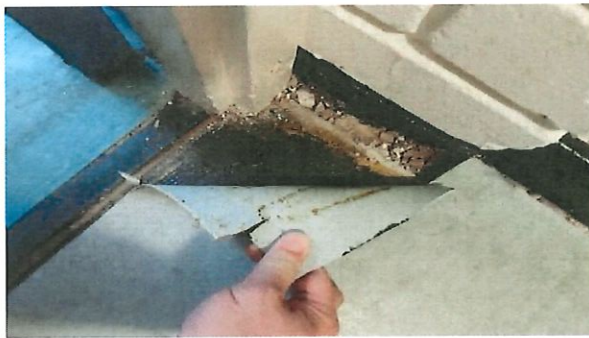
Material Assessment Ref	S026 –	
Building	Main	
Floor	Ground	
Room	010A Art Store	
Position	Below Floor Covering	
Component	Floor Tile Adhesive Only	
Accessibility	Difficult	
Lab	The Testing Lab PLC	
Next Inspection	16/08/2023	
Material Risk	3 (VL)	
Priority Risk	N/A	
Quantity	3 Sqr Mtrs	
Survey Type	Management	
Action	Manage	
Product Type	Bitumen Product	
Asbestos Type	Chrysotile	
Surface Treatment	Composite materials containing asbestos: reinforced plastics, resins, mastics, vinyl tiles, semi rigid paints or decorative finishes.	
Condition	Low damage: a few scratches or surface marks, broken edges on boards, tiles etc.	
Recommendations	Manage	
Comments	Bitumen adhesive to concrete floor beneath modern vinyl.

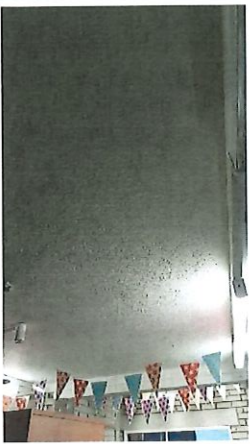
Material Assessment Ref	S027 – (As S020)	
Building	Main	
Floor	Ground	
Room	011 Classroom	
Position	Ceiling	
Component	Textured Coating To Ceiling	
Accessibility	Medium	
Lab	In-House Database	
Next Inspection	16/08/2023	
Material Risk	3 (VL)	
Priority Risk	N/A	
Quantity	40 Sqr Mtrs	
Survey Type	Management	
Action	Manage	
Product Type	Textured Coating	
Asbestos Type	Strongly Presumed Chrysotile	
Surface Treatment	Composite materials containing asbestos: reinforced plastics, resins, mastics, vinyl tiles, semi rigid paints or decorative finishes.	
Condition	Low damage: a few scratches or surface marks, broken edges on boards, tiles etc.	
Recommendations	Manage	
Comments	Textured coating to plasterboard ceiling.

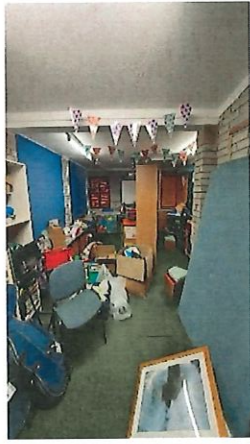
Material Assessment Ref	S028 –	
Building	Main	
Floor	Ground	
Room	011 Classroom	
Position	Walls Internal	
Component	Walls Internal	
Accessibility	N/A	
Lab	In-House Database	
Next Inspection	No further action required	
Material Risk	0 (VL)	
Priority Risk	N/A	
Quantity	Num	
Survey Type	Management	
Action	No further action required	
Product Type	Not Selected	
Asbestos Type	Non suspect material	
Surface Treatment	Not Selected	
Condition	Not Selected	
Recommendations	No further action required	
Comments	Brick walls.

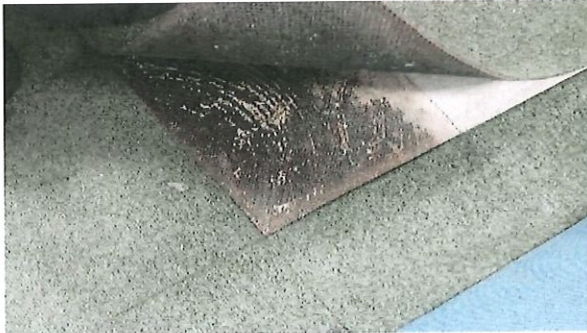
Material Assessment Ref	S029 – (As S026)	
Building	Main	
Floor	Ground	
Room	011 Classroom	
Position	Below Floor Covering	
Component	Floor Tile Adhesive Only	
Accessibility	Difficult	
Lab	In-House Database	
Next Inspection	16/08/2023	
Material Risk	3 (VL)	
Priority Risk	N/A	
Quantity	40 Sqr Mtrs	
Survey Type	Management	
Action	Manage	
Product Type	Bitumen Product	
Asbestos Type	Strongly Presumed Chrysotile	
Surface Treatment	Composite materials containing asbestos: reinforced plastics, resins, mastics, vinyl tiles, semi rigid paints or decorative finishes.	
Condition	Low damage: a few scratches or surface marks, broken edges on boards, tiles etc.	
Recommendations	Manage	
Comments	Bitumen adhesive to concrete floor beneath carpet.

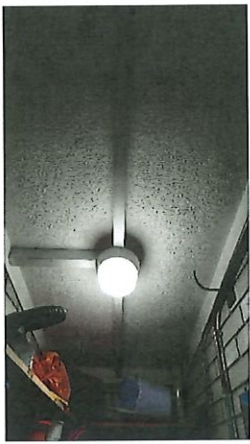
Material Assessment Ref	S030 – (As S020)	
Building	Main	
Floor	Ground	
Room	012 Cleaners Cupboard	
Position	Ceiling	
Component	Textured Coating To Ceiling	
Accessibility	Medium	
Lab	In-House Database	
Next Inspection	16/08/2023	
Material Risk	3 (VL)	
Priority Risk	N/A	
Quantity	2 Sqr Mtrs	
Survey Type	Management	
Action	Manage	
Product Type	Textured Coating	
Asbestos Type	Strongly Presumed Chrysotile	
Surface Treatment	Composite materials containing asbestos: reinforced plastics, resins, mastics, vinyl tiles, semi rigid paints or decorative finishes.	
Condition	Low damage: a few scratches or surface marks, broken edges on boards, tiles etc.	
Recommendations	Manage	
Comments	Textured coating to plasterboard ceiling.

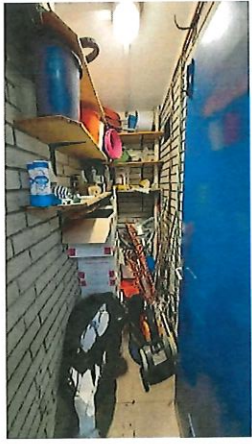
Material Assessment Ref	S031 –	
Building	Main	
Floor	Ground	
Room	012 Cleaners Cupboard	
Position	Walls Internal	
Component	Walls Internal	
Accessibility	N/A	
Lab	In-House Database	
Next Inspection	No further action required	
Material Risk	0 (VL)	
Priority Risk	N/A	
Quantity	Num	
Survey Type	Management	
Action	No further action required	
Product Type	Not Selected	
Asbestos Type	Non suspect material	
Surface Treatment	Not Selected	
Condition	Not Selected	
Recommendations	No further action required	
Comments	Brick walls. Plastic downpipe. Glass door head panel.

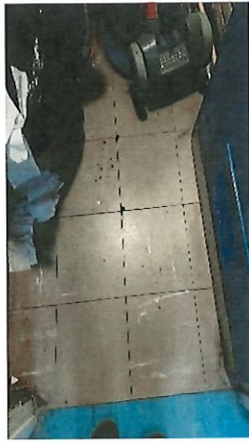
Material Assessment Ref	S032 – (As S009)	
Building	Main	
Floor	Ground	
Room	012 Cleaners Cupboard	
Position	Floor	
Component	Floor Tiles & Adhesive	
Accessibility	Easy	
Lab	In-House Database	
Next Inspection	16/08/2023	
Material Risk	2 (VL)	
Priority Risk	N/A	
Quantity	2 Sqr Mtrs	
Survey Type	Management	
Action	Manage	
Product Type	Thermo Plastic Floor Tiles	
Asbestos Type	Strongly Presumed Chrysotile	
Surface Treatment	Composite materials containing asbestos: reinforced plastics, resins, mastics, vinyl tiles, semi rigid paints or decorative finishes.	
Condition	Good condition: no visible damage.	
Recommendations	Manage	
Comments	Beige floor tiles and bitumen adhesive to concrete floor.

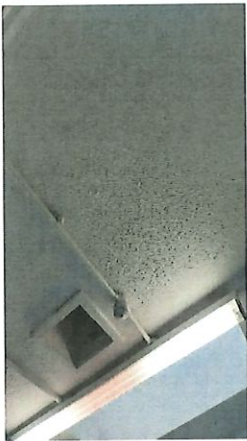
Material Assessment Ref	S033 – (As S020)	
Building	Main	
Floor	Ground	
Room	013 Girls Toilets	
Position	Ceiling	
Component	Textured Coating To Ceiling	
Accessibility	Medium	
Lab	In-House Database	
Next Inspection	16/08/2023	
Material Risk	3 (VL)	
Priority Risk	N/A	
Quantity	6 Sqr Mtrs	
Survey Type	Management	
Action	Manage	
Product Type	Textured Coating	
Asbestos Type	Strongly Presumed Chrysotile	
Surface Treatment	Composite materials containing asbestos: reinforced plastics, resins, mastics, vinyl tiles, semi rigid paints or decorative finishes.	
Condition	Low damage: a few scratches or surface marks, broken edges on boards, tiles etc.	
Recommendations	Manage	
Comments	Textured coating to plasterboard ceiling.

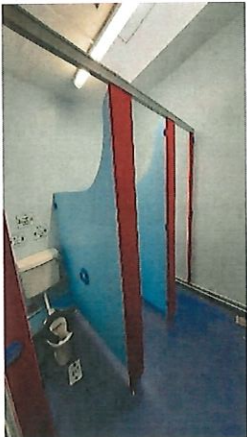
Material Assessment Ref	S034 –	
Building	Main	
Floor	Ground	
Room	013 Girls Toilets	
Position	Walls Internal	
Component	Walls Internal	
Accessibility	N/A	
Lab	In-House Database	
Next Inspection	No further action required	
Material Risk	0 (VL)	
Priority Risk	N/A	
Quantity	Num	
Survey Type	Management	
Action	No further action required	
Product Type	Not Selected	
Asbestos Type	Non suspect material	
Surface Treatment	Not Selected	
Condition	Not Selected	
Recommendations	No further action required	
Comments	Plaster skim to brick walls. Ceramic toilet cisterns.

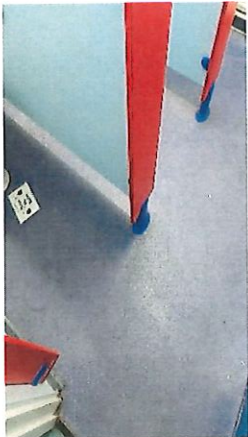
Material Assessment Ref	S035 –	
Building	Main	
Floor	Ground	
Room	013 Girls Toilets	
Position	Below Floor Covering	
Component	Below Floor Covering	
Accessibility	N/A	
Lab	In-House Database	
Next Inspection	No Access	
Material Risk	12 (H)	
Priority Risk	N/A	
Quantity	Num	
Survey Type	Management	
Action	Further investigation may be required.	
Product Type	No Access	
Asbestos Type	No Access	
Surface Treatment	No Access	
Condition	No Access	
Recommendations	Access was denied on the day of survey – see Inspection Comments (Material & Priority Assessment Records) for details.	
Comments	No access was possible beneath the modern vinyl without causing unnecessary damage.

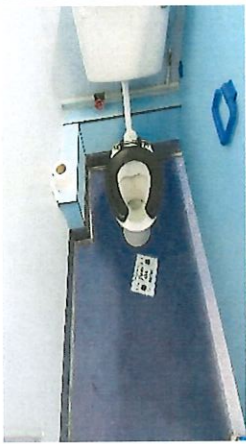
Material Assessment Ref	S036 –	
Building	Main	
Floor	Ground	
Room	013 Girls Toilets	
Position	Toilet Seat	
Component	Toilet Seat	
Accessibility	N/A	
Lab	The Testing Lab PLC	
Next Inspection	No Further Action Required	
Material Risk	0 (VL)	
Priority Risk	N/A	
Quantity	3 Num	
Survey Type	Management	
Action	No Further Action Required	
Product Type	Not Selected	
Asbestos Type	NADIS	
Surface Treatment	Not Selected	
Condition	Not Selected	
Recommendations	No further action required	
Comments	Black plastic toilet seats.

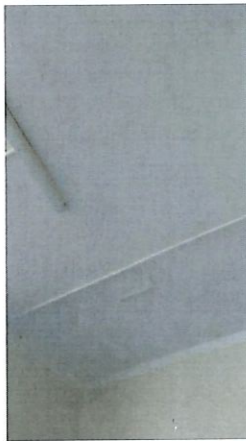
Material Assessment Ref	S037 – (As S020)	
Building	Main	
Floor	Ground	
Room	014 Cloaks	
Position	Ceiling	
Component	Textured Coating To Ceiling	
Accessibility	Medium	
Lab	In-House Database	
Next Inspection	16/08/2023	
Material Risk	3 (VL)	
Priority Risk	N/A	
Quantity	6 Sqr Mtrs	
Survey Type	Management	
Action	Manage	
Product Type	Textured Coating	
Asbestos Type	Strongly Presumed Chrysotile	
Surface Treatment	Composite materials containing asbestos: reinforced plastics, resins, mastics, vinyl tiles, semi rigid paints or decorative finishes.	
Condition	Low damage: a few scratches or surface marks, broken edges on boards, tiles etc.	
Recommendations	Manage	
Comments	Textured coating to plasterboard ceiling.

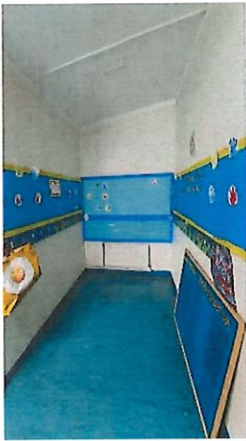
Material Assessment Ref	S038 –	
Building	Main	
Floor	Ground	
Room	014 Cloaks	
Position	Walls Internal	
Component	Walls Internal	
Accessibility	N/A	
Lab	In-House Database	
Next Inspection	No further action required	
Material Risk	0 (VL)	
Priority Risk	N/A	
Quantity	Num	
Survey Type	Management	
Action	No further action required	
Product Type	Not Selected	
Asbestos Type	Non suspect material	
Surface Treatment	Not Selected	
Condition	Not Selected	
Recommendations	No further action required	
Comments	Plaster skim to brick walls.

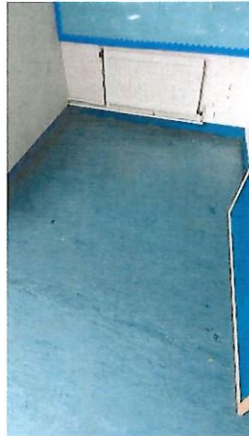
Material Assessment Ref	S039 –	
Building	Main	
Floor	Ground	
Room	014 Cloaks	
Position	Below Floor Covering	
Component	Below Floor Covering	
Accessibility	N/A	
Lab	In-House Database	
Next Inspection	No Access	
Material Risk	12 (H)	
Priority Risk	N/A	
Quantity	Num	
Survey Type	Management	
Action	Further investigation may be required.	
Product Type	No Access	
Asbestos Type	No Access	
Surface Treatment	No Access	
Condition	No Access	
Recommendations	Access was denied on the day of survey – see Inspection Comments (Material & Priority Assessment Records) for details.	
Comments	No access was possible beneath the modern vinyl without causing unnecessary damage.

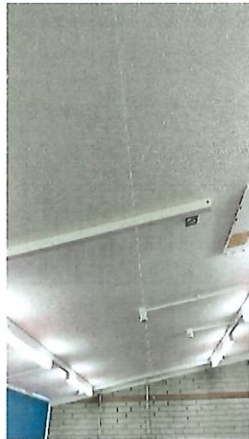
Material Assessment Ref	S040 – (As S020)	
Building	Main	
Floor	Ground	
Room	015 Classroom	
Position	Ceiling	
Component	Textured Coating To Ceiling	
Accessibility	Medium	
Lab	In-House Database	
Next Inspection	16/08/2023	
Material Risk	3 (VL)	
Priority Risk	N/A	
Quantity	50 Sqr Mtrs	
Survey Type	Management	
Action	Manage	
Product Type	Textured Coating	
Asbestos Type	Strongly Presumed Chrysotile	
Surface Treatment	Composite materials containing asbestos: reinforced plastics, resins, mastics, vinyl tiles, semi rigid paints or decorative finishes.	
Condition	Low damage: a few scratches or surface marks, broken edges on boards, tiles etc.	
Recommendations	Manage	
Comments	Textured coating to plasterboard ceiling.

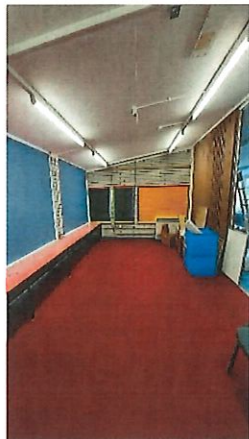
Material Assessment Ref	S041 –	
Building	Main	
Floor	Ground	
Room	015 Classroom	
Position	Walls & Floor	
Component	Walls & Floor	
Accessibility	N/A	
Lab	In-House Database	
Next Inspection	No further action required	
Material Risk	0 (VL)	
Priority Risk	N/A	
Quantity	Num	
Survey Type	Management	
Action	No further action required	
Product Type	Not Selected	
Asbestos Type	Non suspect material	
Surface Treatment	Not Selected	
Condition	Not Selected	
Recommendations	No further action required	
Comments	Brick walls and concrete floor beneath carpet.

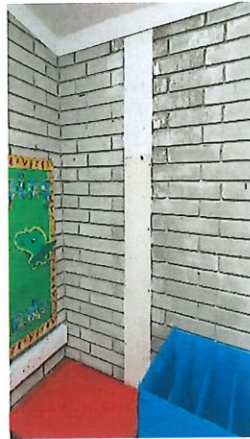
Material Assessment Ref	S042 –	
Building	Main	
Floor	Ground	
Room	015 Classroom	
Position	Behind Boxing	
Component	Behind Boxing	
Accessibility	N/A	
Lab	In-House Database	
Next Inspection	No Access	
Material Risk	12 (H)	
Priority Risk	N/A	
Quantity	Num	
Survey Type	Management	
Action	Further investigation may be required.	
Product Type	No Access	
Asbestos Type	No Access	
Surface Treatment	No Access	
Condition	No Access	
Recommendations	Access was denied on the day of survey – see Inspection Comments (Material & Priority Assessment Records) for details.	
Comments	No access was possible behind the wooden panel to wall without causing unnecessary damage.

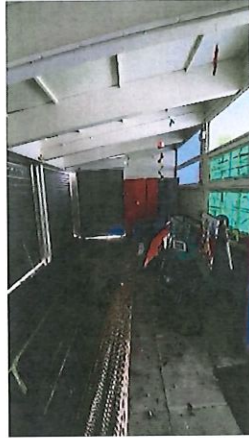
Material Assessment Ref	S043 –	
Building	Main	
Floor	Ground	
Room	016 Covered Play Area	
Position	Ceiling, Walls & Floor	
Component	Ceiling, Walls & Floor	
Accessibility	N/A	
Lab	In-House Database	
Next Inspection	No further action required	
Material Risk	0 (VL)	
Priority Risk	N/A	
Quantity	Num	
Survey Type	Management	
Action	No further action required	
Product Type	Not Selected	
Asbestos Type	Non suspect material	
Surface Treatment	Not Selected	
Condition	Not Selected	
Recommendations	No further action required	
Comments	Timber panels to ceiling, brick walls and concrete floor.

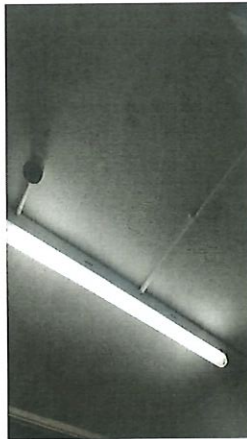
Material Assessment Ref	S044 – (As S020)	
Building	Main	
Floor	Ground	
Room	017 Boys Toilets	
Position	Ceiling	
Component	Textured Coating To Ceiling	
Accessibility	Medium	
Lab	In-House Database	
Next Inspection	16/08/2023	
Material Risk	3 (VL)	
Priority Risk	N/A	
Quantity	6 Sqr Mtrs	
Survey Type	Management	
Action	Manage	
Product Type	Textured Coating	
Asbestos Type	Strongly Presumed Chrysotile	
Surface Treatment	Composite materials containing asbestos: reinforced plastics, resins, mastics, vinyl tiles, semi rigid paints or decorative finishes.	
Condition	Low damage: a few scratches or surface marks, broken edges on boards, tiles etc.	
Recommendations	Manage	
Comments	Textured coating to plasterboard ceiling.

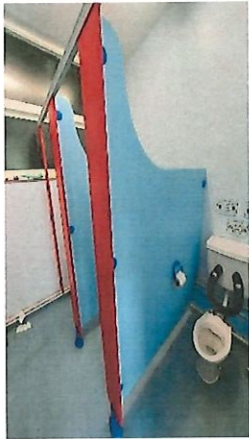
Material Assessment Ref	S045 –	
Building	Main	
Floor	Ground	
Room	017 Boys Toilets	
Position	Walls Internal	
Component	Walls Internal	
Accessibility	N/A	
Lab	In-House Database	
Next Inspection	No further action required	
Material Risk	0 (VL)	
Priority Risk	N/A	
Quantity	Num	
Survey Type	Management	
Action	No further action required	
Product Type	Not Selected	
Asbestos Type	Non suspect material	
Surface Treatment	Not Selected	
Condition	Not Selected	
Recommendations	No further action required	
Comments	Plaster skim to brick walls. Ceramic toilet cisterns.

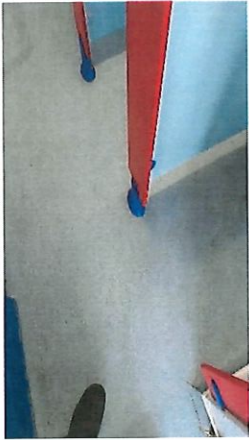
Material Assessment Ref	S046 –	
Building	Main	
Floor	Ground	
Room	017 Boys Toilets	
Position	Below Floor Covering	
Component	Below Floor Covering	
Accessibility	N/A	
Lab	In-House Database	
Next Inspection	No Access	
Material Risk	12 (H)	
Priority Risk	N/A	
Quantity	Num	
Survey Type	Management	
Action	Further investigation may be required.	
Product Type	No Access	
Asbestos Type	No Access	
Surface Treatment	No Access	
Condition	No Access	
Recommendations	Access was denied on the day of survey – see Inspection Comments (Material & Priority Assessment Records) for details.	
Comments	No access was possible beneath the modern vinyl without causing unnecessary damage.

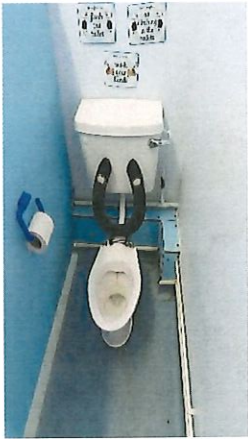
Material Assessment Ref	S047 – (As S036)	
Building	Main	
Floor	Ground	
Room	017 Boys Toilets	
Position	Toilet Seat	
Component	Toilet Seat	
Accessibility	N/A	
Lab	In-House Database	
Next Inspection	No Further Action Required	
Material Risk	0 (VL)	
Priority Risk	N/A	
Quantity	3 Num	
Survey Type	Management	
Action	No Further Action Required	
Product Type	Not Selected	
Asbestos Type	Non suspect material	
Surface Treatment	Not Selected	
Condition	Not Selected	
Recommendations	No further action required	
Comments	Black plastic toilet seats.

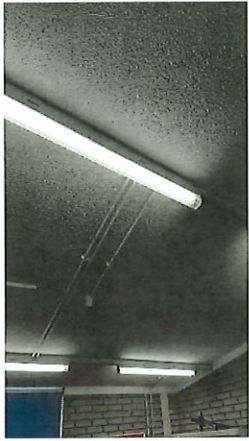
Material Assessment Ref	S048 – (As S020)	
Building	Main	
Floor	Ground	
Room	018 Classroom	
Position	Ceiling	
Component	Textured Coating To Ceiling	
Accessibility	Medium	
Lab	In-House Database	
Next Inspection	16/08/2023	
Material Risk	3 (VL)	
Priority Risk	N/A	
Quantity	50 Sqr Mtrs	
Survey Type	Management	
Action	Manage	
Product Type	Textured Coating	
Asbestos Type	Strongly Presumed Chrysotile	
Surface Treatment	Composite materials containing asbestos: reinforced plastics, resins, mastics, vinyl tiles, semi rigid paints or decorative finishes.	
Condition	Low damage: a few scratches or surface marks, broken edges on boards, tiles etc.	
Recommendations	Manage	
Comments	Textured coating to plasterboard ceiling.

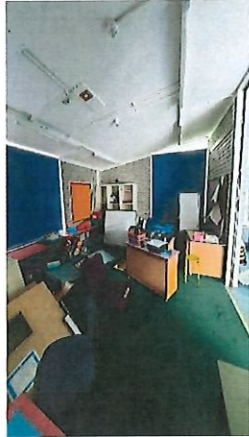
Material Assessment Ref	S049 –	
Building	Main	
Floor	Ground	
Room	018 Classroom	
Position	Walls & Floor	
Component	Walls & Floor	
Accessibility	N/A	
Lab	In-House Database	
Next Inspection	No further action required	
Material Risk	0 (VL)	
Priority Risk	N/A	
Quantity	Num	
Survey Type	Management	
Action	No further action required	
Product Type	Not Selected	
Asbestos Type	Non suspect material	
Surface Treatment	Not Selected	
Condition	Not Selected	
Recommendations	No further action required	
Comments	Brick walls and concrete floor beneath carpet.

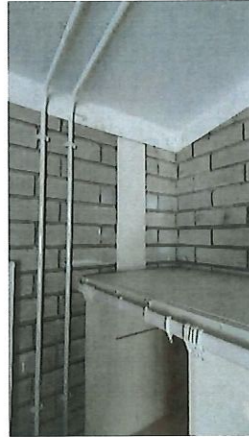
Material Assessment Ref	S050 –	
Building	Main	
Floor	Ground	
Room	018 Classroom	
Position	Behind Boxing	
Component	Behind Boxing	
Accessibility	N/A	
Lab	In-House Database	
Next Inspection	No Access	
Material Risk	12 (H)	
Priority Risk	N/A	
Quantity	Num	
Survey Type	Management	
Action	Further investigation may be required.	
Product Type	No Access	
Asbestos Type	No Access	
Surface Treatment	No Access	
Condition	No Access	
Recommendations	Access was denied on the day of survey – see Inspection Comments (Material & Priority Assessment Records) for details.	
Comments	No access was possible behind the wooden panel to wall without causing unnecessary damage.
