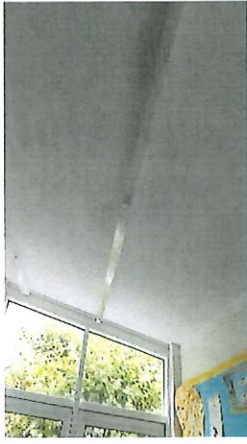
Material Assessment Ref	S051 – (As S020)	
Building	Main	
Floor	Ground	
Room	019 Cloaks	
Position	Ceiling	
Component	Textured Coating To Ceiling	
Accessibility	Medium	
Lab	In-House Database	
Next Inspection	16/08/2023	
Material Risk	3 (VL)	
Priority Risk	N/A	
Quantity	6 Sqr Mtrs	
Survey Type	Management	
Action	Manage	
Product Type	Textured Coating	
Asbestos Type	Strongly Presumed Chrysotile	
Surface Treatment	Composite materials containing asbestos: reinforced plastics, resins, mastics, vinyl tiles, semi rigid paints or decorative finishes.	
Condition	Low damage: a few scratches or surface marks, broken edges on boards, tiles etc.	
Recommendations	Manage	
Comments	Textured coating to plasterboard ceiling.

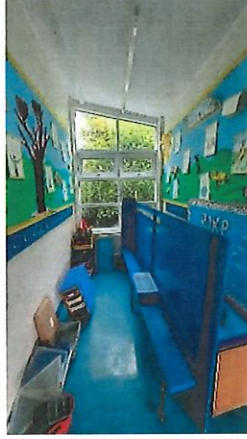
Material Assessment Ref	S052 –	
Building	Main	
Floor	Ground	
Room	019 Cloaks	
Position	Walls Internal	
Component	Walls Internal	
Accessibility	N/A	
Lab	In-House Database	
Next Inspection	No further action required	
Material Risk	0 (VL)	
Priority Risk	N/A	
Quantity	Num	
Survey Type	Management	
Action	No further action required	
Product Type	Not Selected	
Asbestos Type	Non suspect material	
Surface Treatment	Not Selected	
Condition	Not Selected	
Recommendations	No further action required	
Comments	Plaster skim to brick walls.

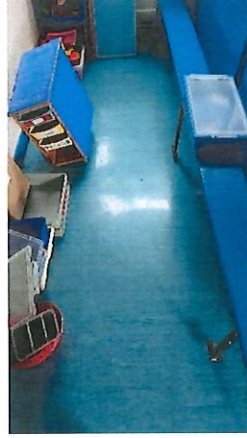
Material Assessment Ref	S053 –	
Building	Main	
Floor	Ground	
Room	019 Cloaks	
Position	Below Floor Covering	
Component	Below Floor Covering	
Accessibility	N/A	
Lab	In-House Database	
Next Inspection	No Access	
Material Risk	12 (H)	
Priority Risk	N/A	
Quantity	Num	
Survey Type	Management	
Action	Further investigation may be required.	
Product Type	No Access	
Asbestos Type	No Access	
Surface Treatment	No Access	
Condition	No Access	
Recommendations	Access was denied on the day of survey – see Inspection Comments (Material & Priority Assessment Records) for details.	
Comments	No access was possible beneath the modern vinyl without causing unnecessary damage.

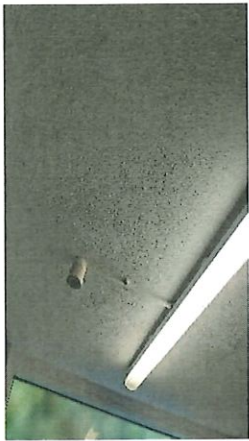
Material Assessment Ref	S054 – (As S020)	
Building	Main	
Floor	Ground	
Room	020 Girls Toilets	
Position	Ceiling	
Component	Textured Coating To Ceiling	
Accessibility	Medium	
Lab	In-House Database	
Next Inspection	16/08/2023	
Material Risk	3 (VL)	
Priority Risk	N/A	
Quantity	6 Sqr Mtrs	
Survey Type	Management	
Action	Manage	
Product Type	Textured Coating	
Asbestos Type	Strongly Presumed Chrysotile	
Surface Treatment	Composite materials containing asbestos: reinforced plastics, resins, mastics, vinyl tiles, semi rigid paints or decorative finishes.	
Condition	Low damage: a few scratches or surface marks, broken edges on boards, tiles etc.	
Recommendations	Manage	
Comments	Textured coating to plasterboard ceiling.

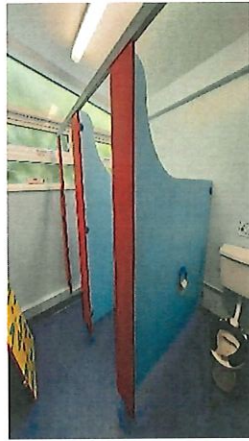
Material Assessment Ref	S055 –	
Building	Main	
Floor	Ground	
Room	020 Girls Toilets	
Position	Walls Internal	
Component	Walls Internal	
Accessibility	N/A	
Lab	In-House Database	
Next Inspection	No further action required	
Material Risk	0 (VL)	
Priority Risk	N/A	
Quantity	Num	
Survey Type	Management	
Action	No further action required	
Product Type	Not Selected	
Asbestos Type	Non suspect material	
Surface Treatment	Not Selected	
Condition	Not Selected	
Recommendations	No further action required	
Comments	Plaster skim to brick walls. Ceramic toilet cisterns.

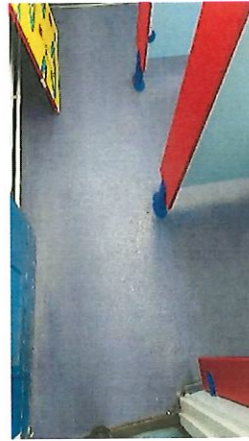
Material Assessment Ref	S056 –	
Building	Main	
Floor	Ground	
Room	020 Girls Toilets	
Position	Below Floor Covering	
Component	Below Floor Covering	
Accessibility	N/A	
Lab	In-House Database	
Next Inspection	No Access	
Material Risk	12 (H)	
Priority Risk	N/A	
Quantity	Num	
Survey Type	Management	
Action	Further investigation may be required.	
Product Type	No Access	
Asbestos Type	No Access	
Surface Treatment	No Access	
Condition	No Access	
Recommendations	Access was denied on the day of survey – see Inspection Comments (Material & Priority Assessment Records) for details.	
Comments	No access was possible beneath the modern vinyl without causing unnecessary damage.

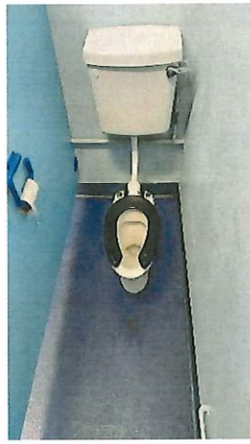
Material Assessment Ref	S057 – (As S036)	
Building	Main	
Floor	Ground	
Room	020 Girls Toilets	
Position	Toilet Seat	
Component	Toilet Seat	
Accessibility	N/A	
Lab	In-House Database	
Next Inspection	No Further Action Required	
Material Risk	0 (VL)	
Priority Risk	N/A	
Quantity	3 Num	
Survey Type	Management	
Action	No Further Action Required	
Product Type	Not Selected	
Asbestos Type	Non suspect material	
Surface Treatment	Not Selected	
Condition	Not Selected	
Recommendations	No further action required	
Comments	Black plastic toilet seats.

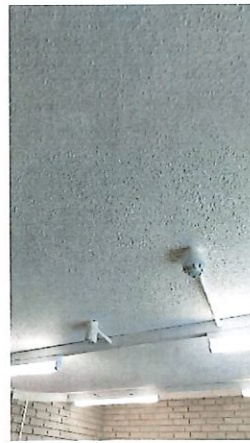
Material Assessment Ref	S058 – (As S020)	
Building	Main	
Floor	Ground	
Room	021 Classroom	
Position	Ceiling	
Component	Textured Coating To Ceiling	
Accessibility	Medium	
Lab	In-House Database	
Next Inspection	16/08/2023	
Material Risk	3 (VL)	
Priority Risk	N/A	
Quantity	50 Sqr Mtrs	
Survey Type	Management	
Action	Manage	
Product Type	Textured Coating	
Asbestos Type	Strongly Presumed Chrysotile	
Surface Treatment	Composite materials containing asbestos: reinforced plastics, resins, mastics, vinyl tiles, semi rigid paints or decorative finishes.	
Condition	Low damage: a few scratches or surface marks, broken edges on boards, tiles etc.	
Recommendations	Manage	
Comments	Textured coating to plasterboard ceiling.

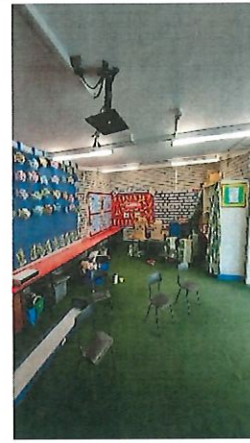
Material Assessment Ref	S059 –	
Building	Main	
Floor	Ground	
Room	021 Classroom	
Position	Walls & Floor	
Component	Walls & Floor	
Accessibility	N/A	
Lab	In-House Database	
Next Inspection	No further action required	
Material Risk	0 (VL)	
Priority Risk	N/A	
Quantity	Num	
Survey Type	Management	
Action	No further action required	
Product Type	Not Selected	
Asbestos Type	Non suspect material	
Surface Treatment	Not Selected	
Condition	Not Selected	
Recommendations	No further action required	
Comments	Brick walls and concrete floor beneath carpet.

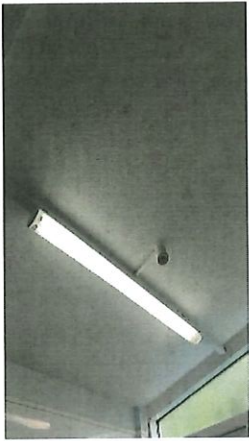
Material Assessment Ref	S060 – (As S020)	
Building	Main	
Floor	Ground	
Room	022 Boys Toilets	
Position	Ceiling	
Component	Textured Coating To Ceiling	
Accessibility	Medium	
Lab	In-House Database	
Next Inspection	16/08/2023	
Material Risk	3 (VL)	
Priority Risk	N/A	
Quantity	6 Sqr Mtrs	
Survey Type	Management	
Action	Manage	
Product Type	Textured Coating	
Asbestos Type	Strongly Presumed Chrysotile	
Surface Treatment	Composite materials containing asbestos: reinforced plastics, resins, mastics, vinyl tiles, semi rigid paints or decorative finishes.	
Condition	Low damage: a few scratches or surface marks, broken edges on boards, tiles etc.	
Recommendations	Manage	
Comments	Textured coating to plasterboard ceiling.

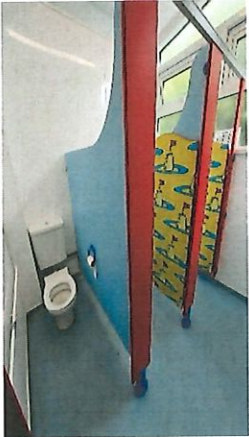
Material Assessment Ref	S061 –	
Building	Main	
Floor	Ground	
Room	022 Boys Toilets	
Position	Walls Internal	
Component	Walls Internal	
Accessibility	N/A	
Lab	In-House Database	
Next Inspection	No further action required	
Material Risk	0 (VL)	
Priority Risk	N/A	
Quantity	Num	
Survey Type	Management	
Action	No further action required	
Product Type	Not Selected	
Asbestos Type	Non suspect material	
Surface Treatment	Not Selected	
Condition	Not Selected	
Recommendations	No further action required	
Comments	Plaster skim to brick walls. Ceramic toilet cisterns and modern seats.

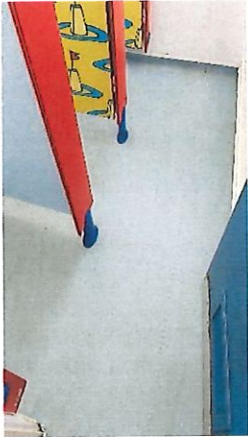
Material Assessment Ref	S062 –	
Building	Main	
Floor	Ground	
Room	022 Boys Toilets	
Position	Below Floor Covering	
Component	Below Floor Covering	
Accessibility	N/A	
Lab	In-House Database	
Next Inspection	No Access	
Material Risk	12 (H)	
Priority Risk	N/A	
Quantity	Num	
Survey Type	Management	
Action	Further investigation may be required.	
Product Type	No Access	
Asbestos Type	No Access	
Surface Treatment	No Access	
Condition	No Access	
Recommendations	Access was denied on the day of survey – see Inspection Comments (Material & Priority Assessment Records) for details.	
Comments	No access was possible beneath the modern vinyl without causing unnecessary damage.

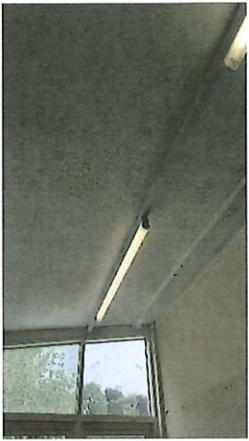
Material Assessment Ref	S063 – (As S020)	
Building	Main	
Floor	Ground	
Room	023 Cloaks	
Position	Ceiling	
Component	Textured Coating To Ceiling	
Accessibility	Medium	
Lab	In-House Database	
Next Inspection	16/08/2023	
Material Risk	3 (VL)	
Priority Risk	N/A	
Quantity	6 Sqr Mtrs	
Survey Type	Management	
Action	Manage	
Product Type	Textured Coating	
Asbestos Type	Strongly Presumed Chrysotile	
Surface Treatment	Composite materials containing asbestos: reinforced plastics, resins, mastics, vinyl tiles, semi rigid paints or decorative finishes.	
Condition	Low damage: a few scratches or surface marks, broken edges on boards, tiles etc.	
Recommendations	Manage	
Comments	Textured coating to plasterboard ceiling.

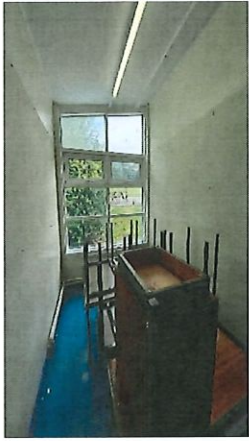
Material Assessment Ref	S064 –	
Building	Main	
Floor	Ground	
Room	023 Cloaks	
Position	Walls Internal	
Component	Walls Internal	
Accessibility	N/A	
Lab	In-House Database	
Next Inspection	No further action required	
Material Risk	0 (VL)	
Priority Risk	N/A	
Quantity	Num	
Survey Type	Management	
Action	No further action required	
Product Type	Not Selected	
Asbestos Type	Non suspect material	
Surface Treatment	Not Selected	
Condition	Not Selected	
Recommendations	No further action required	
Comments	Plaster skim to brick walls.

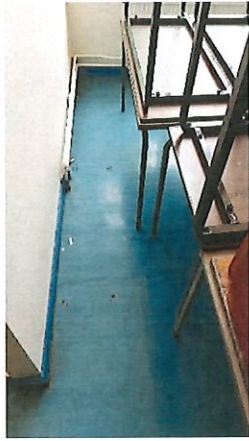
Material Assessment Ref	S065 –	
Building	Main	
Floor	Ground	
Room	023 Cloaks	
Position	Below Floor Covering	
Component	Below Floor Covering	
Accessibility	N/A	
Lab	In-House Database	
Next Inspection	No Access	
Material Risk	12 (H)	
Priority Risk	N/A	
Quantity	Num	
Survey Type	Management	
Action	Further investigation may be required.	
Product Type	No Access	
Asbestos Type	No Access	
Surface Treatment	No Access	
Condition	No Access	
Recommendations	Access was denied on the day of survey – see Inspection Comments (Material & Priority Assessment Records) for details.	
Comments	No access was possible beneath the modern vinyl without causing unnecessary damage.

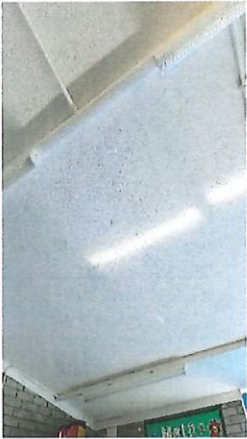
Material Assessment Ref	S066 – (As S020)	
Building	Main	
Floor	Ground	
Room	024 Classroom	
Position	Ceiling	
Component	Textured Coating To Ceiling	
Accessibility	Medium	
Lab	In-House Database	
Next Inspection	16/08/2023	
Material Risk	3 (VL)	
Priority Risk	N/A	
Quantity	50 Sqr Mtrs	
Survey Type	Management	
Action	Manage	
Product Type	Textured Coating	
Asbestos Type	Strongly Presumed Chrysotile	
Surface Treatment	Composite materials containing asbestos: reinforced plastics, resins, mastics, vinyl tiles, semi rigid paints or decorative finishes.	
Condition	Low damage: a few scratches or surface marks, broken edges on boards, tiles etc.	
Recommendations	Manage	
Comments	Textured coating to plasterboard ceiling.

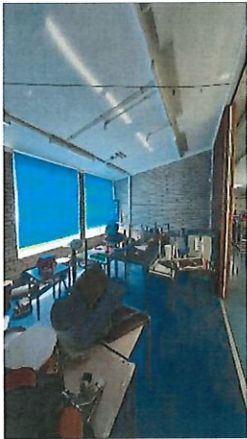
Material Assessment Ref	S067 –	
Building	Main	
Floor	Ground	
Room	024 Classroom	
Position	Walls & Floor	
Component	Walls & Floor	
Accessibility	N/A	
Lab	In-House Database	
Next Inspection	No further action required	
Material Risk	0 (VL)	
Priority Risk	N/A	
Quantity	Num	
Survey Type	Management	
Action	No further action required	
Product Type	Not Selected	
Asbestos Type	Non suspect material	
Surface Treatment	Not Selected	
Condition	Not Selected	
Recommendations	No further action required	
Comments	Brick walls and concrete floor beneath carpet.

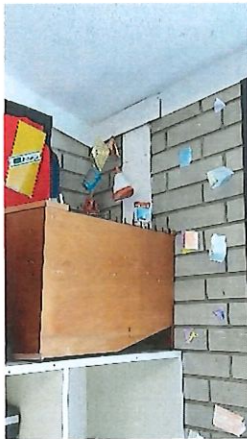
Material Assessment Ref	S068 –	
Building	Main	
Floor	Ground	
Room	024 Classroom	
Position	Behind Boxing	
Component	Behind Boxing	
Accessibility	N/A	
Lab	In-House Database	
Next Inspection	No Access	
Material Risk	12 (H)	
Priority Risk	N/A	
Quantity	Num	
Survey Type	Management	
Action	Further investigation may be required.	
Product Type	No Access	
Asbestos Type	No Access	
Surface Treatment	No Access	
Condition	No Access	
Recommendations	Access was denied on the day of survey – see Inspection Comments (Material & Priority Assessment Records) for details.	
Comments	No access was possible behind the wooden panel to wall without causing unnecessary damage.

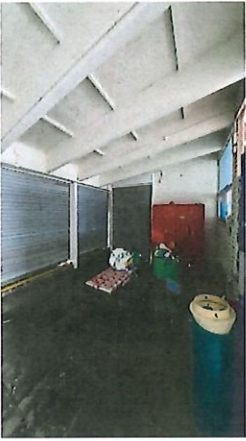
Material Assessment Ref	S069 –	
Building	Main	
Floor	Ground	
Room	026 Covered Play Area	
Position	Ceiling, Walls & Floor	
Component	Ceiling, Walls & Floor	
Accessibility	N/A	
Lab	In-House Database	
Next Inspection	No further action required	
Material Risk	0 (VL)	
Priority Risk	N/A	
Quantity	Num	
Survey Type	Management	
Action	No further action required	
Product Type	Not Selected	
Asbestos Type	Non suspect material	
Surface Treatment	Not Selected	
Condition	Not Selected	
Recommendations	No further action required	
Comments	Timber panels to ceiling, brick walls and concrete floor.

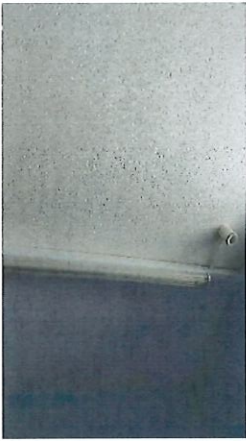
Material Assessment Ref	S070 – (As S020)	
Building	Main	
Floor	Ground	
Room	027 Girls Toilets	
Position	Ceiling	
Component	Textured Coating To Ceiling	
Accessibility	Medium	
Lab	In-House Database	
Next Inspection	16/08/2023	
Material Risk	3 (VL)	
Priority Risk	N/A	
Quantity	6 Sqr Mtrs	
Survey Type	Management	
Action	Manage	
Product Type	Textured Coating	
Asbestos Type	Strongly Presumed Chrysotile	
Surface Treatment	Composite materials containing asbestos: reinforced plastics, resins, mastics, vinyl tiles, semi rigid paints or decorative finishes.	
Condition	Low damage: a few scratches or surface marks, broken edges on boards, tiles etc.	
Recommendations	Manage	
Comments	Textured coating to plasterboard ceiling.

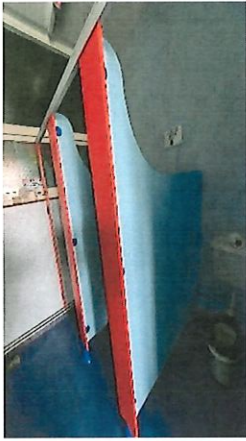
Material Assessment Ref	S071 –	
Building	Main	
Floor	Ground	
Room	027 Girls Toilets	
Position	Walls Internal	
Component	Walls Internal	
Accessibility	N/A	
Lab	In-House Database	
Next Inspection	No further action required	
Material Risk	0 (VL)	
Priority Risk	N/A	
Quantity	Num	
Survey Type	Management	
Action	No further action required	
Product Type	Not Selected	
Asbestos Type	Non suspect material	
Surface Treatment	Not Selected	
Condition	Not Selected	
Recommendations	No further action required	
Comments	Plaster skim to brick walls. Ceramic toilet cisterns.

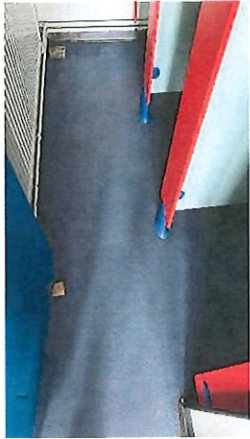
Material Assessment Ref	S072 –	
Building	Main	
Floor	Ground	
Room	027 Girls Toilets	
Position	Below Floor Covering	
Component	Below Floor Covering	
Accessibility	N/A	
Lab	In-House Database	
Next Inspection	No Access	
Material Risk	12 (H)	
Priority Risk	N/A	
Quantity	Num	
Survey Type	Management	
Action	Further investigation may be required.	
Product Type	No Access	
Asbestos Type	No Access	
Surface Treatment	No Access	
Condition	No Access	
Recommendations	Access was denied on the day of survey – see Inspection Comments (Material & Priority Assessment Records) for details.	
Comments	No access was possible beneath the modern vinyl without causing unnecessary damage.

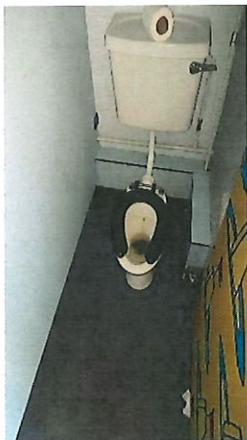
Material Assessment Ref	S073 – (As S036)	
Building	Main	
Floor	Ground	
Room	027 Girls Toilets	
Position	Toilet Seat	
Component	Toilet Seat	
Accessibility	N/A	
Lab	In-House Database	
Next Inspection	No Further Action Required	
Material Risk	0 (VL)	
Priority Risk	N/A	
Quantity	3 Num	
Survey Type	Management	
Action	No Further Action Required	
Product Type	Not Selected	
Asbestos Type	Non suspect material	
Surface Treatment	Not Selected	
Condition	Not Selected	
Recommendations	No further action required	
Comments	Black plastic toilet seats.

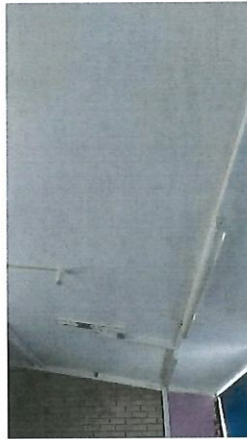
Material Assessment Ref	S074 – (As S020)	
Building	Main	
Floor	Ground	
Room	028 Classroom	
Position	Ceiling	
Component	Textured Coating To Ceiling	
Accessibility	Medium	
Lab	In-House Database	
Next Inspection	16/08/2023	
Material Risk	3 (VL)	
Priority Risk	N/A	
Quantity	50 Sqr Mtrs	
Survey Type	Management	
Action	Manage	
Product Type	Textured Coating	
Asbestos Type	Strongly Presumed Chrysotile	
Surface Treatment	Composite materials containing asbestos: reinforced plastics, resins, mastics, vinyl tiles, semi rigid paints or decorative finishes.	
Condition	Low damage: a few scratches or surface marks, broken edges on boards, tiles etc.	
Recommendations	Manage	
Comments	Textured coating to plasterboard ceiling.

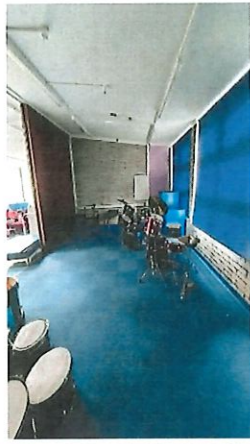
Material Assessment Ref	S075 –	
Building	Main	
Floor	Ground	
Room	028 Classroom	
Position	Walls & Floor	
Component	Walls & Floor	
Accessibility	N/A	
Lab	In-House Database	
Next Inspection	No further action required	
Material Risk	0 (VL)	
Priority Risk	N/A	
Quantity	Num	
Survey Type	Management	
Action	No further action required	
Product Type	Not Selected	
Asbestos Type	Non suspect material	
Surface Treatment	Not Selected	
Condition	Not Selected	
Recommendations	No further action required	
Comments	Brick walls and concrete floor beneath carpet.

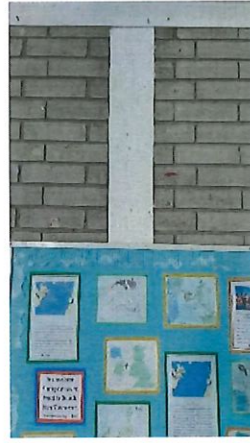
Material Assessment Ref	S076 –	
Building	Main	
Floor	Ground	
Room	028 Classroom	
Position	Behind Boxing	
Component	Behind Boxing	
Accessibility	N/A	
Lab	In-House Database	
Next Inspection	No Access	
Material Risk	12 (H)	
Priority Risk	N/A	
Quantity	Num	
Survey Type	Management	
Action	Further investigation may be required.	
Product Type	No Access	
Asbestos Type	No Access	
Surface Treatment	No Access	
Condition	No Access	
Recommendations	Access was denied on the day of survey – see Inspection Comments (Material & Priority Assessment Records) for details.	
Comments	No access was possible behind the wooden panel to wall without causing unnecessary damage.

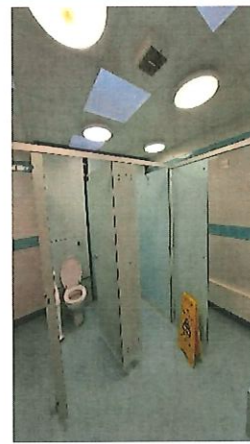
Material Assessment Ref	S077 –	
Building	Main	
Floor	Ground	
Room	029 Female Toilets	
Position	Ceiling & Walls	
Component	Ceiling & Walls	
Accessibility	N/A	
Lab	In-House Database	
Next Inspection	No further action required	
Material Risk	0 (VL)	
Priority Risk	N/A	
Quantity	Num	
Survey Type	Management	
Action	No further action required	
Product Type	Not Selected	
Asbestos Type	Non suspect material	
Surface Treatment	Not Selected	
Condition	Not Selected	
Recommendations	No further action required	
Comments	Timber roof decking boards above suspended ceiling and plaster skim to plasterboard and brick walls with ceramic tiles. Modern toilet cisterns and seats.

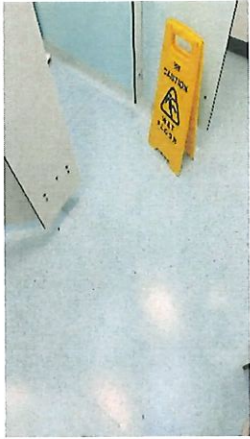
Material Assessment Ref	S078 –	
Building	Main	
Floor	Ground	
Room	029 Female Toilets	
Position	Below Floor Covering	
Component	Below Floor Covering	
Accessibility	N/A	
Lab	In-House Database	
Next Inspection	No Access	
Material Risk	12 (H)	
Priority Risk	N/A	
Quantity	Num	
Survey Type	Management	
Action	Further investigation may be required.	
Product Type	No Access	
Asbestos Type	No Access	
Surface Treatment	No Access	
Condition	No Access	
Recommendations	Access was denied on the day of survey – see Inspection Comments (Material & Priority Assessment Records) for details.	
Comments	No access was possible beneath the modern vinyl without causing unnecessary damage.

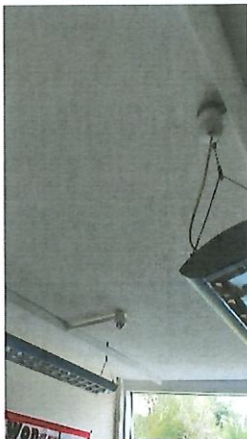
Material Assessment Ref	S079 – (As S001)	
Building	Main	
Floor	Ground	
Room	030 Head Teachers Office	
Position	Ceiling	
Component	Textured Coating To Ceiling	
Accessibility	Medium	
Lab	In-House Database	
Next Inspection	16/08/2023	
Material Risk	3 (VL)	
Priority Risk	N/A	
Quantity	16 Sqr Mtrs	
Survey Type	Management	
Action	Manage	
Product Type	Textured Coating	
Asbestos Type	Strongly Presumed Chrysotile	
Surface Treatment	Composite materials containing asbestos: reinforced plastics, resins, mastics, vinyl tiles, semi rigid paints or decorative finishes.	
Condition	Low damage: a few scratches or surface marks, broken edges on boards, tiles etc.	
Recommendations	Manage	
Comments	Textured coating to plasterboard ceiling.

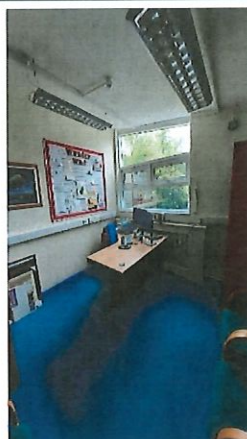
Material Assessment Ref	S080 –	
Building	Main	
Floor	Ground	
Room	030 Head Teachers Office	
Position	Walls Internal	
Component	Walls Internal	
Accessibility	N/A	
Lab	In-House Database	
Next Inspection	No further action required	
Material Risk	0 (VL)	
Priority Risk	N/A	
Quantity	Num	
Survey Type	Management	
Action	No further action required	
Product Type	Not Selected	
Asbestos Type	Non suspect material	
Surface Treatment	Not Selected	
Condition	Not Selected	
Recommendations	No further action required	
Comments	Plaster skim to brick walls. Glass door head panel.

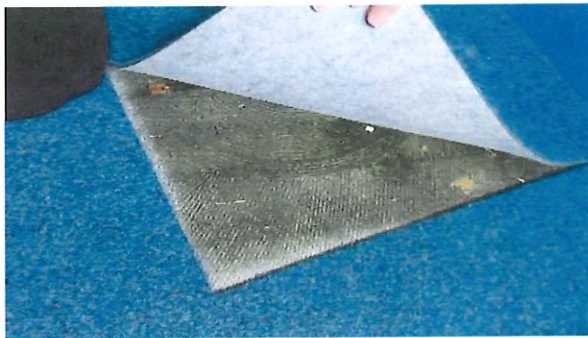
Material Assessment Ref	S081 – (As S026)	
Building	Main	
Floor	Ground	
Room	030 Head Teachers Office	
Position	Below Floor Covering	
Component	Floor Tile Adhesive Only	
Accessibility	Difficult	
Lab	In-House Database	
Next Inspection	16/08/2023	
Material Risk	3 (VL)	
Priority Risk	N/A	
Quantity	16 Sqr Mtrs	
Survey Type	Management	
Action	Manage	
Product Type	Bitumen Product	
Asbestos Type	Strongly Presumed Chrysotile	
Surface Treatment	Composite materials containing asbestos: reinforced plastics, resins, mastics, vinyl tiles, semi rigid paints or decorative finishes.	
Condition	Low damage: a few scratches or surface marks, broken edges on boards, tiles etc.	
Recommendations	Manage	
Comments	Bitumen adhesive to concrete floor beneath carpet.

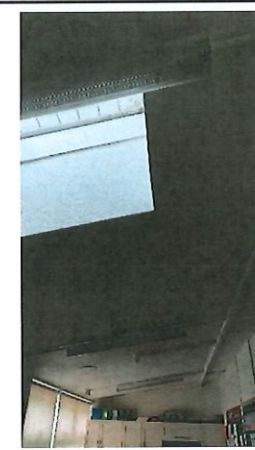
Material Assessment Ref	S082 – (As S001)	
Building	Main	
Floor	Ground	
Room	031 Staff Room	
Position	Ceiling	
Component	Textured Coating To Ceiling	
Accessibility	Medium	
Lab	In-House Database	
Next Inspection	16/08/2023	
Material Risk	3 (VL)	
Priority Risk	N/A	
Quantity	50 Sqr Mtrs	
Survey Type	Management	
Action	Manage	
Product Type	Textured Coating	
Asbestos Type	Strongly Presumed Chrysotile	
Surface Treatment	Composite materials containing asbestos: reinforced plastics, resins, mastics, vinyl tiles, semi rigid paints or decorative finishes.	
Condition	Low damage: a few scratches or surface marks, broken edges on boards, tiles etc.	
Recommendations	Manage	
Comments	Textured coating to plasterboard ceiling.

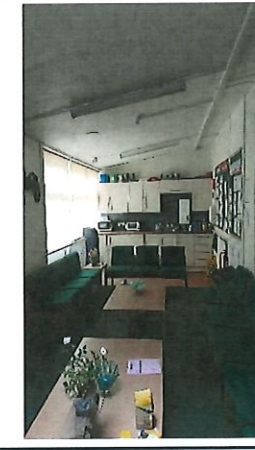
Material Assessment Ref	S083 –	
Building	Main	
Floor	Ground	
Room	031 Staff Room	
Position	Walls & Floor	
Component	Walls & Floor	
Accessibility	N/A	
Lab	In-House Database	
Next Inspection	No further action required	
Material Risk	0 (VL)	
Priority Risk	N/A	
Quantity	Num	
Survey Type	Management	
Action	No further action required	
Product Type	Not Selected	
Asbestos Type	Non suspect material	
Surface Treatment	Not Selected	
Condition	Not Selected	
Recommendations	No further action required	
Comments	Plaster skim to plasterboard and brick walls and concrete floor beneath modern vinyl and carpet. Glass door head panel. Modern sink unit.

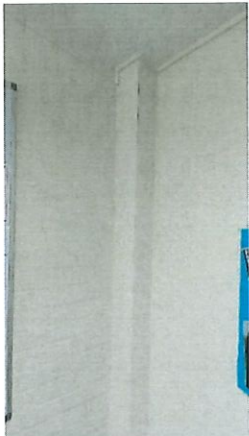
Material Assessment Ref	S084 –	
Building	Main	
Floor	Ground	
Room	031 Staff Room	
Position	Behind Boxing	
Component	Behind Boxing	
Accessibility	N/A	
Lab	In-House Database	
Next Inspection	No Access	
Material Risk	12 (H)	
Priority Risk	N/A	
Quantity	Num	
Survey Type	Management	
Action	Further investigation may be required.	
Product Type	No Access	
Asbestos Type	No Access	
Surface Treatment	No Access	
Condition	No Access	
Recommendations	Access was denied on the day of survey – see Inspection Comments (Material & Priority Assessment Records) for details.	
Comments	No access was possible behind the wooden boxings without causing unnecessary damage.

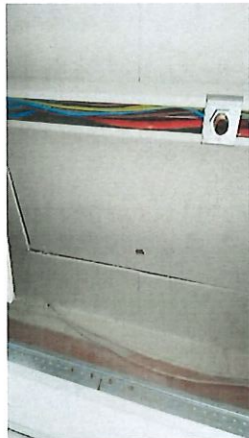
Material Assessment Ref	S085 –	
Building	Main	
Floor	Ground	
Room	031A Passage	
Position	Ceiling	
Component	Ceiling	
Accessibility	N/A	
Lab	The Testing Lab PLC	
Next Inspection	No Further Action Required	
Material Risk	0 (VL)	
Priority Risk	N/A	
Quantity	8 Sqr Mtrs	
Survey Type	Management	
Action	No Further Action Required	
Product Type	Not Selected	
Asbestos Type	NADIS	
Surface Treatment	Not Selected	
Condition	Not Selected	
Recommendations	No further action required	
Comments	Insulating boards to the ceiling above the suspended ceiling.

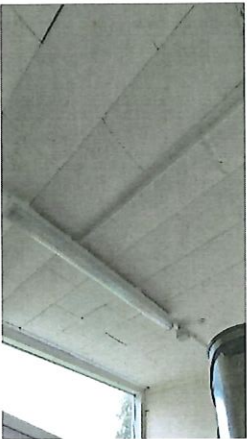
Material Assessment Ref	S087 – (As S085)	
Building	Main	
Floor	Ground	
Room	032 Site Managers Room	
Position	Ceiling	
Component	Ceiling	
Accessibility	N/A	
Lab	In-House Database	
Next Inspection	No Further Action Required	
Material Risk	0 (VL)	
Priority Risk	N/A	
Quantity	8 Sqr Mtrs	
Survey Type	Management	
Action	No Further Action Required	
Product Type	Not Selected	
Asbestos Type	Non suspect material	
Surface Treatment	Not Selected	
Condition	Not Selected	
Recommendations	No further action required	
Comments	Insulating boards to the ceiling.

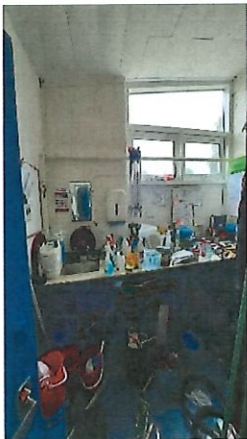
Material Assessment Ref	S088 –	
Building	Main	
Floor	Ground	
Room	032 Site Managers Room	
Position	Walls Internal	
Component	Walls Internal	
Accessibility	N/A	
Lab	In-House Database	
Next Inspection	No further action required	
Material Risk	0 (VL)	
Priority Risk	N/A	
Quantity	Num	
Survey Type	Management	
Action	No further action required	
Product Type	Not Selected	
Asbestos Type	Non suspect material	
Surface Treatment	Not Selected	
Condition	Not Selected	
Recommendations	No further action required	
Comments	Brick walls. Glass door head panel.

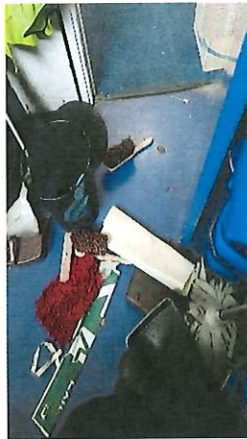
Material Assessment Ref	S089 –	
Building	Main	
Floor	Ground	
Room	032 Site Managers Room	
Position	Below Floor Covering	
Component	Below Floor Covering	
Accessibility	N/A	
Lab	In-House Database	
Next Inspection	No Access	
Material Risk	12 (H)	
Priority Risk	N/A	
Quantity	Num	
Survey Type	Management	
Action	Further investigation may be required.	
Product Type	No Access	
Asbestos Type	No Access	
Surface Treatment	No Access	
Condition	No Access	
Recommendations	Access was denied on the day of survey – see Inspection Comments (Material & Priority Assessment Records) for details.	
Comments	No access was possible beneath the modern vinyl without causing unnecessary damage.

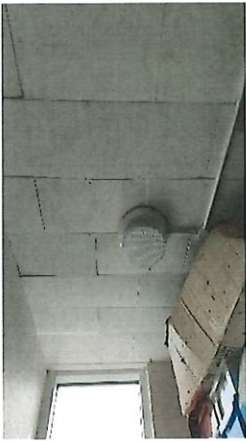
Material Assessment Ref	S090 – (As S085)	
Building	Main	
Floor	Ground	
Room	033 Store Room	
Position	Ceiling	
Component	Ceiling	
Accessibility	N/A	
Lab	In-House Database	
Next Inspection	No Further Action Required	
Material Risk	0 (VL)	
Priority Risk	N/A	
Quantity	4 Sqr Mtrs	
Survey Type	Management	
Action	No Further Action Required	
Product Type	Not Selected	
Asbestos Type	Non suspect material	
Surface Treatment	Not Selected	
Condition	Not Selected	
Recommendations	No further action required	
Comments	Insulating boards to the ceiling.

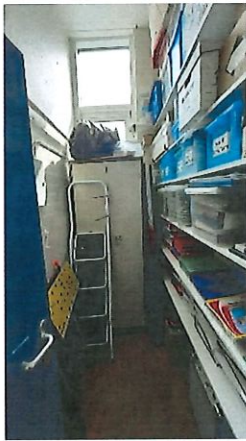
Material Assessment Ref	S091 –	
Building	Main	
Floor	Ground	
Room	033 Store Room	
Position	Walls Internal	
Component	Walls Internal	
Accessibility	N/A	
Lab	In-House Database	
Next Inspection	No further action required	
Material Risk	0 (VL)	
Priority Risk	N/A	
Quantity	Num	
Survey Type	Management	
Action	No further action required	
Product Type	Not Selected	
Asbestos Type	Non suspect material	
Surface Treatment	Not Selected	
Condition	Not Selected	
Recommendations	No further action required	
Comments	Brick walls. Glass door head panel.

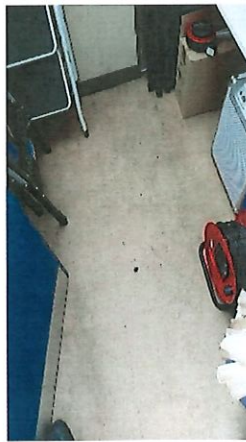
Material Assessment Ref	S092 – (As S009)	
Building	Main	
Floor	Ground	
Room	033 Store Room	
Position	Floor	
Component	Floor Tiles & Adhesive	
Accessibility	Easy	
Lab	In-House Database	
Next Inspection	16/08/2023	
Material Risk	2 (VL)	
Priority Risk	N/A	
Quantity	4 Sqr Mtrs	
Survey Type	Management	
Action	Manage	
Product Type	Thermo Plastic Floor Tiles	
Asbestos Type	Strongly Presumed Chrysotile	
Surface Treatment	Composite materials containing asbestos: reinforced plastics, resins, mastics, vinyl tiles, semi rigid paints or decorative finishes.	
Condition	Good condition: no visible damage.	
Recommendations	Manage	
Comments	Beige floor tiles and bitumen adhesive to concrete floor.

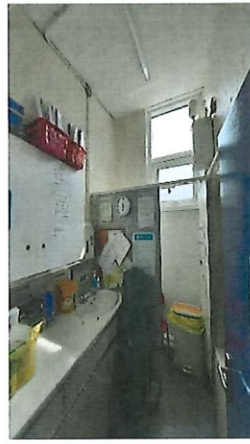
Material Assessment Ref	S093 –	
Building	Main	
Floor	Ground	
Room	034 First Aid Room	
Position	Ceiling & Walls	
Component	Ceiling & Walls	
Accessibility	N/A	
Lab	In-House Database	
Next Inspection	16/08/2023	
Material Risk	0 (VL)	
Priority Risk	N/A	
Quantity	Num	
Survey Type	Management	
Action	No further action required	
Product Type	Not Selected	
Asbestos Type	Non suspect material	
Surface Treatment	Not Selected	
Condition	Not Selected	
Recommendations	No further action required	
Comments	Timber panels to ceiling and brick walls. Glass door head panel.

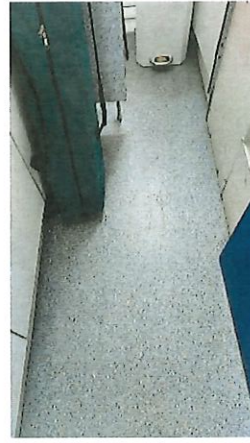
Material Assessment Ref	S094 –	
Building	Main	
Floor	Ground	
Room	034 First Aid Room	
Position	Below Floor Covering	
Component	Below Floor Covering	
Accessibility	N/A	
Lab	In-House Database	
Next Inspection	No Access	
Material Risk	12 (H)	
Priority Risk	N/A	
Quantity	Num	
Survey Type	Management	
Action	Further investigation may be required.	
Product Type	No Access	
Asbestos Type	No Access	
Surface Treatment	No Access	
Condition	No Access	
Recommendations	Access was denied on the day of survey – see Inspection Comments (Material & Priority Assessment Records) for details.	
Comments	No access was possible beneath the modern vinyl without causing unnecessary damage.

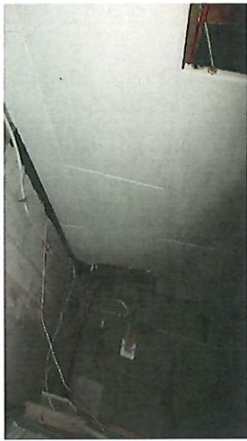
Material Assessment Ref	S096 – (As S085)	
Building	Main	
Floor	Ground	
Room	035 Wet Room	
Position	Ceiling	
Component	Ceiling	
Accessibility	N/A	
Lab	In-House Database	
Next Inspection	No Further Action Required	
Material Risk	0 (VL)	
Priority Risk	N/A	
Quantity	9 Sqr Mtrs	
Survey Type	Management	
Action	No Further Action Required	
Product Type	Not Selected	
Asbestos Type	Non suspect material	
Surface Treatment	Not Selected	
Condition	Not Selected	
Recommendations	No further action required	
Comments	Insulating boards to the ceiling above the suspended ceiling.

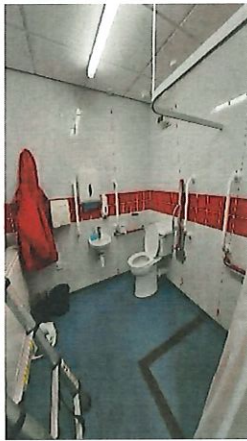
Material Assessment Ref	S097 –	
Building	Main	
Floor	Ground	
Room	035 Wet Room	
Position	Walls Internal	
Component	Walls Internal	
Accessibility	N/A	
Lab	In-House Database	
Next Inspection	No further action required	
Material Risk	0 (VL)	
Priority Risk	N/A	
Quantity	Num	
Survey Type	Management	
Action	No further action required	
Product Type	Not Selected	
Asbestos Type	Non suspect material	
Surface Treatment	Not Selected	
Condition	Not Selected	
Recommendations	No further action required	
Comments	Plaster skim to brick walls with ceramic tiles. Ceramic toilet cistern and plastic soil pipe.

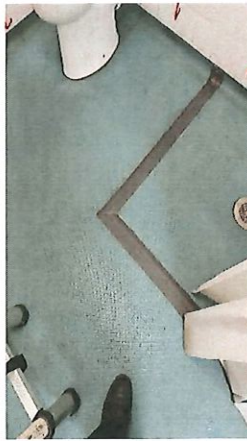
Material Assessment Ref	S098 –	
Building	Main	
Floor	Ground	
Room	035 Wet Room	
Position	Below Floor Covering	
Component	Below Floor Covering	
Accessibility	N/A	
Lab	In-House Database	
Next Inspection	No Access	
Material Risk	12 (H)	
Priority Risk	N/A	
Quantity	Num	
Survey Type	Management	
Action	Further investigation may be required.	
Product Type	No Access	
Asbestos Type	No Access	
Surface Treatment	No Access	
Condition	No Access	
Recommendations	Access was denied on the day of survey – see Inspection Comments (Material & Priority Assessment Records) for details.	
Comments	No access was possible beneath the modern vinyl without causing unnecessary damage.

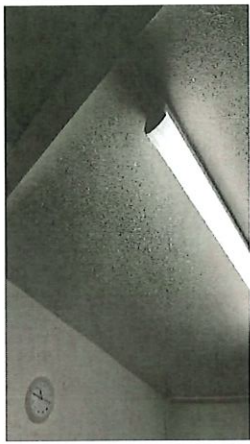
Material Assessment Ref	S099 – (As S001)	
Building	Main	
Floor	Ground	
Room	076 Reprographics	
Position	Ceiling	
Component	Textured Coating To Ceiling	
Accessibility	Medium	
Lab	In-House Database	
Next Inspection	16/08/2023	
Material Risk	3 (VL)	
Priority Risk	N/A	
Quantity	16 Sqr Mtrs	
Survey Type	Management	
Action	Manage	
Product Type	Textured Coating	
Asbestos Type	Strongly Presumed Chrysotile	
Surface Treatment	Composite materials containing asbestos: reinforced plastics, resins, mastics, vinyl tiles, semi rigid paints or decorative finishes.	
Condition	Low damage: a few scratches or surface marks, broken edges on boards, tiles etc.	
Recommendations	Manage	
Comments	Textured coating to plasterboard ceiling.

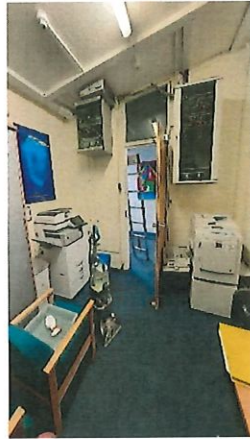
Material Assessment Ref	S100 –	
Building	Main	
Floor	Ground	
Room	076 Reprographics	
Position	Walls Internal	
Component	Walls Internal	
Accessibility	N/A	
Lab	In-House Database	
Next Inspection	No further action required	
Material Risk	0 (VL)	
Priority Risk	N/A	
Quantity	Num	
Survey Type	Management	
Action	No further action required	
Product Type	Not Selected	
Asbestos Type	Non suspect material	
Surface Treatment	Not Selected	
Condition	Not Selected	
Recommendations	No further action required	
Comments	Plaster skim to plasterboard or brick walls. Glass door head panel.

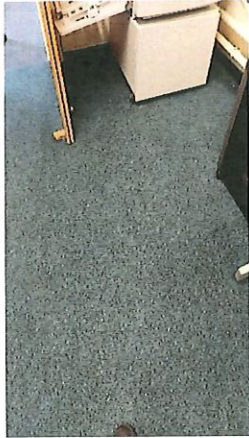
Material Assessment Ref	S101 –	
Building	Main	
Floor	Ground	
Room	076 Reprographics	
Position	Below Floor Covering	
Component	Below Floor Covering	
Accessibility	N/A	
Lab	In-House Database	
Next Inspection	No Access	
Material Risk	12 (H)	
Priority Risk	N/A	
Quantity	Num	
Survey Type	Management	
Action	Further investigation may be required.	
Product Type	No Access	
Asbestos Type	No Access	
Surface Treatment	No Access	
Condition	No Access	
Recommendations	Access was denied on the day of survey – see Inspection Comments (Material & Priority Assessment Records) for details.	
Comments	No access was possible beneath the modern vinyl and carpet without causing unnecessary damage.

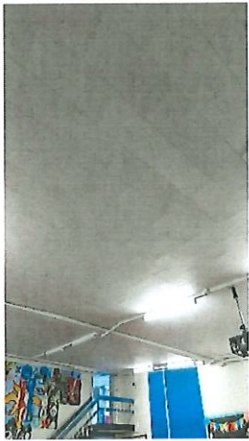
Material Assessment Ref	S102 – (As S085)	
Building	Main	
Floor	Ground	
Room	036 Junior Hall	
Position	Ceiling	
Component	Ceiling	
Accessibility	N/A	
Lab	In-House Database	
Next Inspection	No Further Action Required	
Material Risk	0 (VL)	
Priority Risk	N/A	
Quantity	250 Sqr Mtrs	
Survey Type	Management	
Action	No Further Action Required	
Product Type	Not Selected	
Asbestos Type	Non suspect material	
Surface Treatment	Not Selected	
Condition	Not Selected	
Recommendations	No further action required	
Comments	Insulating boards to the ceiling.

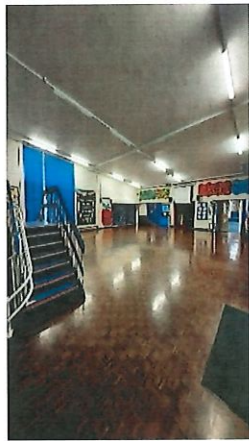
Material Assessment Ref	S103 –	
Building	Main	
Floor	Ground	
Room	036 Junior Hall	
Position	Walls & Floor	
Component	Walls & Floor	
Accessibility	N/A	
Lab	In-House Database	
Next Inspection	No further action required	
Material Risk	0 (VL)	
Priority Risk	N/A	
Quantity	Num	
Survey Type	Management	
Action	No further action required	
Product Type	Not Selected	
Asbestos Type	Non suspect material	
Surface Treatment	Not Selected	
Condition	Not Selected	
Recommendations	No further action required	
Comments	Plaster skim to plasterboard or brick walls. Parquet floor covering throughout. Rubber stair nosing strips to staircase.

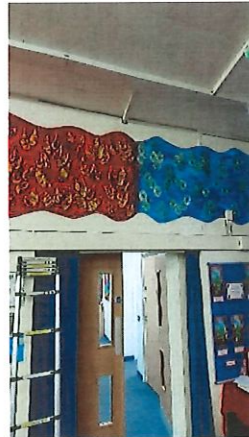
Material Assessment Ref	S104 –	
Building	Main	
Floor	Ground	
Room	036 Junior Hall	
Position	Behind Cladding	
Component	Behind Cladding	
Accessibility	N/A	
Lab	In-House Database	
Next Inspection	No Access	
Material Risk	12 (H)	
Priority Risk	N/A	
Quantity	Num	
Survey Type	Management	
Action	Further investigation may be required.	
Product Type	No Access	
Asbestos Type	No Access	
Surface Treatment	No Access	
Condition	No Access	
Recommendations	Access was denied on the day of survey – see Inspection Comments (Material & Priority Assessment Records) for details.	
Comments	No access was possible behind the high level wooden cladding to the walls and above the doors to corridor.

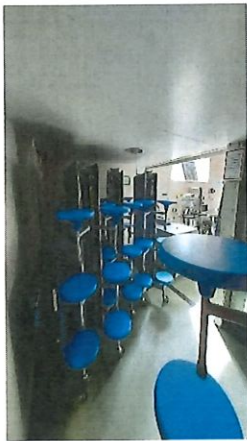
Material Assessment Ref	S108 –	
Building	Main	
Floor	Ground	
Room	037 Servery / Chair Store	
Position	Ceiling & Walls	
Component	Ceiling & Walls	
Accessibility	N/A	
Lab	In-House Database	
Next Inspection	No further action required	
Material Risk	0 (VL)	
Priority Risk	N/A	
Quantity	Num	
Survey Type	Management	
Action	No further action required	
Product Type	Not Selected	
Asbestos Type	Non suspect material	
Surface Treatment	Not Selected	
Condition	Not Selected	
Recommendations	No further action required	
Comments	Timber panels to ceiling and plaster skim to plasterboard or brick walls.

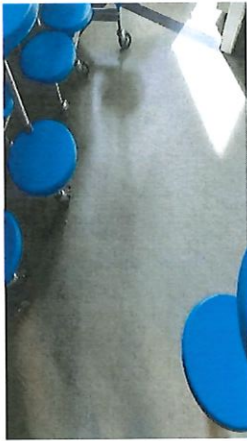
Material Assessment Ref	S109 –	
Building	Main	
Floor	Ground	
Room	037 Servery / Chair Store	
Position	Below Floor Covering	
Component	Below Floor Covering	
Accessibility	N/A	
Lab	In-House Database	
Next Inspection	No Access	
Material Risk	12 (H)	
Priority Risk	N/A	
Quantity	Num	
Survey Type	Management	
Action	Further investigation may be required.	
Product Type	No Access	
Asbestos Type	No Access	
Surface Treatment	No Access	
Condition	No Access	
Recommendations	Access was denied on the day of survey – see Inspection Comments (Material & Priority Assessment Records) for details.	
Comments	No access was possible beneath the modern vinyl without causing unnecessary damage.

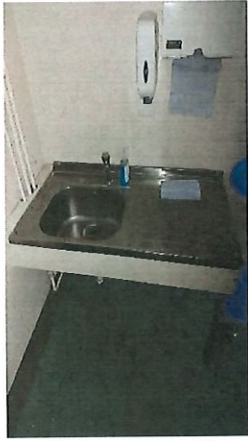
Material Assessment Ref	S110 –	
Building	Main	
Floor	Ground	
Room	037 Servery / Chair Store	
Position	Sink Pad	
Component	Sink Pad	
Accessibility	Medium	
Lab	The Testing Lab PLC	
Next Inspection	16/08/2023	
Material Risk	3 (VL)	
Priority Risk	N/A	
Quantity	1 Num	
Survey Type	Management	
Action	Manage	
Product Type	Bitumen Product	
Asbestos Type	Chrysotile	
Surface Treatment	Composite materials containing asbestos: reinforced plastics, resins, mastics, vinyl tiles, semi rigid paints or decorative finishes.	
Condition	Low damage: a few scratches or surface marks, broken edges on boards, tiles etc.	
Recommendations	Manage	
Comments	Bitumen sink pad to the underside of the sink unit.

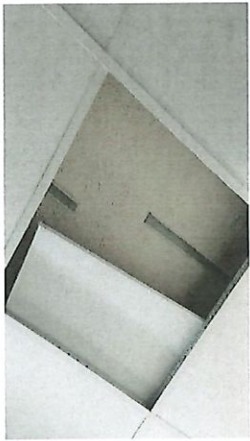
Material Assessment Ref	S111 –	
Building	Main	
Floor	Ground	
Room	052 Wash Up Area	
Position	Ceiling	
Component	Textured Coating To Ceiling	
Accessibility	N/A	
Lab	The Testing Lab PLC	
Next Inspection	No Further Action Required	
Material Risk	0 (VL)	
Priority Risk	N/A	
Quantity	20 Sqr Mtrs	
Survey Type	Management	
Action	No Further Action Required	
Product Type	Not Selected	
Asbestos Type	NADIS	
Surface Treatment	Not Selected	
Condition	Not Selected	
Recommendations	No further action required	
Comments	Textured coating to plasterboard ceiling above suspended ceiling.

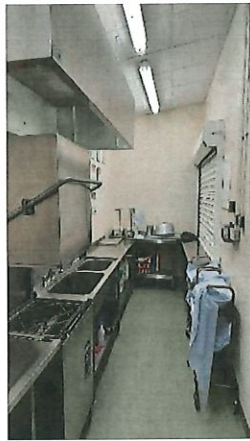
Material Assessment Ref	S112 –	
Building	Main	
Floor	Ground	
Room	052 Wah Up Area	
Position	Walls & Floor	
Component	Walls & Floor	
Accessibility	N/A	
Lab	In-House Database	
Next Inspection	No further action required	
Material Risk	0 (VL)	
Priority Risk	N/A	
Quantity	Num	
Survey Type	Management	
Action	No further action required	
Product Type	Not Selected	
Asbestos Type	Non suspect material	
Surface Treatment	Not Selected	
Condition	Not Selected	
Recommendations	No further action required	
Comments	Brick or wooden panels to the walls and concrete floor beneath modern vinyl. All modern kitchen equipment.

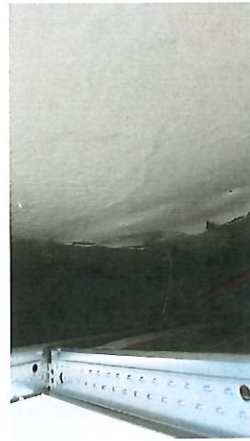
Material Assessment Ref	S113 – (As S111)	
Building	Main	
Floor	Ground	
Room	038 Kitchen	
Position	Ceiling	
Component	Textured Coating To Ceiling	
Accessibility	N/A	
Lab	In-House Database	
Next Inspection	No Further Action Required	
Material Risk	0 (VL)	
Priority Risk	N/A	
Quantity	60 Sqr Mtrs	
Survey Type	Management	
Action	No Further Action Required	
Product Type	Not Selected	
Asbestos Type	Non suspect material	
Surface Treatment	Not Selected	
Condition	Not Selected	
Recommendations	No further action required	
Comments	Textured coating to plasterboard ceiling above suspended ceiling. The textured coating was severely delaminating. Access above the suspended ceiling should be restricted until remedial works are carried out.

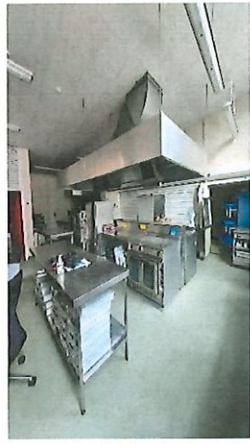
Material Assessment Ref	S114 –	
Building	Main	
Floor	Ground	
Room	038 Kitchen	
Position	Walls & Floor	
Component	Walls & Floor	
Accessibility	N/A	
Lab	In-House Database	
Next Inspection	No further action required	
Material Risk	0 (VL)	
Priority Risk	N/A	
Quantity	Num	
Survey Type	Management	
Action	No further action required	
Product Type	Not Selected	
Asbestos Type	Non suspect material	
Surface Treatment	Not Selected	
Condition	Not Selected	
Recommendations	No further action required	
Comments	Brick or wooden panels to the walls and concrete floor beneath modern vinyl.

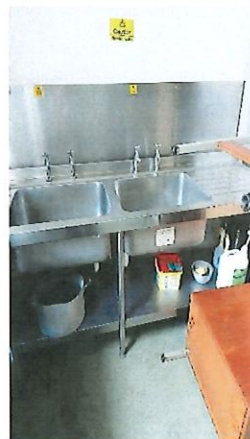
Material Assessment Ref	S115 –	
Building	Main	
Floor	Ground	
Room	038 Kitchen	
Position	Sink Pad	
Component	Sink Pad	
Accessibility	N/A	
Lab	The Testing Lab PLC	
Next Inspection	No Further Action Required	
Material Risk	0 (VL)	
Priority Risk	N/A	
Quantity	2 Num	
Survey Type	Management	
Action	No Further Action Required	
Product Type	Not Selected	
Asbestos Type	NADIS	
Surface Treatment	Not Selected	
Condition	Not Selected	
Recommendations	No further action required	
Comments	Bitumen sink pads to the underside of the double sink unit.

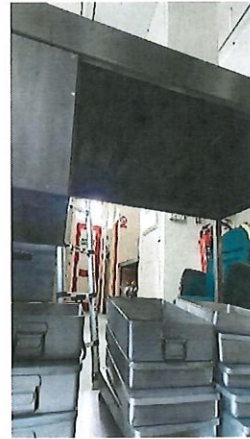
Material Assessment Ref	S116 –	
Building	Main	
Floor	Ground	
Room	038 Kitchen	
Position	Table	
Component	Bitumen Paint	
Accessibility	Medium	
Lab	The Testing Lab PLC	
Next Inspection	16/08/2023	
Material Risk	3 (VL)	
Priority Risk	N/A	
Quantity	2 Sqr Mtrs	
Survey Type	Management	
Action	Manage	
Product Type	Bitumen Product	
Asbestos Type	Chrysotile	
Surface Treatment	Composite materials containing asbestos: reinforced plastics, resins, mastics, vinyl tiles, semi rigid paints or decorative finishes.	
Condition	Low damage: a few scratches or surface marks, broken edges on boards, tiles etc.	
Recommendations	Manage	
Comments	Bitumen paint to the underside of 1 x metal table.

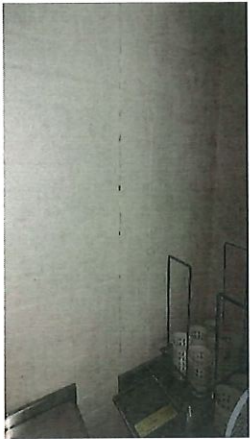
Material Assessment Ref	S117 –	
Building	Main	
Floor	Ground	
Room	052 Wash Up Area	
Position	Behind Boxing	
Component	Behind Boxing	
Accessibility	N/A	
Lab	In-House Database	
Next Inspection	No Access	
Material Risk	12 (H)	
Priority Risk	N/A	
Quantity	Num	
Survey Type	Management	
Action	Further investigation may be required.	
Product Type	No Access	
Asbestos Type	No Access	
Surface Treatment	No Access	
Condition	No Access	
Recommendations	Access was denied on the day of survey – see Inspection Comments (Material & Priority Assessment Records) for details.	
Comments	No access was possible behind the wooden panel to wall without causing unnecessary damage.

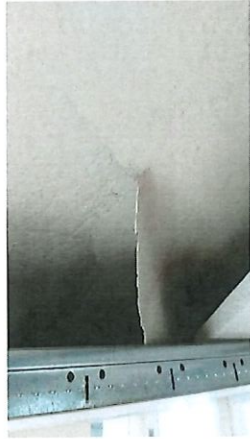
Material Assessment Ref	S118 – (As S111)	
Building	Main	
Floor	Ground	
Room	039 & 040 Fire Exit	
Position	Ceiling	
Component	Textured Coating To Ceiling	
Accessibility	N/A	
Lab	In-House Database	
Next Inspection	No Further Action Required	
Material Risk	0 (VL)	
Priority Risk	N/A	
Quantity	18 Sqr Mtrs	
Survey Type	Management	
Action	No Further Action Required	
Product Type	Not Selected	
Asbestos Type	Non suspect material	
Surface Treatment	Not Selected	
Condition	Not Selected	
Recommendations	No further action required	
Comments	Textured coating to plasterboard ceiling above suspended ceiling. The textured coating was severely delaminating. Access above the suspended ceiling should be restricted until remedial works are carried out.

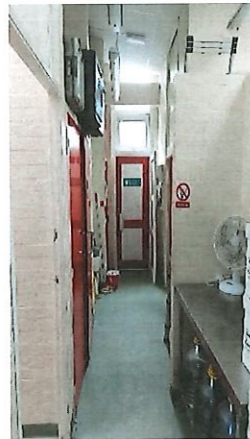
Material Assessment Ref	S119 –	
Building	Main	
Floor	Ground	
Room	039 & 040 Fire Exit	
Position	Walls & Floor	
Component	Walls & Floor	
Accessibility	N/A	
Lab	In-House Database	
Next Inspection	No further action required	
Material Risk	0 (VL)	
Priority Risk	N/A	
Quantity	Num	
Survey Type	Management	
Action	No further action required	
Product Type	Not Selected	
Asbestos Type	Non suspect material	
Surface Treatment	Not Selected	
Condition	Not Selected	
Recommendations	No further action required	
Comments	Brick or wooden panels to the walls and concrete floor beneath modern vinyl.

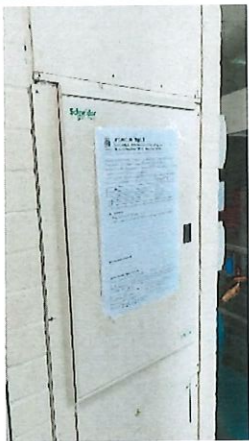
Material Assessment Ref	S120 –	
Building	Main	
Floor	Ground	
Room	039 & 040 Fire Exit	
Position	Consumer Unit	
Component	Consumer Unit	
Accessibility	N/A	
Lab	In-House Database	
Next Inspection	No further action required	
Material Risk	0 (VL)	
Priority Risk	N/A	
Quantity	Num	
Survey Type	Management	
Action	No further action required	
Product Type	Not Selected	
Asbestos Type	Non suspect material	
Surface Treatment	Not Selected	
Condition	Not Selected	
Recommendations	No further action required	
Comments	Modern consumer unit.

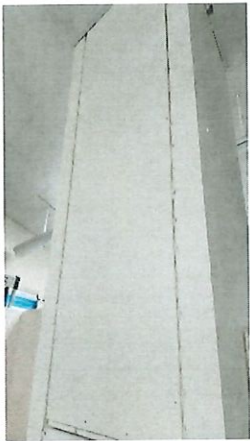
Material Assessment Ref	S121 –	
Building	Main	
Floor	Ground	
Room	039 & 040 Fire Exit	
Position	Behind Boxing	
Component	Behind Boxing	
Accessibility	N/A	
Lab	In-House Database	
Next Inspection	No Access	
Material Risk	12 (H)	
Priority Risk	N/A	
Quantity	Num	
Survey Type	Management	
Action	Further investigation may be required.	
Product Type	No Access	
Asbestos Type	No Access	
Surface Treatment	No Access	
Condition	No Access	
Recommendations	Access was denied on the day of survey – see Inspection Comments (Material & Priority Assessment Records) for details.	
Comments	No access was possible behind the wooden boxings without causing unnecessary damage.

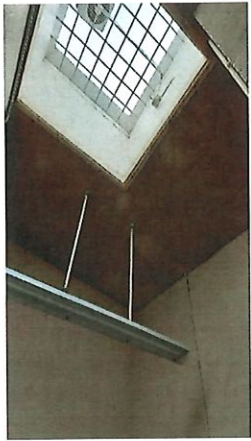
Material Assessment Ref	S122 –	
Building	Main	
Floor	Ground	
Room	041 Kitchen Office	
Position	Above Ceiling	
Component	Above Ceiling	
Accessibility	N/A	
Lab	In-House Database	
Next Inspection	No Access	
Material Risk	12 (H)	
Priority Risk	N/A	
Quantity	Num	
Survey Type	Management	
Action	Further investigation may be required.	
Product Type	No Access	
Asbestos Type	No Access	
Surface Treatment	No Access	
Condition	No Access	
Recommendations	Access was denied on the day of survey – see Inspection Comments (Material & Priority Assessment Records) for details.	
Comments	No access was possible above the new plasterboard ceiling without causing unnecessary damage.

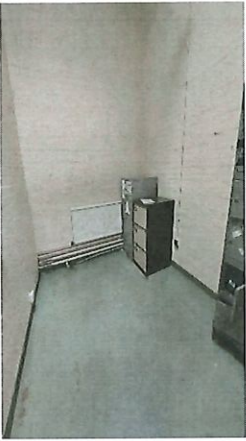
Material Assessment Ref	S123 –	
Building	Main	
Floor	Ground	
Room	041 Kitchen Office	
Position	Walls & Floor	
Component	Walls & Floor	
Accessibility	N/A	
Lab	In-House Database	
Next Inspection	No further action required	
Material Risk	0 (VL)	
Priority Risk	N/A	
Quantity	Num	
Survey Type	Management	
Action	No further action required	
Product Type	Not Selected	
Asbestos Type	Non suspect material	
Surface Treatment	Not Selected	
Condition	Not Selected	
Recommendations	No further action required	
Comments	Brick walls and concrete floor beneath modern vinyl. Glass door head panel.

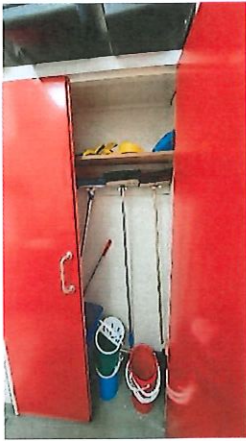
Material Assessment Ref	S124 –	
Building	Main	
Floor	Ground	
Room	042 Cupboard	
Position	Ceiling, Walls & Floor	
Component	Ceiling, Walls & Floor	
Accessibility	N/A	
Lab	In-House Database	
Next Inspection	No further action required	
Material Risk	0 (VL)	
Priority Risk	N/A	
Quantity	Num	
Survey Type	Management	
Action	No further action required	
Product Type	Not Selected	
Asbestos Type	Non suspect material	
Surface Treatment	Not Selected	
Condition	Not Selected	
Recommendations	No further action required	
Comments	Timber ceiling, brick walls and concrete floor beneath modern vinyl.

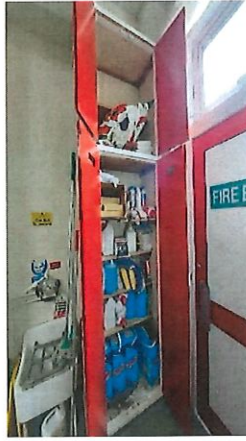
Material Assessment Ref	S125 –	
Building	Main	
Floor	Ground	
Room	044 Cleaners Cupboard	
Position	Ceiling, Walls & Floor	
Component	Ceiling, Walls & Floor	
Accessibility	N/A	
Lab	In-House Database	
Next Inspection	No further action required	
Material Risk	0 (VL)	
Priority Risk	N/A	
Quantity	Num	
Survey Type	Management	
Action	No further action required	
Product Type	Not Selected	
Asbestos Type	Non suspect material	
Surface Treatment	Not Selected	
Condition	Not Selected	
Recommendations	No further action required	
Comments	Timber ceiling, brick walls and wooden panels to floor.
