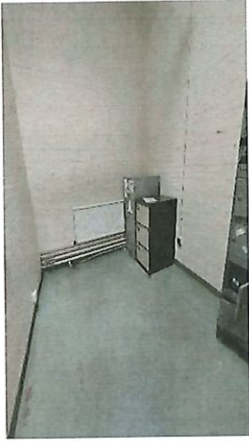
Material Assessment Ref	S123 –	
Building	Main	
Floor	Ground	
Room	041 Kitchen Office	
Position	Walls & Floor	
Component	Walls & Floor	
Accessibility	N/A	
Lab	In-House Database	
Next Inspection	No further action required	
Material Risk	0 (VL)	
Priority Risk	N/A	
Quantity	Num	
Survey Type	Management	
Action	No further action required	
Product Type	Not Selected	
Asbestos Type	Non suspect material	
Surface Treatment	Not Selected	
Condition	Not Selected	
Recommendations	No further action required	
Comments	Brick walls and concrete floor beneath modern vinyl. Glass door head panel.

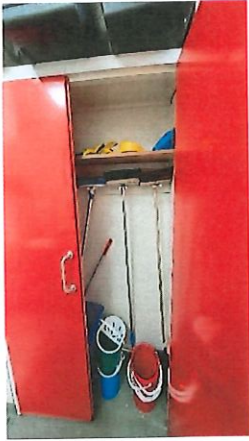
Material Assessment Ref	S124 –	
Building	Main	
Floor	Ground	
Room	042 Cupboard	
Position	Ceiling, Walls & Floor	
Component	Ceiling, Walls & Floor	
Accessibility	N/A	
Lab	In-House Database	
Next Inspection	No further action required	
Material Risk	0 (VL)	
Priority Risk	N/A	
Quantity	Num	
Survey Type	Management	
Action	No further action required	
Product Type	Not Selected	
Asbestos Type	Non suspect material	
Surface Treatment	Not Selected	
Condition	Not Selected	
Recommendations	No further action required	
Comments	Timber ceiling, brick walls and concrete floor beneath modern vinyl.

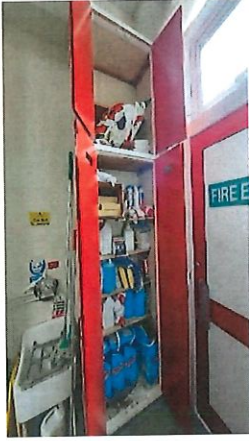
Material Assessment Ref	S125 –	
Building	Main	
Floor	Ground	
Room	044 Cleaners Cupboard	
Position	Ceiling, Walls & Floor	
Component	Ceiling, Walls & Floor	
Accessibility	N/A	
Lab	In-House Database	
Next Inspection	No further action required	
Material Risk	0 (VL)	
Priority Risk	N/A	
Quantity	Num	
Survey Type	Management	
Action	No further action required	
Product Type	Not Selected	
Asbestos Type	Non suspect material	
Surface Treatment	Not Selected	
Condition	Not Selected	
Recommendations	No further action required	
Comments	Timber ceiling, brick walls and wooden panels to floor.

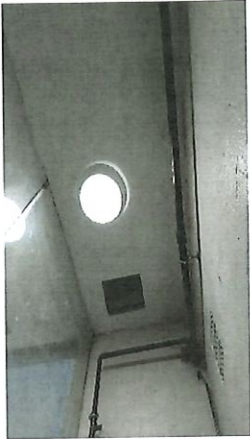
Material Assessment Ref	S126 –	
Building	Main	
Floor	Ground	
Room	045 Kitchen Toilet	
Position	Above Ceiling	
Component	Above Ceiling	
Accessibility	N/A	
Lab	In-House Database	
Next Inspection	No Access	
Material Risk	12 (H)	
Priority Risk	N/A	
Quantity	Num	
Survey Type	Management	
Action	Further investigation may be required.	
Product Type	No Access	
Asbestos Type	No Access	
Surface Treatment	No Access	
Condition	No Access	
Recommendations	Access was denied on the day of survey – see Inspection Comments (Material & Priority Assessment Records) for details.	
Comments	No access was possible above the new plasterboard ceiling without causing unnecessary damage.

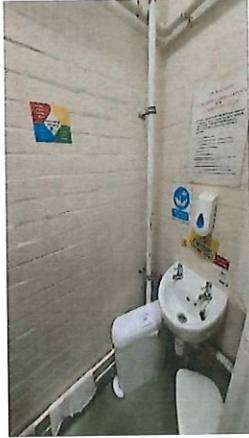
Material Assessment Ref	S127 –	
Building	Main	
Floor	Ground	
Room	045 Kitchen Toilet	
Position	Walls & Floor	
Component	Walls & Floor	
Accessibility	N/A	
Lab	In-House Database	
Next Inspection	No further action required	
Material Risk	0 (VL)	
Priority Risk	N/A	
Quantity	Num	
Survey Type	Management	
Action	No further action required	
Product Type	Not Selected	
Asbestos Type	Non suspect material	
Surface Treatment	Not Selected	
Condition	Not Selected	
Recommendations	No further action required	
Comments	Brick walls and concrete floor beneath modern vinyl. Ceramic toilet cistern.

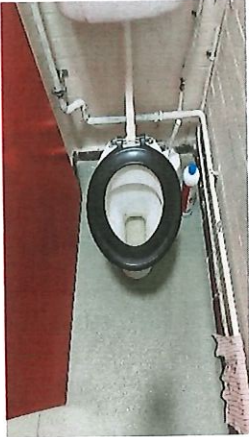
Material Assessment Ref	S128 – (As S036)	
Building	Main	
Floor	Ground	
Room	045 Kitchen Toilet	
Position	Toilet Seat	
Component	Toilet Seat	
Accessibility	N/A	
Lab	In-House Database	
Next Inspection	No Further Action Required	
Material Risk	0 (VL)	
Priority Risk	N/A	
Quantity	1 Num	
Survey Type	Management	
Action	No Further Action Required	
Product Type	Not Selected	
Asbestos Type	Non suspect material	
Surface Treatment	Not Selected	
Condition	Not Selected	
Recommendations	No further action required	
Comments	Black plastic toilet seat.

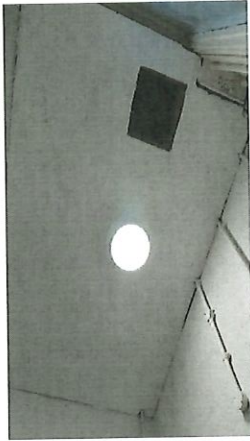
Material Assessment Ref	S129 –	
Building	Main	
Floor	Ground	
Room	046 Changing Room	
Position	Above Ceiling	
Component	Above Ceiling	
Accessibility	N/A	
Lab	In-House Database	
Next Inspection	No Access	
Material Risk	12 (H)	
Priority Risk	N/A	
Quantity	Num	
Survey Type	Management	
Action	Further investigation may be required.	
Product Type	No Access	
Asbestos Type	No Access	
Surface Treatment	No Access	
Condition	No Access	
Recommendations	Access was denied on the day of survey – see Inspection Comments (Material & Priority Assessment Records) for details.	
Comments	No access was possible above the new plasterboard ceiling without causing unnecessary damage.

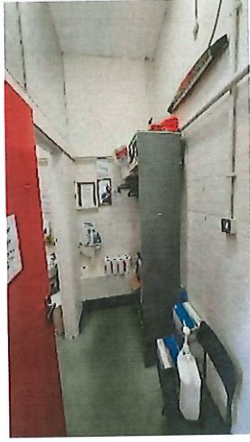
Material Assessment Ref	S130 –	
Building	Main	
Floor	Ground	
Room	046 Changing Room	
Position	Walls & Floor	
Component	Walls & Floor	
Accessibility	N/A	
Lab	In-House Database	
Next Inspection	No further action required	
Material Risk	0 (VL)	
Priority Risk	N/A	
Quantity	Num	
Survey Type	Management	
Action	No further action required	
Product Type	Not Selected	
Asbestos Type	Non suspect material	
Surface Treatment	Not Selected	
Condition	Not Selected	
Recommendations	No further action required	
Comments	Brick walls and concrete floor beneath modern vinyl. Glass door head panel.

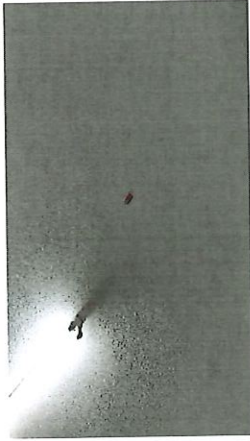
Material Assessment Ref	S131 – (As S111)	
Building	Main	
Floor	Ground	
Room	048 Kitchen Store	
Position	Ceiling	
Component	Textured Coating To Ceiling	
Accessibility	N/A	
Lab	In-House Database	
Next Inspection	No Further Action Required	
Material Risk	0 (VL)	
Priority Risk	N/A	
Quantity	20 Sqr Mtrs	
Survey Type	Management	
Action	No Further Action Required	
Product Type	Not Selected	
Asbestos Type	Non suspect material	
Surface Treatment	Not Selected	
Condition	Not Selected	
Recommendations	No further action required	
Comments	Textured coating to plasterboard ceiling.

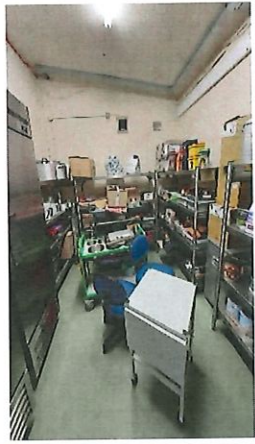
Material Assessment Ref	S132 –	
Building	Main	
Floor	Ground	
Room	048 Kitchen Store	
Position	Walls & Floor	
Component	Walls & Floor	
Accessibility	N/A	
Lab	In-House Database	
Next Inspection	No further action required	
Material Risk	0 (VL)	
Priority Risk	N/A	
Quantity	Num	
Survey Type	Management	
Action	No further action required	
Product Type	Not Selected	
Asbestos Type	Non suspect material	
Surface Treatment	Not Selected	
Condition	Not Selected	
Recommendations	No further action required	
Comments	Brick walls and concrete floor beneath modern vinyl.

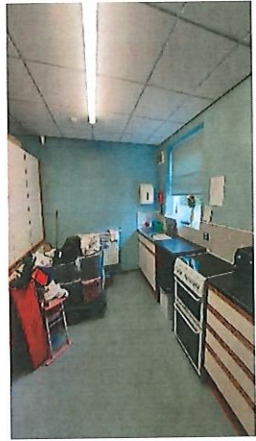
Material Assessment Ref	S133 –	
Building	Main	
Floor	Ground	
Room	050 Small Kitchen	
Position	Ceiling, Walls & Floor	
Component	Ceiling, Walls & Floor	
Accessibility	N/A	
Lab	In-House Database	
Next Inspection	No further action required	
Material Risk	0 (VL)	
Priority Risk	N/A	
Quantity	Num	
Survey Type	Management	
Action	No further action required	
Product Type	Not Selected	
Asbestos Type	Non suspect material	
Surface Treatment	Not Selected	
Condition	Not Selected	
Recommendations	No further action required	
Comments	Plasterboard ceiling above suspended ceiling, plaster skim to brick walls and concrete floor beneath modern vinyl. Modern sink unit.

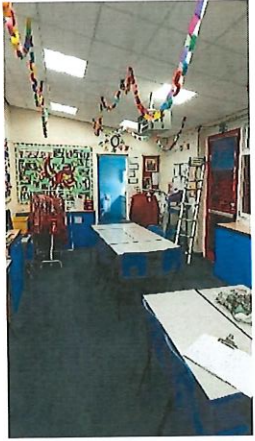
Material Assessment Ref	S134 –	
Building	Main	
Floor	Ground	
Room	051 Classroom	
Position	Ceiling, Walls & Floor	
Component	Ceiling, Walls & Floor	
Accessibility	N/A	
Lab	In-House Database	
Next Inspection	No further action required	
Material Risk	0 (VL)	
Priority Risk	N/A	
Quantity	Num	
Survey Type	Management	
Action	No further action required	
Product Type	Not Selected	
Asbestos Type	Non suspect material	
Surface Treatment	Not Selected	
Condition	Not Selected	
Recommendations	No further action required	
Comments	Timber roof decking boards above suspended ceiling, plaster skim to brick walls and concrete floor beneath carpet.

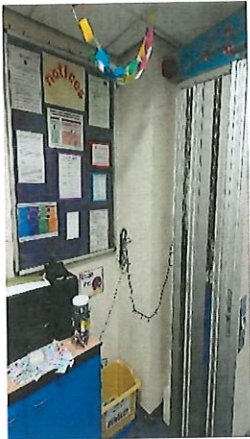
Material Assessment Ref	S135 –	
Building	Main	
Floor	Ground	
Room	051 Classroom	
Position	Behind Boxing	
Component	Behind Boxing	
Accessibility	N/A	
Lab	In-House Database	
Next Inspection	No Access	
Material Risk	12 (H)	
Priority Risk	N/A	
Quantity	Num	
Survey Type	Management	
Action	Further investigation may be required.	
Product Type	No Access	
Asbestos Type	No Access	
Surface Treatment	No Access	
Condition	No Access	
Recommendations	Access was denied on the day of survey – see Inspection Comments (Material & Priority Assessment Records) for details.	
Comments	No access was possible behind the wooden boxing without causing unnecessary damage.

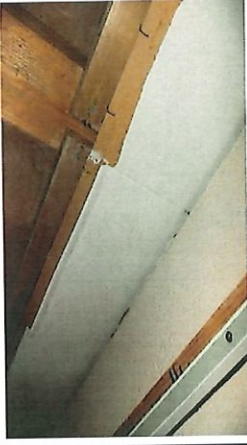
Material Assessment Ref	S136 – (As S085)	
Building	Main	
Floor	Ground	
Room	051A Resource Room	
Position	Ceiling	
Component	Ceiling	
Accessibility	N/A	
Lab	In-House Database	
Next Inspection	No Further Action Required	
Material Risk	0 (VL)	
Priority Risk	N/A	
Quantity	4 Sqr Mtrs	
Survey Type	Management	
Action	No Further Action Required	
Product Type	Not Selected	
Asbestos Type	Non suspect material	
Surface Treatment	Not Selected	
Condition	Not Selected	
Recommendations	No further action required	
Comments	Insulating boards to the ceiling above the suspended ceiling.

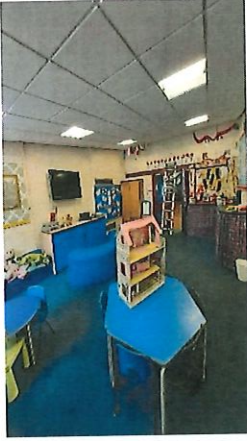
Material Assessment Ref	S137 –	
Building	Main	
Floor	Ground	
Room	051A Resource Room	
Position	Walls & Floor	
Component	Walls & Floor	
Accessibility	N/A	
Lab	In-House Database	
Next Inspection	No further action required	
Material Risk	0 (VL)	
Priority Risk	N/A	
Quantity	Num	
Survey Type	Management	
Action	No further action required	
Product Type	Not Selected	
Asbestos Type	Non suspect material	
Surface Treatment	Not Selected	
Condition	Not Selected	
Recommendations	No further action required	
Comments	Plaster skim to brick walls and concrete floor beneath carpet.

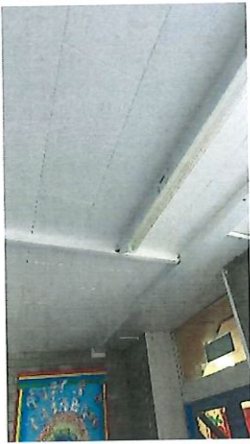
Material Assessment Ref	S138 –	
Building	Main	
Floor	Ground	
Room	053 Lobby 1	
Position	Ceiling	
Component	Ceiling	
Accessibility	N/A	
Lab	The Testing Lab PLC	
Next Inspection	No Further Action Required	
Material Risk	0 (VL)	
Priority Risk	N/A	
Quantity	18 Sqr Mtrs	
Survey Type	Management	
Action	No Further Action Required	
Product Type	Not Selected	
Asbestos Type	NADIS	
Surface Treatment	Not Selected	
Condition	Not Selected	
Recommendations	No further action required	
Comments	Insulating boards to the ceiling.

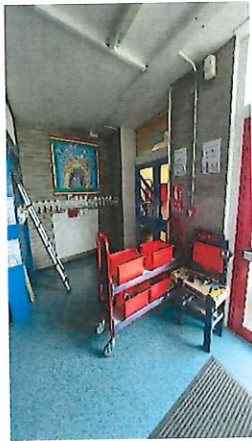
Material Assessment Ref	S139 –	
Building	Main	
Floor	Ground	
Room	053 Lobby 1	
Position	Walls Internal	
Component	Walls Internal	
Accessibility	N/A	
Lab	In-House Database	
Next Inspection	No further action required	
Material Risk	0 (VL)	
Priority Risk	N/A	
Quantity	Num	
Survey Type	Management	
Action	No further action required	
Product Type	Not Selected	
Asbestos Type	Non suspect material	
Surface Treatment	Not Selected	
Condition	Not Selected	
Recommendations	No further action required	
Comments	Brick walls. Glass door head panels.

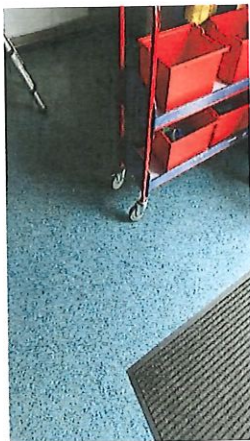
Material Assessment Ref	S140 –	
Building	Main	
Floor	Ground	
Room	053 Lobby 1	
Position	Below Floor Covering	
Component	Below Floor Covering	
Accessibility	N/A	
Lab	In-House Database	
Next Inspection	No Access	
Material Risk	12 (H)	
Priority Risk	N/A	
Quantity	Num	
Survey Type	Management	
Action	Further investigation may be required.	
Product Type	No Access	
Asbestos Type	No Access	
Surface Treatment	No Access	
Condition	No Access	
Recommendations	Access was denied on the day of survey – see Inspection Comments (Material & Priority Assessment Records) for details.	
Comments	No access was possible beneath the modern vinyl without causing unnecessary damage.

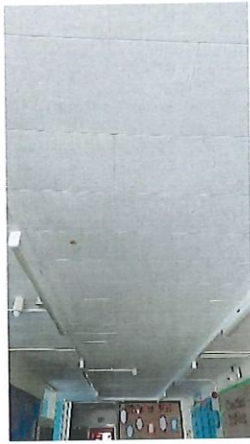
Material Assessment Ref	S141 – (As S138)	
Building	Main	
Floor	Ground	
Room	054 Resource Area	
Position	Ceiling	
Component	Ceiling	
Accessibility	N/A	
Lab	In-House Database	
Next Inspection	No Further Action Required	
Material Risk	0 (VL)	
Priority Risk	N/A	
Quantity	60 Sqr Mtrs	
Survey Type	Management	
Action	No Further Action Required	
Product Type	Not Selected	
Asbestos Type	Non suspect material	
Surface Treatment	Not Selected	
Condition	Not Selected	
Recommendations	No further action required	
Comments	Insulating boards to the ceiling.

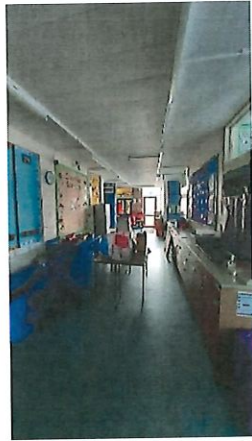
Material Assessment Ref	S142 –	
Building	Main	
Floor	Ground	
Room	054 Resource Area	
Position	Walls Internal	
Component	Walls Internal	
Accessibility	N/A	
Lab	In-House Database	
Next Inspection	No further action required	
Material Risk	0 (VL)	
Priority Risk	N/A	
Quantity	Num	
Survey Type	Management	
Action	No further action required	
Product Type	Not Selected	
Asbestos Type	Non suspect material	
Surface Treatment	Not Selected	
Condition	Not Selected	
Recommendations	No further action required	
Comments	Brick walls or plaster skim to plasterboard partitions. Modern sink unit.

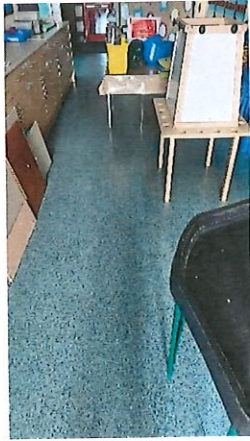
Material Assessment Ref	S143 –	
Building	Main	
Floor	Ground	
Room	054 Resource Area	
Position	Below Floor Covering	
Component	Below Floor Covering	
Accessibility	N/A	
Lab	In-House Database	
Next Inspection	No Access	
Material Risk	12 (H)	
Priority Risk	N/A	
Quantity	Num	
Survey Type	Management	
Action	Further investigation may be required.	
Product Type	No Access	
Asbestos Type	No Access	
Surface Treatment	No Access	
Condition	No Access	
Recommendations	Access was denied on the day of survey – see Inspection Comments (Material & Priority Assessment Records) for details.	
Comments	No access was possible beneath the modern vinyl without causing unnecessary damage.

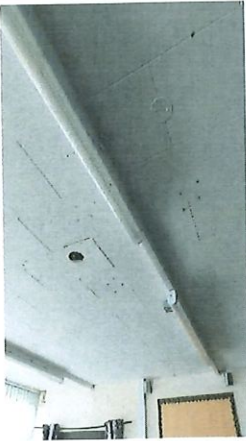
Material Assessment Ref	S144 – (As S138)	
Building	Main	
Floor	Ground	
Room	055 Classroom	
Position	Ceiling	
Component	Ceiling	
Accessibility	N/A	
Lab	In-House Database	
Next Inspection	No Further Action Required	
Material Risk	0 (VL)	
Priority Risk	N/A	
Quantity	60 Sqr Mtrs	
Survey Type	Management	
Action	No Further Action Required	
Product Type	Not Selected	
Asbestos Type	Non suspect material	
Surface Treatment	Not Selected	
Condition	Not Selected	
Recommendations	No further action required	
Comments	Insulating boards to the ceiling.

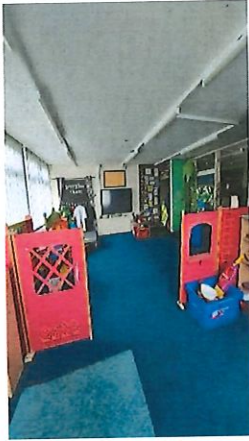
Material Assessment Ref	S145 –	
Building	Main	
Floor	Ground	
Room	055 Classroom	
Position	Walls Internal	
Component	Walls Internal	
Accessibility	N/A	
Lab	In-House Database	
Next Inspection	No further action required	
Material Risk	0 (VL)	
Priority Risk	N/A	
Quantity	Num	
Survey Type	Management	
Action	No further action required	
Product Type	Not Selected	
Asbestos Type	Non suspect material	
Surface Treatment	Not Selected	
Condition	Not Selected	
Recommendations	No further action required	
Comments	Brick walls. Glass door head panels.

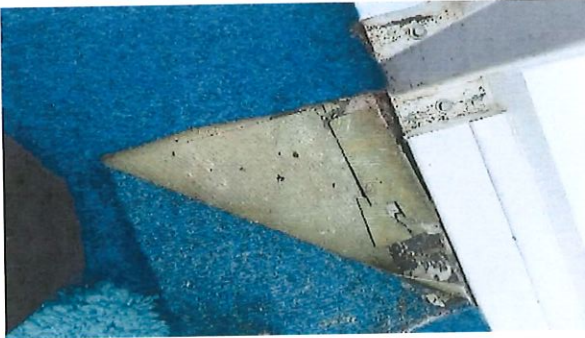
Material Assessment Ref	S146 –	
Building	Main	
Floor	Ground	
Room	055 Classroom	
Position	Below Floor Covering	
Component	Floor Tiles & Adhesive	
Accessibility	Difficult	
Lab	The Testing Lab PLC	
Next Inspection	16/08/2023	
Material Risk	3 (VL)	
Priority Risk	N/A	
Quantity	60 Sqr Mtrs	
Survey Type	Management	
Action	Manage	
Product Type	Thermo Plastic Floor Tiles	
Asbestos Type	Chrysotile	
Surface Treatment	Composite materials containing asbestos: reinforced plastics, resins, mastics, vinyl tiles, semi rigid paints or decorative finishes.	
Condition	Low damage: a few scratches or surface marks, broken edges on boards, tiles etc.	
Recommendations	Manage	
Comments	Green floor tiles and bitumen adhesive to concrete floor beneath carpet.

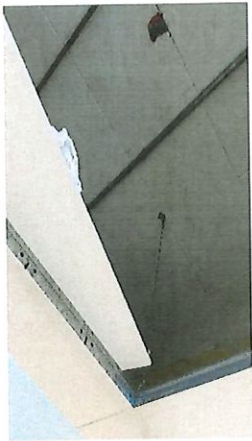
Material Assessment Ref	S147 – (As S138)	
Building	Main	
Floor	Ground	
Room	056 Girls Toilets	
Position	Ceiling	
Component	Ceiling	
Accessibility	N/A	
Lab	In-House Database	
Next Inspection	No Further Action Required	
Material Risk	0 (VL)	
Priority Risk	N/A	
Quantity	9 Sqr Mtrs	
Survey Type	Management	
Action	No Further Action Required	
Product Type	Not Selected	
Asbestos Type	Non suspect material	
Surface Treatment	Not Selected	
Condition	Not Selected	
Recommendations	No further action required	
Comments	Insulating boards to the ceiling above the suspended ceiling.

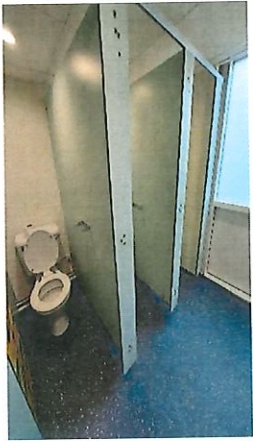
Material Assessment Ref	S148 –	
Building	Main	
Floor	Ground	
Room	056 Girls Toilets	
Position	Walls Internal	
Component	Walls Internal	
Accessibility	N/A	
Lab	In-House Database	
Next Inspection	No further action required	
Material Risk	0 (VL)	
Priority Risk	N/A	
Quantity	Num	
Survey Type	Management	
Action	No further action required	
Product Type	Not Selected	
Asbestos Type	Non suspect material	
Surface Treatment	Not Selected	
Condition	Not Selected	
Recommendations	No further action required	
Comments	Brick walls. Ceramic toilet cisterns and modern seats. Plastic downpipe.

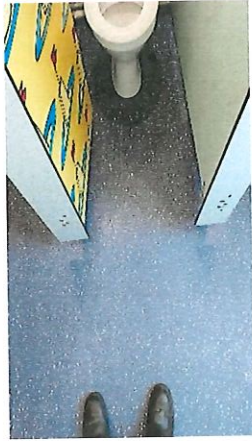
Material Assessment Ref	S149 –	
Building	Main	
Floor	Ground	
Room	056 Girls Toilets	
Position	Below Floor Covering	
Component	Below Floor Covering	
Accessibility	N/A	
Lab	In-House Database	
Next Inspection	No Access	
Material Risk	12 (H)	
Priority Risk	N/A	
Quantity	Num	
Survey Type	Management	
Action	Further investigation may be required.	
Product Type	No Access	
Asbestos Type	No Access	
Surface Treatment	No Access	
Condition	No Access	
Recommendations	Access was denied on the day of survey – see Inspection Comments (Material & Priority Assessment Records) for details.	
Comments	No access was possible beneath the modern vinyl without causing unnecessary damage.

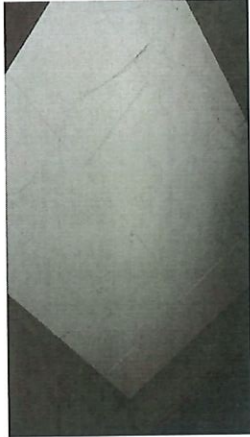
Material Assessment Ref	S150 – (As S138)	
Building	Main	
Floor	Ground	
Room	057 & 58 Classroom Store	
Position	Ceiling	
Component	Ceiling	
Accessibility	N/A	
Lab	In-House Database	
Next Inspection	No Further Action Required	
Material Risk	0 (VL)	
Priority Risk	N/A	
Quantity	1 Sqr Mtrs	
Survey Type	Management	
Action	No Further Action Required	
Product Type	Not Selected	
Asbestos Type	Non suspect material	
Surface Treatment	Not Selected	
Condition	Not Selected	
Recommendations	No further action required	
Comments	Insulating boards to the ceiling.

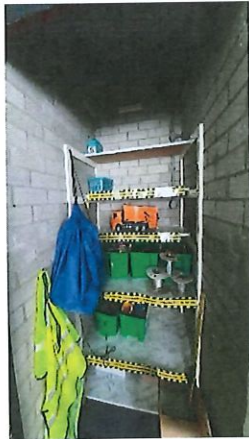
Material Assessment Ref	S151 –	
Building	Main	
Floor	Ground	
Room	057 & 058 Classroom Store	
Position	Walls Internal	
Component	Walls Internal	
Accessibility	N/A	
Lab	In-House Database	
Next Inspection	No further action required	
Material Risk	0 (VL)	
Priority Risk	N/A	
Quantity	Num	
Survey Type	Management	
Action	No further action required	
Product Type	Not Selected	
Asbestos Type	Non suspect material	
Surface Treatment	Not Selected	
Condition	Not Selected	
Recommendations	No further action required	
Comments	Brick walls. Wood door head panel.

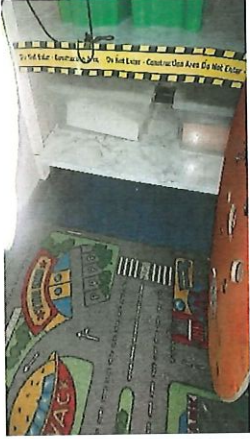
Material Assessment Ref	S152 – (As S146)	
Building	Main	
Floor	Ground	
Room	057 & 058 Classroom Store	
Position	Below Floor Covering	
Component	Floor Tiles & Adhesive	
Accessibility	Difficult	
Lab	In-House Database	
Next Inspection	16/08/2023	
Material Risk	3 (VL)	
Priority Risk	N/A	
Quantity	1 Sqr Mtrs	
Survey Type	Management	
Action	Manage	
Product Type	Thermo Plastic Floor Tiles	
Asbestos Type	Strongly Presumed Chrysotile	
Surface Treatment	Composite materials containing asbestos: reinforced plastics, resins, mastics, vinyl tiles, semi rigid paints or decorative finishes.	
Condition	Low damage: a few scratches or surface marks, broken edges on boards, tiles etc.	
Recommendations	Manage	
Comments	Green floor tiles and bitumen adhesive to concrete floor beneath carpet.

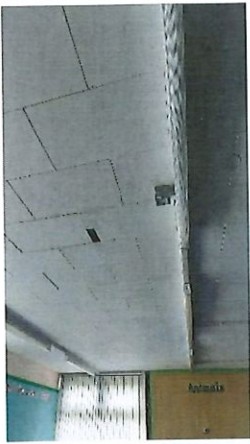
Material Assessment Ref	S153 – (As S138)	
Building	Main	
Floor	Ground	
Room	059 Classroom	
Position	Ceiling	
Component	Ceiling	
Accessibility	N/A	
Lab	In-House Database	
Next Inspection	No Further Action Required	
Material Risk	0 (VL)	
Priority Risk	N/A	
Quantity	60 Sqr Mtrs	
Survey Type	Management	
Action	No Further Action Required	
Product Type	Not Selected	
Asbestos Type	Non suspect material	
Surface Treatment	Not Selected	
Condition	Not Selected	
Recommendations	No further action required	
Comments	Insulating boards to the ceiling.

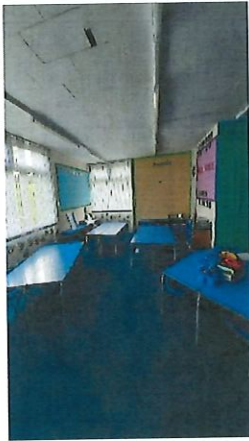
Material Assessment Ref	S154 –	
Building	Main	
Floor	Ground	
Room	059 Classroom	
Position	Walls Internal	
Component	Walls Internal	
Accessibility	N/A	
Lab	In-House Database	
Next Inspection	No further action required	
Material Risk	0 (VL)	
Priority Risk	N/A	
Quantity	Num	
Survey Type	Management	
Action	No further action required	
Product Type	Not Selected	
Asbestos Type	Non suspect material	
Surface Treatment	Not Selected	
Condition	Not Selected	
Recommendations	No further action required	
Comments	Brick walls.

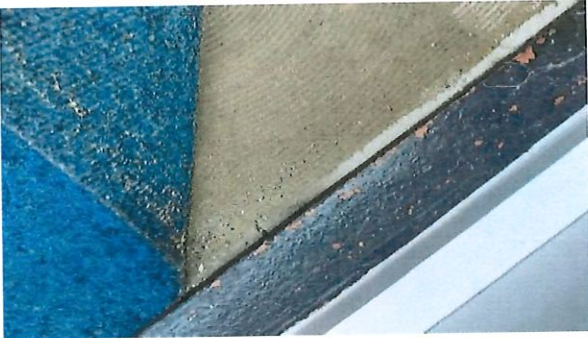
Material Assessment Ref	S155 – (As S146)	
Building	Main	
Floor	Ground	
Room	059 Classroom	
Position	Below Floor Covering	
Component	Floor Tiles & Adhesive	
Accessibility	Difficult	
Lab	In-House Database	
Next Inspection	16/08/2023	
Material Risk	3 (VL)	
Priority Risk	N/A	
Quantity	60 Sqr Mtrs	
Survey Type	Management	
Action	Manage	
Product Type	Thermo Plastic Floor Tiles	
Asbestos Type	Strongly Presumed Chrysotile	
Surface Treatment	Composite materials containing asbestos: reinforced plastics, resins, mastics, vinyl tiles, semi rigid paints or decorative finishes.	
Condition	Low damage: a few scratches or surface marks, broken edges on boards, tiles etc.	
Recommendations	Manage	
Comments	Green floor tiles and bitumen adhesive to concrete floor beneath carpet.

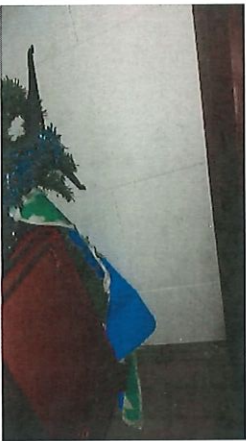
Material Assessment Ref	S156 – (As S138)	
Building	Main	
Floor	Ground	
Room	060 Classroom Store	
Position	Ceiling	
Component	Ceiling	
Accessibility	N/A	
Lab	In-House Database	
Next Inspection	No Further Action Required	
Material Risk	0 (VL)	
Priority Risk	N/A	
Quantity	1 Sqr Mtrs	
Survey Type	Management	
Action	No Further Action Required	
Product Type	Not Selected	
Asbestos Type	Non suspect material	
Surface Treatment	Not Selected	
Condition	Not Selected	
Recommendations	No further action required	
Comments	Insulating boards to the ceiling.

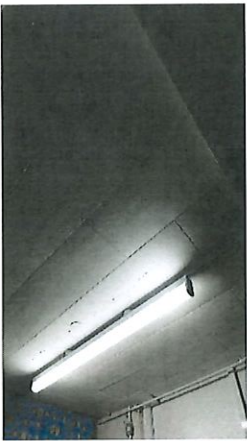
Material Assessment Ref	S159 – (As S138)	
Building	Main	
Floor	Ground	
Room	061 Cloaks	
Position	Ceiling	
Component	Ceiling	
Accessibility	N/A	
Lab	In-House Database	
Next Inspection	No Further Action Required	
Material Risk	0 (VL)	
Priority Risk	N/A	
Quantity	12 Sqr Mtrs	
Survey Type	Management	
Action	No Further Action Required	
Product Type	Not Selected	
Asbestos Type	Non suspect material	
Surface Treatment	Not Selected	
Condition	Not Selected	
Recommendations	No further action required	
Comments	Insulating boards to the ceiling.

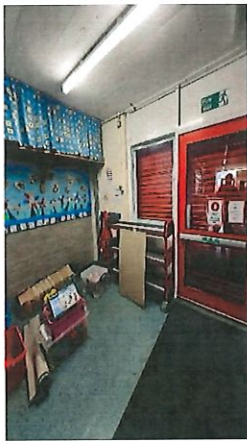
Material Assessment Ref	S160 –	
Building	Main	
Floor	Ground	
Room	061 Cloaks	
Position	Walls Internal	
Component	Walls Internal	
Accessibility	N/A	
Lab	In-House Database	
Next Inspection	No further action required	
Material Risk	0 (VL)	
Priority Risk	N/A	
Quantity	Num	
Survey Type	Management	
Action	No further action required	
Product Type	Not Selected	
Asbestos Type	Non suspect material	
Surface Treatment	Not Selected	
Condition	Not Selected	
Recommendations	No further action required	
Comments	Brick walls. Plastic downpipe.

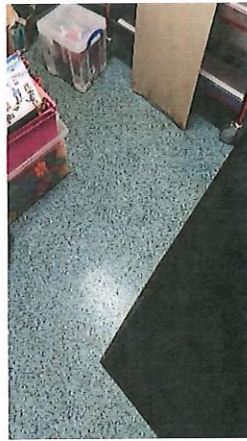
Material Assessment Ref	S161 –	
Building	Main	
Floor	Ground	
Room	061 Cloaks	
Position	Below Floor Covering	
Component	Below Floor Covering	
Accessibility	N/A	
Lab	In-House Database	
Next Inspection	No Access	
Material Risk	12 (H)	
Priority Risk	N/A	
Quantity	Num	
Survey Type	Management	
Action	Further investigation may be required.	
Product Type	No Access	
Asbestos Type	No Access	
Surface Treatment	No Access	
Condition	No Access	
Recommendations	Access was denied on the day of survey – see Inspection Comments (Material & Priority Assessment Records) for details.	
Comments	No access was possible beneath the modern vinyl without causing unnecessary damage.

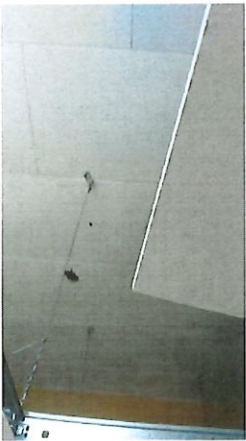
Material Assessment Ref	S162 – (As S138)	
Building	Main	
Floor	Ground	
Room	062 Boys Toilets	
Position	Ceiling	
Component	Ceiling	
Accessibility	N/A	
Lab	In-House Database	
Next Inspection	No Further Action Required	
Material Risk	0 (VL)	
Priority Risk	N/A	
Quantity	9 Sqr Mtrs	
Survey Type	Management	
Action	No Further Action Required	
Product Type	Not Selected	
Asbestos Type	Non suspect material	
Surface Treatment	Not Selected	
Condition	Not Selected	
Recommendations	No further action required	
Comments	Insulating boards to the ceiling above the suspended ceiling.

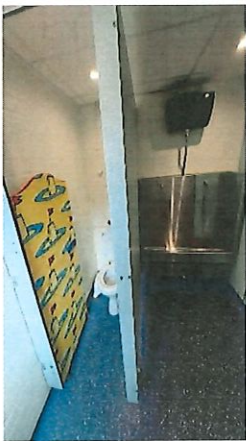
Material Assessment Ref	S163 –	
Building	Main	
Floor	Ground	
Room	062 Boys Toilets	
Position	Walls Internal	
Component	Walls Internal	
Accessibility	N/A	
Lab	In-House Database	
Next Inspection	No further action required	
Material Risk	0 (VL)	
Priority Risk	N/A	
Quantity	Num	
Survey Type	Management	
Action	No further action required	
Product Type	Not Selected	
Asbestos Type	Non suspect material	
Surface Treatment	Not Selected	
Condition	Not Selected	
Recommendations	No further action required	
Comments	Brick walls. Ceramic toilet cisterns and modern seats. Modern black plastic cistern to urinals.

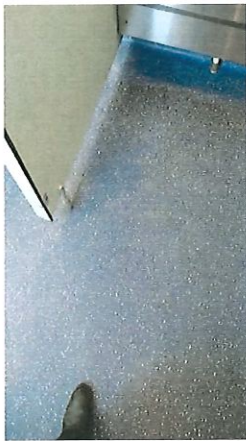
Material Assessment Ref	S164 –	
Building	Main	
Floor	Ground	
Room	062 Boys Toilets	
Position	Below Floor Covering	
Component	Below Floor Covering	
Accessibility	N/A	
Lab	In-House Database	
Next Inspection	No Access	
Material Risk	12 (H)	
Priority Risk	N/A	
Quantity	Num	
Survey Type	Management	
Action	Further investigation may be required.	
Product Type	No Access	
Asbestos Type	No Access	
Surface Treatment	No Access	
Condition	No Access	
Recommendations	Access was denied on the day of survey – see Inspection Comments (Material & Priority Assessment Records) for details.	
Comments	No access was possible beneath the modern vinyl without causing unnecessary damage.

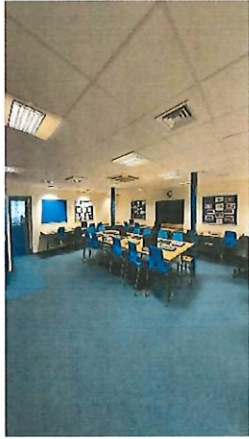
Material Assessment Ref	S165 –	
Building	Main	
Floor	Ground	
Room	063 ICT Suite	
Position	Ceiling, Walls & Floor	
Component	Ceiling, Walls & Floor	
Accessibility	N/A	
Lab	In-House Database	
Next Inspection	No further action required	
Material Risk	0 (VL)	
Priority Risk	N/A	
Quantity	Num	
Survey Type	Management	
Action	No further action required	
Product Type	Not Selected	
Asbestos Type	Non suspect material	
Surface Treatment	Not Selected	
Condition	Not Selected	
Recommendations	No further action required	
Comments	Timber panels to ceiling above suspended ceiling and plaster skim to plasterboard and brick walls. Concrete floor beneath carpet and screed.

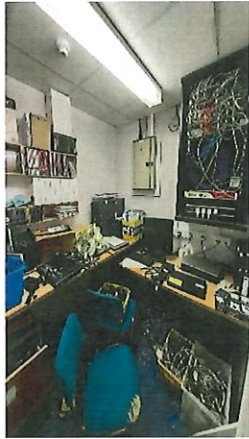
Material Assessment Ref	S166 –	
Building	Main	
Floor	Ground	
Room	064 ICT Server Room	
Position	Ceiling, Walls & Floor	
Component	Ceiling, Walls & Floor	
Accessibility	N/A	
Lab	In-House Database	
Next Inspection	No further action required	
Material Risk	0 (VL)	
Priority Risk	N/A	
Quantity	Num	
Survey Type	Management	
Action	No further action required	
Product Type	Not Selected	
Asbestos Type	Non suspect material	
Surface Treatment	Not Selected	
Condition	Not Selected	
Recommendations	No further action required	
Comments	Timber panels to ceiling above suspended ceiling and plaster skim to plasterboard and brick walls. Concrete floor beneath carpet and screed. Modern consumer unit.

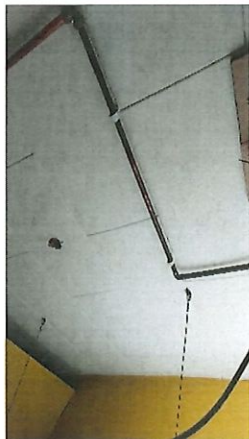
Material Assessment Ref	S167 – (As S138)	
Building	Main	
Floor	Ground	
Room	065 Girls Toilets	
Position	Ceiling	
Component	Ceiling	
Accessibility	N/A	
Lab	In-House Database	
Next Inspection	No Further Action Required	
Material Risk	0 (VL)	
Priority Risk	N/A	
Quantity	9 Sqr Mtrs	
Survey Type	Management	
Action	No Further Action Required	
Product Type	Not Selected	
Asbestos Type	Non suspect material	
Surface Treatment	Not Selected	
Condition	Not Selected	
Recommendations	No further action required	
Comments	Insulating boards to the ceiling above suspended ceiling.

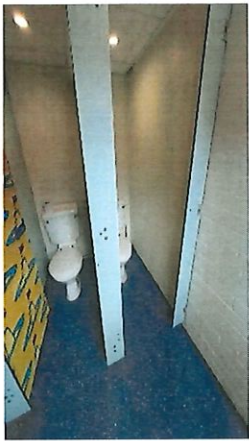
Material Assessment Ref	S168 –	
Building	Main	
Floor	Ground	
Room	065 Girls Toilets	
Position	Walls Internal	
Component	Walls Internal	
Accessibility	N/A	
Lab	In-House Database	
Next Inspection	No further action required	
Material Risk	0 (VL)	
Priority Risk	N/A	
Quantity	Num	
Survey Type	Management	
Action	No further action required	
Product Type	Not Selected	
Asbestos Type	Non suspect material	
Surface Treatment	Not Selected	
Condition	Not Selected	
Recommendations	No further action required	
Comments	Brick walls. Ceramic toilet cisterns and modern seats.

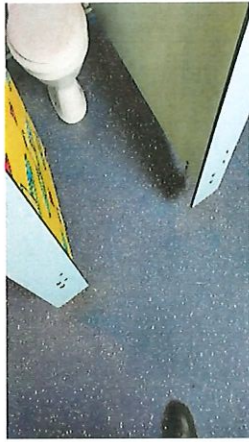
Material Assessment Ref	S169 –	
Building	Main	
Floor	Ground	
Room	065 Girls Toilets	
Position	Below Floor Covering	
Component	Below Floor Covering	
Accessibility	N/A	
Lab	In-House Database	
Next Inspection	No Access	
Material Risk	12 (H)	
Priority Risk	N/A	
Quantity	Num	
Survey Type	Management	
Action	Further investigation may be required.	
Product Type	No Access	
Asbestos Type	No Access	
Surface Treatment	No Access	
Condition	No Access	
Recommendations	Access was denied on the day of survey – see Inspection Comments (Material & Priority Assessment Records) for details.	
Comments	No access was possible beneath the modern vinyl without causing unnecessary damage.

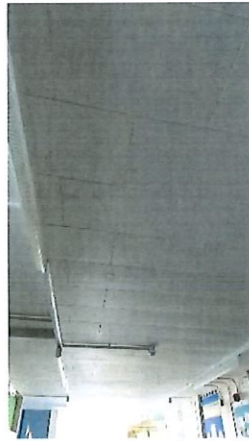
Material Assessment Ref	S170 – (As S138)	
Building	Main	
Floor	Ground	
Room	066 Resource Area	
Position	Ceiling	
Component	Ceiling	
Accessibility	N/A	
Lab	In-House Database	
Next Inspection	No Further Action Required	
Material Risk	0 (VL)	
Priority Risk	N/A	
Quantity	60 Sqr Mtrs	
Survey Type	Management	
Action	No Further Action Required	
Product Type	Not Selected	
Asbestos Type	Non suspect material	
Surface Treatment	Not Selected	
Condition	Not Selected	
Recommendations	No further action required	
Comments	Insulating boards to the ceiling.

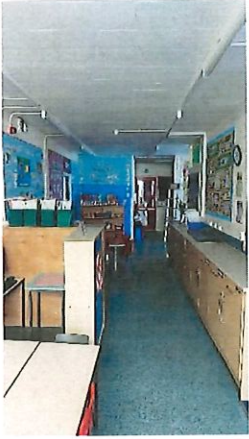
Material Assessment Ref	S171 –	
Building	Main	
Floor	Ground	
Room	066 Resource Area	
Position	Walls Internal	
Component	Walls Internal	
Accessibility	N/A	
Lab	In-House Database	
Next Inspection	No further action required	
Material Risk	0 (VL)	
Priority Risk	N/A	
Quantity	Num	
Survey Type	Management	
Action	No further action required	
Product Type	Not Selected	
Asbestos Type	Non suspect material	
Surface Treatment	Not Selected	
Condition	Not Selected	
Recommendations	No further action required	
Comments	Brick walls or plaster skim to plasterboard partitions. Modern sink unit.

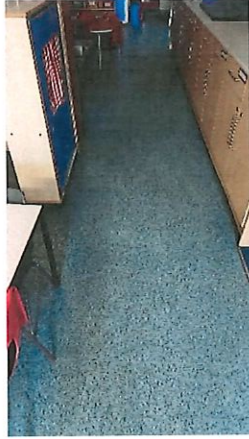
Material Assessment Ref	S172 –	
Building	Main	
Floor	Ground	
Room	066 Resource Area	
Position	Below Floor Covering	
Component	Below Floor Covering	
Accessibility	N/A	
Lab	In-House Database	
Next Inspection	No Access	
Material Risk	12 (H)	
Priority Risk	N/A	
Quantity	Num	
Survey Type	Management	
Action	Further investigation may be required.	
Product Type	No Access	
Asbestos Type	No Access	
Surface Treatment	No Access	
Condition	No Access	
Recommendations	Access was denied on the day of survey – see Inspection Comments (Material & Priority Assessment Records) for details.	
Comments	No access was possible beneath the modern vinyl without causing unnecessary damage.

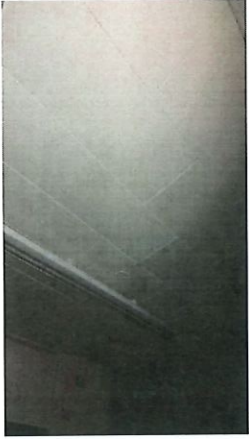
Material Assessment Ref	S173 – (As S138)	
Building	Main	
Floor	Ground	
Room	067 Cloaks	
Position	Ceiling	
Component	Ceiling	
Accessibility	N/A	
Lab	In-House Database	
Next Inspection	No Further Action Required	
Material Risk	0 (VL)	
Priority Risk	N/A	
Quantity	12 Sqr Mtrs	
Survey Type	Management	
Action	No Further Action Required	
Product Type	Not Selected	
Asbestos Type	Non suspect material	
Surface Treatment	Not Selected	
Condition	Not Selected	
Recommendations	No further action required	
Comments	Insulating boards to the ceiling.

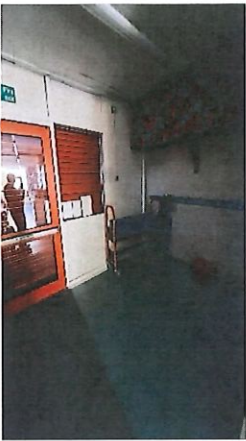
Material Assessment Ref	S174 –	
Building	Main	
Floor	Ground	
Room	067 Cloaks	
Position	Walls Internal	
Component	Walls Internal	
Accessibility	N/A	
Lab	In-House Database	
Next Inspection	No further action required	
Material Risk	0 (VL)	
Priority Risk	N/A	
Quantity	Num	
Survey Type	Management	
Action	No further action required	
Product Type	Not Selected	
Asbestos Type	Non suspect material	
Surface Treatment	Not Selected	
Condition	Not Selected	
Recommendations	No further action required	
Comments	Brick walls. Plastic downpipe.

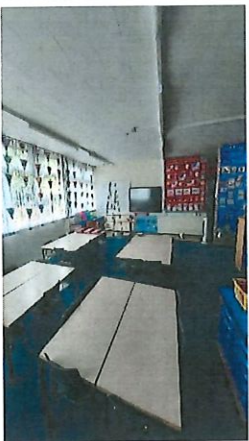
Material Assessment Ref	S177 –	
Building	Main	
Floor	Ground	
Room	068 Classroom	
Position	Walls Internal	
Component	Walls Internal	
Accessibility	N/A	
Lab	In-House Database	
Next Inspection	No further action required	
Material Risk	0 (VL)	
Priority Risk	N/A	
Quantity	Num	
Survey Type	Management	
Action	No further action required	
Product Type	Not Selected	
Asbestos Type	Non suspect material	
Surface Treatment	Not Selected	
Condition	Not Selected	
Recommendations	No further action required	
Comments	Brick walls.

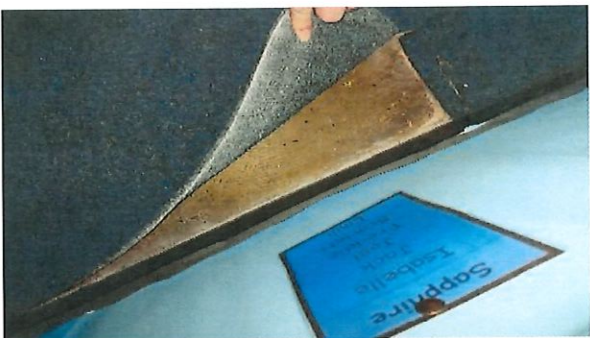
Material Assessment Ref	S178 – (As S146)	
Building	Main	
Floor	Ground	
Room	068 Classroom	
Position	Below Floor Covering	
Component	Floor Tiles & Adhesive	
Accessibility	Difficult	
Lab	In-House Database	
Next Inspection	16/08/2023	
Material Risk	3 (VL)	
Priority Risk	N/A	
Quantity	60 Sqr Mtrs	
Survey Type	Management	
Action	Manage	
Product Type	Thermo Plastic Floor Tiles	
Asbestos Type	Strongly Presumed Chrysotile	
Surface Treatment	Composite materials containing asbestos: reinforced plastics, resins, mastics, vinyl tiles, semi rigid paints or decorative finishes.	
Condition	Low damage: a few scratches or surface marks, broken edges on boards, tiles etc.	
Recommendations	Manage	
Comments	Green floor tiles and bitumen adhesive to concrete floor beneath carpet.

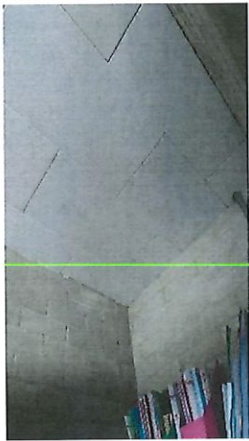
Material Assessment Ref	S179 – (As S138)	
Building	Main	
Floor	Ground	
Room	069 Classroom Store	
Position	Ceiling	
Component	Ceiling	
Accessibility	N/A	
Lab	In-House Database	
Next Inspection	No Further Action Required	
Material Risk	0 (VL)	
Priority Risk	N/A	
Quantity	1 Sqr Mtrs	
Survey Type	Management	
Action	No Further Action Required	
Product Type	Not Selected	
Asbestos Type	Non suspect material	
Surface Treatment	Not Selected	
Condition	Not Selected	
Recommendations	No further action required	
Comments	Insulating boards to the ceiling.

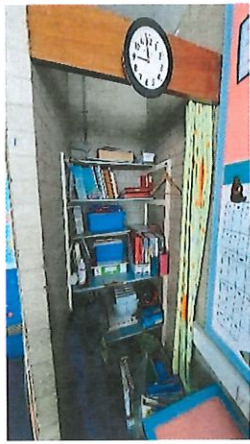
Material Assessment Ref	S183 –	
Building	Main	
Floor	Ground	
Room	070 Classroom Store	
Position	Walls Internal	
Component	Walls Internal	
Accessibility	N/A	
Lab	In-House Database	
Next Inspection	No further action required	
Material Risk	0 (VL)	
Priority Risk	N/A	
Quantity	Num	
Survey Type	Management	
Action	No further action required	
Product Type	Not Selected	
Asbestos Type	Non suspect material	
Surface Treatment	Not Selected	
Condition	Not Selected	
Recommendations	No further action required	
Comments	Brick walls. Wood door head panel.

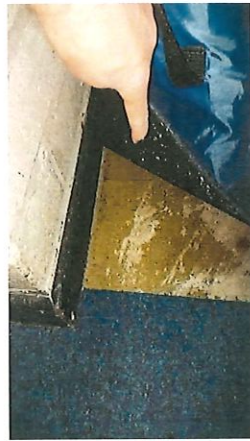
Material Assessment Ref	S184 – (As S146)	
Building	Main	
Floor	Ground	
Room	070 Classroom Store	
Position	Below Floor Covering	
Component	Floor Tiles & Adhesive	
Accessibility	Difficult	
Lab	In-House Database	
Next Inspection	16/08/2023	
Material Risk	3 (VL)	
Priority Risk	N/A	
Quantity	1 Sqr Mtrs	
Survey Type	Management	
Action	Manage	
Product Type	Thermo Plastic Floor Tiles	
Asbestos Type	Strongly Presumed Chrysotile	
Surface Treatment	Composite materials containing asbestos: reinforced plastics, resins, mastics, vinyl tiles, semi rigid paints or decorative finishes.	
Condition	Low damage: a few scratches or surface marks, broken edges on boards, tiles etc.	
Recommendations	Manage	
Comments	Green floor tiles and bitumen adhesive to concrete floor beneath carpet.

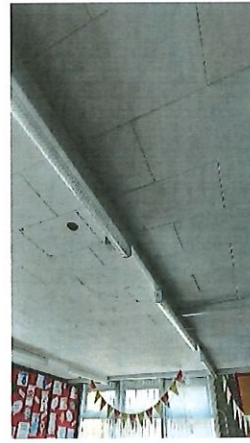
Material Assessment Ref	S185 – (As S138)	
Building	Main	
Floor	Ground	
Room	071 Classroom	
Position	Ceiling	
Component	Ceiling	
Accessibility	N/A	
Lab	In-House Database	
Next Inspection	No Further Action Required	
Material Risk	0 (VL)	
Priority Risk	N/A	
Quantity	60 Sqr Mtrs	
Survey Type	Management	
Action	No Further Action Required	
Product Type	Not Selected	
Asbestos Type	Non suspect material	
Surface Treatment	Not Selected	
Condition	Not Selected	
Recommendations	No further action required	
Comments	Insulating boards to the ceiling.

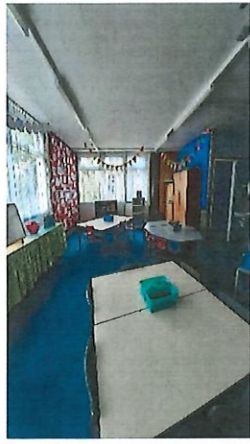
Material Assessment Ref	S186 –	
Building	Main	
Floor	Ground	
Room	071 Classroom	
Position	Walls Internal	
Component	Walls Internal	
Accessibility	N/A	
Lab	In-House Database	
Next Inspection	No further action required	
Material Risk	0 (VL)	
Priority Risk	N/A	
Quantity	Num	
Survey Type	Management	
Action	No further action required	
Product Type	Not Selected	
Asbestos Type	Non suspect material	
Surface Treatment	Not Selected	
Condition	Not Selected	
Recommendations	No further action required	
Comments	Brick walls.

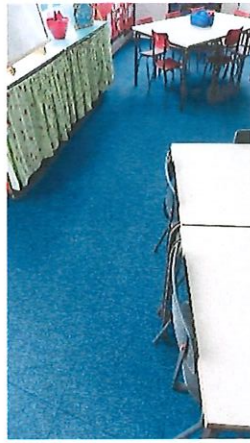
Material Assessment Ref	S187 – (As S146)	
Building	Main	
Floor	Ground	
Room	071 Classroom	
Position	Below Floor Covering	
Component	Floor Tiles & Adhesive	
Accessibility	Difficult	
Lab	In-House Database	
Next Inspection	16/08/2023	
Material Risk	3 (VL)	
Priority Risk	N/A	
Quantity	60 Sqr Mtrs	
Survey Type	Management	
Action	Manage	
Product Type	Thermo Plastic Floor Tiles	
Asbestos Type	Strongly Presumed Chrysotile	
Surface Treatment	Composite materials containing asbestos: reinforced plastics, resins, mastics, vinyl tiles, semi rigid paints or decorative finishes.	
Condition	Low damage: a few scratches or surface marks, broken edges on boards, tiles etc.	
Recommendations	Manage	
Comments	Green floor tiles and bitumen adhesive to concrete floor beneath carpet.

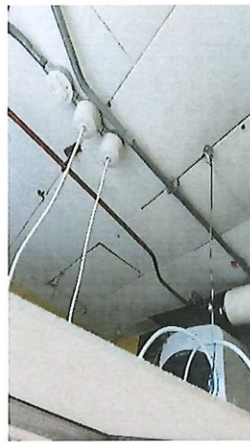
Material Assessment Ref	S188 – (As S138)	
Building	Main	
Floor	Ground	
Room	072 Boys Toilets	
Position	Ceiling	
Component	Ceiling	
Accessibility	N/A	
Lab	In-House Database	
Next Inspection	No Further Action Required	
Material Risk	0 (VL)	
Priority Risk	N/A	
Quantity	9 Sqr Mtrs	
Survey Type	Management	
Action	No Further Action Required	
Product Type	Not Selected	
Asbestos Type	Non suspect material	
Surface Treatment	Not Selected	
Condition	Not Selected	
Recommendations	No further action required	
Comments	Insulating boards to the ceiling.

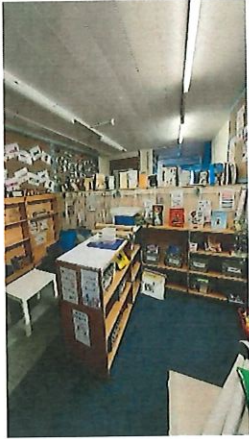
Material Assessment Ref	S192 –	
Building	Main	
Floor	Ground	
Room	073 & 074 Reading Area	
Position	Walls & Floor	
Component	Walls & Floor	
Accessibility	N/A	
Lab	In-House Database	
Next Inspection	No further action required	
Material Risk	0 (VL)	
Priority Risk	N/A	
Quantity	Num	
Survey Type	Management	
Action	No further action required	
Product Type	Not Selected	
Asbestos Type	Non suspect material	
Surface Treatment	Not Selected	
Condition	Not Selected	
Recommendations	No further action required	
Comments	Brick walls or plaster skim to plasterboard partitions. Plastic downpipe. Concrete floor beneath carpet.

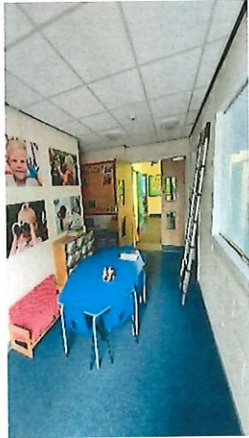
Material Assessment Ref	S193 –	
Building	Main	
Floor	Ground	
Room	077 & 088 Entrance Lobby	
Position	Ceiling, Walls & Floor	
Component	Ceiling, Walls & Floor	
Accessibility	N/A	
Lab	In-House Database	
Next Inspection	No further action required	
Material Risk	0 (VL)	
Priority Risk	N/A	
Quantity	Num	
Survey Type	Management	
Action	No further action required	
Product Type	Not Selected	
Asbestos Type	Non suspect material	
Surface Treatment	Not Selected	
Condition	Not Selected	
Recommendations	No further action required	
Comments	Timber roof decking boards above suspended ceiling, block walls and concrete floor beneath carpet.

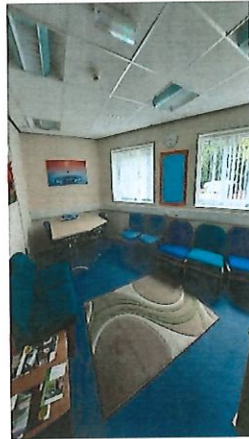
Material Assessment Ref	S194 –	
Building	Main	
Floor	Ground	
Room	078 Meeting Room	
Position	Ceiling, Walls & Floor	
Component	Ceiling, Walls & Floor	
Accessibility	N/A	
Lab	In-House Database	
Next Inspection	No further action required	
Material Risk	0 (VL)	
Priority Risk	N/A	
Quantity	Num	
Survey Type	Management	
Action	No further action required	
Product Type	Not Selected	
Asbestos Type	Non suspect material	
Surface Treatment	Not Selected	
Condition	Not Selected	
Recommendations	No further action required	
Comments	Timber roof decking boards above suspended ceiling, block walls and concrete floor beneath carpet.

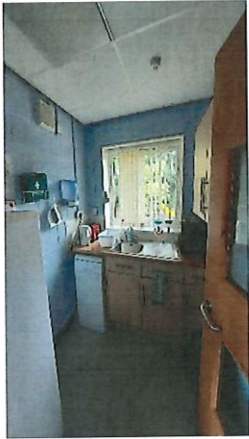
Material Assessment Ref	S198 –	
Building	Main	
Floor	Ground	
Room	082 Kitchen	
Position	Ceiling, Walls & Floor	
Component	Ceiling, Walls & Floor	
Accessibility	N/A	
Lab	In-House Database	
Next Inspection	No further action required	
Material Risk	0 (VL)	
Priority Risk	N/A	
Quantity	Num	
Survey Type	Management	
Action	No further action required	
Product Type	Not Selected	
Asbestos Type	Non suspect material	
Surface Treatment	Not Selected	
Condition	Not Selected	
Recommendations	No further action required	
Comments	Timber roof decking boards above suspended ceiling, block walls and concrete floor beneath modern vinyl. Modern sink unit.

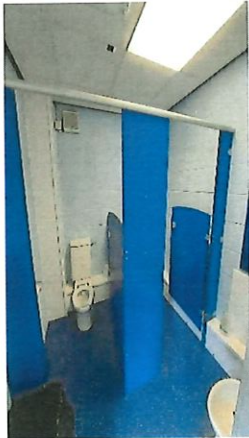
Material Assessment Ref	S199 –	
Building	Main	
Floor	Ground	
Room	083 Toilets	
Position	Ceiling, Walls & Floor	
Component	Ceiling, Walls & Floor	
Accessibility	N/A	
Lab	In-House Database	
Next Inspection	No further action required	
Material Risk	0 (VL)	
Priority Risk	N/A	
Quantity	Num	
Survey Type	Management	
Action	No further action required	
Product Type	Not Selected	
Asbestos Type	Non suspect material	
Surface Treatment	Not Selected	
Condition	Not Selected	
Recommendations	No further action required	
Comments	Timber roof decking boards above suspended ceiling, block walls and concrete floor beneath modern vinyl. Ceramic toilet cisterns and modern seats.

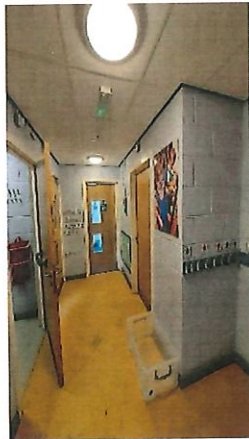
Material Assessment Ref	S200 –	
Building	Main	
Floor	Ground	
Room	084 Corridor / Cloaks	
Position	Ceiling, Walls & Floor	
Component	Ceiling, Walls & Floor	
Accessibility	N/A	
Lab	In-House Database	
Next Inspection	No further action required	
Material Risk	0 (VL)	
Priority Risk	N/A	
Quantity	Num	
Survey Type	Management	
Action	No further action required	
Product Type	Not Selected	
Asbestos Type	Non suspect material	
Surface Treatment	Not Selected	
Condition	Not Selected	
Recommendations	No further action required	
Comments	Timber roof decking boards above suspended ceiling, block walls and concrete floor beneath modern vinyl.

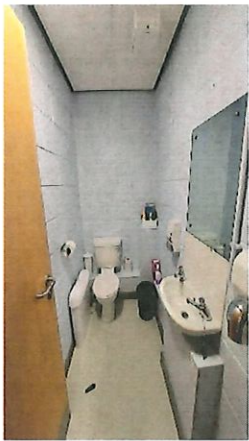
Material Assessment Ref	S201 –	
Building	Main	
Floor	Ground	
Room	085 Toilet	
Position	Ceiling, Walls & Floor	
Component	Ceiling, Walls & Floor	
Accessibility	N/A	
Lab	In-House Database	
Next Inspection	No further action required	
Material Risk	0 (VL)	
Priority Risk	N/A	
Quantity	Num	
Survey Type	Management	
Action	No further action required	
Product Type	Not Selected	
Asbestos Type	Non suspect material	
Surface Treatment	Not Selected	
Condition	Not Selected	
Recommendations	No further action required	
Comments	Timber roof decking boards above suspended ceiling, block walls and concrete floor beneath modern vinyl. Ceramic toilet cisterns and modern seats.

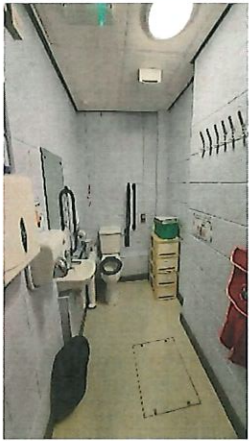
Material Assessment Ref	S202 –	
Building	Main	
Floor	Ground	
Room	086 Disabled Toilet	
Position	Ceiling, Walls & Floor	
Component	Ceiling, Walls & Floor	
Accessibility	N/A	
Lab	In-House Database	
Next Inspection	No further action required	
Material Risk	0 (VL)	
Priority Risk	N/A	
Quantity	Num	
Survey Type	Management	
Action	No further action required	
Product Type	Not Selected	
Asbestos Type	Non suspect material	
Surface Treatment	Not Selected	
Condition	Not Selected	
Recommendations	No further action required	
Comments	Timber roof decking boards above suspended ceiling, block walls and concrete floor beneath modern vinyl. Ceramic toilet cisterns and modern seats.

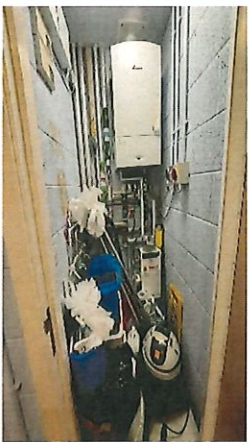
Material Assessment Ref	S203 –	
Building	Main	
Floor	Ground	
Room	087 Plant Room	
Position	Ceiling, Walls & Floor	
Component	Ceiling, Walls & Floor	
Accessibility	N/A	
Lab	In-House Database	
Next Inspection	No further action required	
Material Risk	0 (VL)	
Priority Risk	N/A	
Quantity	Num	
Survey Type	Management	
Action	No further action required	
Product Type	Not Selected	
Asbestos Type	Non suspect material	
Surface Treatment	Not Selected	
Condition	Not Selected	
Recommendations	No further action required	
Comments	Plaster skim to plasterboard ceiling, block walls and concrete floor beneath modern vinyl. Modern boiler unit and plant equipment.

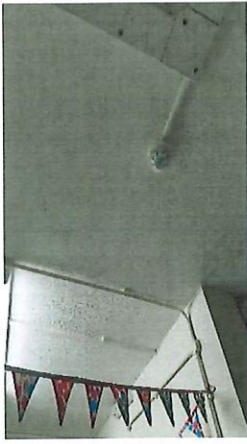
Material Assessment Ref	S204 –	
Building	Main	
Floor	Ground	
Room	N001 Cloakroom	
Position	Ceiling	
Component	Textured Coating To Ceiling	
Accessibility	Medium	
Lab	The Testing Lab PLC	
Next Inspection	17/08/2023	
Material Risk	3 (VL)	
Priority Risk	N/A	
Quantity	10 Sqr Mtrs	
Survey Type	Management	
Action	Manage	
Product Type	Textured Coating	
Asbestos Type	Chrysotile	
Surface Treatment	Composite materials containing asbestos: reinforced plastics, resins, mastics, vinyl tiles, semi rigid paints or decorative finishes.	
Condition	Low damage: a few scratches or surface marks, broken edges on boards, tiles etc.	
Recommendations	Manage	
Comments	Textured coating to plasterboard ceiling.
