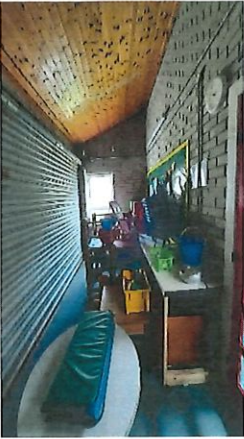
Material Assessment Ref	S216 –	
Building	Main	
Floor	Ground	
Room	N006A Covered Play Area	
Position	Ceiling, Walls & Floor	
Component	Ceiling, Walls & Floor	
Accessibility	N/A	
Lab	In-House Database	
Next Inspection	No further action required	
Material Risk	0 (VL)	
Priority Risk	N/A	
Quantity	Num	
Survey Type	Management	
Action	No further action required	
Product Type	Not Selected	
Asbestos Type	Non suspect material	
Surface Treatment	Not Selected	
Condition	Not Selected	
Recommendations	No further action required	
Comments	Timber panels to ceiling, brick walls and concrete floor beneath modern vinyl.

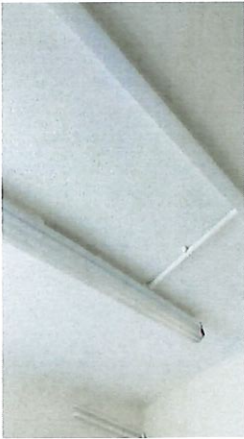
Material Assessment Ref	S217 – (As S204)	
Building	Main	
Floor	Ground	
Room	N007 Laundry	
Position	Ceiling	
Component	Textured Coating To Ceiling	
Accessibility	Medium	
Lab	In-House Database	
Next Inspection	17/08/2023	
Material Risk	3 (VL)	
Priority Risk	N/A	
Quantity	7 Sqr Mtrs	
Survey Type	Management	
Action	Manage	
Product Type	Textured Coating	
Asbestos Type	Strongly Presumed Chrysotile	
Surface Treatment	Composite materials containing asbestos: reinforced plastics, resins, mastics, vinyl tiles, semi rigid paints or decorative finishes.	
Condition	Low damage: a few scratches or surface marks, broken edges on boards, tiles etc.	
Recommendations	Manage	
Comments	Textured coating to plasterboard ceiling.

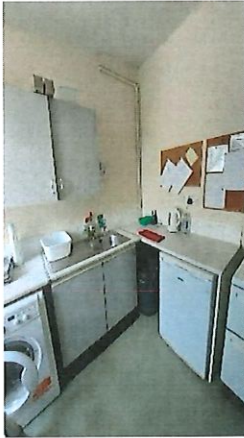
Material Assessment Ref	S218 –	
Building	Main	
Floor	Ground	
Room	N007 Laundry	
Position	Walls Internal	
Component	Walls Internal	
Accessibility	N/A	
Lab	In-House Database	
Next Inspection	No further action required	
Material Risk	0 (VL)	
Priority Risk	N/A	
Quantity	Num	
Survey Type	Management	
Action	No further action required	
Product Type	Not Selected	
Asbestos Type	Non suspect material	
Surface Treatment	Not Selected	
Condition	Not Selected	
Recommendations	No further action required	
Comments	Plaster skim to brick walls. Modern sink unit.

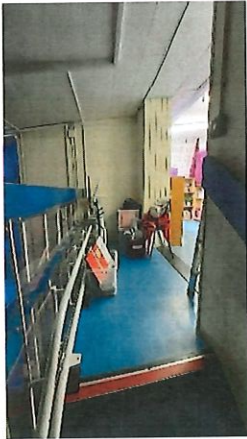
Material Assessment Ref	S224 –	
Building	Main	
Floor	First	
Room	101 Stairwells	
Position	Walls & Floor	
Component	Walls & Floor	
Accessibility	N/A	
Lab	In-House Database	
Next Inspection	No further action required	
Material Risk	0 (VL)	
Priority Risk	N/A	
Quantity	Num	
Survey Type	Management	
Action	No further action required	
Product Type	Not Selected	
Asbestos Type	Non suspect material	
Surface Treatment	Not Selected	
Condition	Not Selected	
Recommendations	No further action required	
Comments	Brick walls and timber staircase beneath modern vinyl. Rubber stair nosing strips.

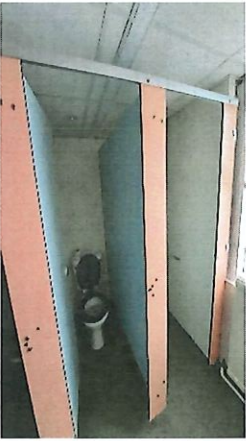
Material Assessment Ref	S228 –	
Building	Main	
Floor	First	
Room	103 Girls Toilets	
Position	Ceiling & Walls	
Component	Ceiling & Walls	
Accessibility	N/A	
Lab	In-House Database	
Next Inspection	No further action required	
Material Risk	0 (VL)	
Priority Risk	N/A	
Quantity	Num	
Survey Type	Management	
Action	No further action required	
Product Type	Not Selected	
Asbestos Type	Non suspect material	
Surface Treatment	Not Selected	
Condition	Not Selected	
Recommendations	No further action required	
Comments	Polystyrene tiles to ceiling above suspended ceiling and brick walls. Ceramic toilet cisterns.

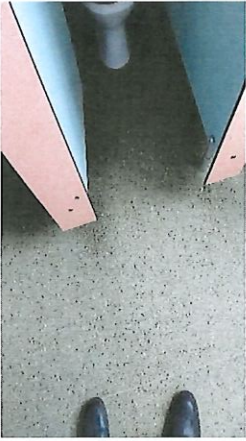
Material Assessment Ref	S229 –	
Building	Main	
Floor	First	
Room	103 Girls Toilets	
Position	Below Floor Covering	
Component	Below Floor Covering	
Accessibility	N/A	
Lab	In-House Database	
Next Inspection	No Access	
Material Risk	12 (H)	
Priority Risk	N/A	
Quantity	Num	
Survey Type	Management	
Action	Further investigation may be required.	
Product Type	No Access	
Asbestos Type	No Access	
Surface Treatment	No Access	
Condition	No Access	
Recommendations	Access was denied on the day of survey – see Inspection Comments (Material & Priority Assessment Records) for details.	
Comments	No access was possible beneath the modern vinyl without causing unnecessary damage.

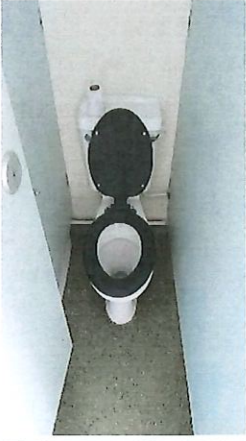
Material Assessment Ref	S230 –	
Building	Main	
Floor	First	
Room	103 Girls Toilets	
Position	Toilet Seat	
Component	Toilet Seat	
Accessibility	N/A	
Lab	The Testing Lab PLC	
Next Inspection	No Further Action Required	
Material Risk	0 (VL)	
Priority Risk	N/A	
Quantity	3 Num	
Survey Type	Management	
Action	No Further Action Required	
Product Type	Not Selected	
Asbestos Type	NADIS	
Surface Treatment	Not Selected	
Condition	Not Selected	
Recommendations	No further action required	
Comments	Black plastic toilet seats.

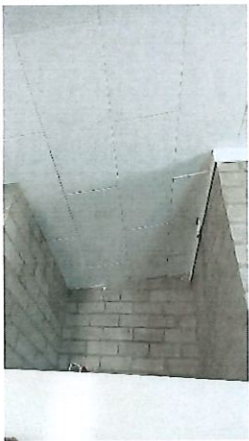
Material Assessment Ref	S234 – (As S223)	
Building	Main	
Floor	First	
Room	105 Cleaners Store	
Position	Ceiling	
Component	Ceiling	
Accessibility	N/A	
Lab	In-House Database	
Next Inspection	No Further Action Required	
Material Risk	0 (VL)	
Priority Risk	N/A	
Quantity	1 Sqr Mtrs	
Survey Type	Management	
Action	No Further Action Required	
Product Type	Not Selected	
Asbestos Type	Non suspect material	
Surface Treatment	Not Selected	
Condition	Not Selected	
Recommendations	No further action required	
Comments	Insulating boards to the ceiling.

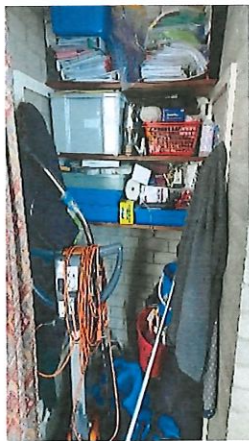
Material Assessment Ref	S235 –	
Building	Main	
Floor	First	
Room	105 Cleaners Store	
Position	Walls Internal	
Component	Walls Internal	
Accessibility	N/A	
Lab	In-House Database	
Next Inspection	No further action required	
Material Risk	0 (VL)	
Priority Risk	N/A	
Quantity	Num	
Survey Type	Management	
Action	No further action required	
Product Type	Not Selected	
Asbestos Type	Non suspect material	
Surface Treatment	Not Selected	
Condition	Not Selected	
Recommendations	No further action required	
Comments	Brick walls.

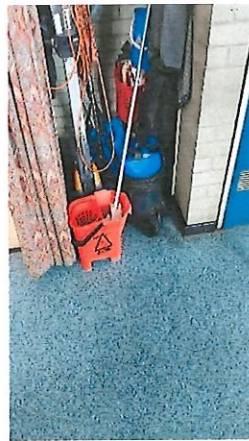
Material Assessment Ref	S236 –	
Building	Main	
Floor	First	
Room	105 Cleaners Store	
Position	Below Floor Covering	
Component	Below Floor Covering	
Accessibility	N/A	
Lab	In-House Database	
Next Inspection	No Access	
Material Risk	12 (H)	
Priority Risk	N/A	
Quantity	Num	
Survey Type	Management	
Action	Further investigation may be required.	
Product Type	No Access	
Asbestos Type	No Access	
Surface Treatment	No Access	
Condition	No Access	
Recommendations	Access was denied on the day of survey – see Inspection Comments (Material & Priority Assessment Records) for details.	
Comments	No access was possible beneath the modern vinyl without causing unnecessary damage.

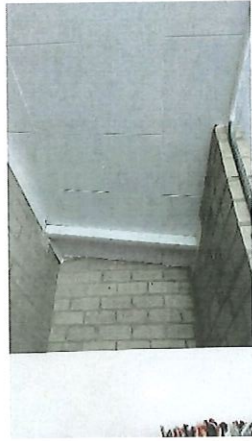
Material Assessment Ref	S237 – (As S223)	
Building	Main	
Floor	First	
Room	106 Classroom Store	
Position	Ceiling	
Component	Ceiling	
Accessibility	N/A	
Lab	In-House Database	
Next Inspection	No Further Action Required	
Material Risk	0 (VL)	
Priority Risk	N/A	
Quantity	1 Sqr Mtrs	
Survey Type	Management	
Action	No Further Action Required	
Product Type	Not Selected	
Asbestos Type	Non suspect material	
Surface Treatment	Not Selected	
Condition	Not Selected	
Recommendations	No further action required	
Comments	Insulating boards to the ceiling.

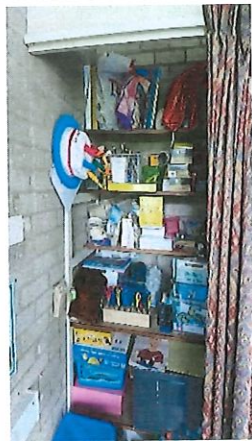
Material Assessment Ref	S238 –	
Building	Main	
Floor	First	
Room	106 Classroom Store	
Position	Walls Internal	
Component	Walls Internal	
Accessibility	N/A	
Lab	In-House Database	
Next Inspection	No further action required	
Material Risk	0 (VL)	
Priority Risk	N/A	
Quantity	Num	
Survey Type	Management	
Action	No further action required	
Product Type	Not Selected	
Asbestos Type	Non suspect material	
Surface Treatment	Not Selected	
Condition	Not Selected	
Recommendations	No further action required	
Comments	Brick walls.

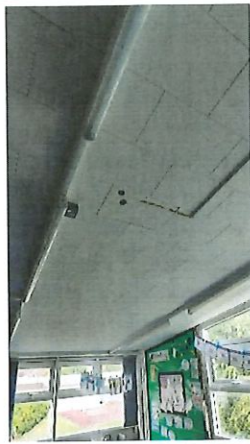
Material Assessment Ref	S240 – (As S223)	
Building	Main	
Floor	First	
Room	107 Classroom	
Position	Ceiling	
Component	Ceiling	
Accessibility	N/A	
Lab	In-House Database	
Next Inspection	No Further Action Required	
Material Risk	0 (VL)	
Priority Risk	N/A	
Quantity	60 Sqr Mtrs	
Survey Type	Management	
Action	No Further Action Required	
Product Type	Not Selected	
Asbestos Type	Non suspect material	
Surface Treatment	Not Selected	
Condition	Not Selected	
Recommendations	No further action required	
Comments	Insulating boards to the ceiling.

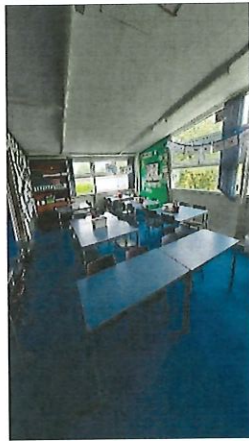
Material Assessment Ref	S241 –	
Building	Main	
Floor	First	
Room	107 Classroom	
Position	Walls Internal	
Component	Walls Internal	
Accessibility	N/A	
Lab	In-House Database	
Next Inspection	No further action required	
Material Risk	0 (VL)	
Priority Risk	N/A	
Quantity	Num	
Survey Type	Management	
Action	No further action required	
Product Type	Not Selected	
Asbestos Type	Non suspect material	
Surface Treatment	Not Selected	
Condition	Not Selected	
Recommendations	No further action required	
Comments	Brick walls.

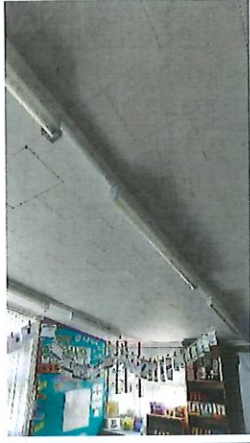
Material Assessment Ref	S243 – (As S223)	
Building	Main	
Floor	First	
Room	108 Classroom	
Position	Ceiling	
Component	Ceiling	
Accessibility	N/A	
Lab	In-House Database	
Next Inspection	No Further Action Required	
Material Risk	0 (VL)	
Priority Risk	N/A	
Quantity	60 Sqr Mtrs	
Survey Type	Management	
Action	No Further Action Required	
Product Type	Not Selected	
Asbestos Type	Non suspect material	
Surface Treatment	Not Selected	
Condition	Not Selected	
Recommendations	No further action required	
Comments	Insulating boards to the ceiling.

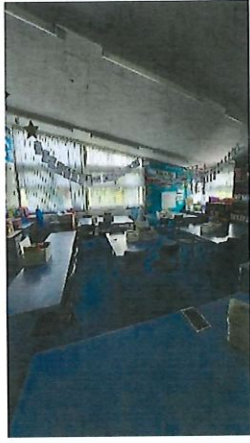
Material Assessment Ref	S244 –	
Building	Main	
Floor	First	
Room	108 Classroom	
Position	Walls Internal	
Component	Walls Internal	
Accessibility	N/A	
Lab	In-House Database	
Next Inspection	No further action required	
Material Risk	0 (VL)	
Priority Risk	N/A	
Quantity	Num	
Survey Type	Management	
Action	No further action required	
Product Type	Not Selected	
Asbestos Type	Non suspect material	
Surface Treatment	Not Selected	
Condition	Not Selected	
Recommendations	No further action required	
Comments	Brick walls.

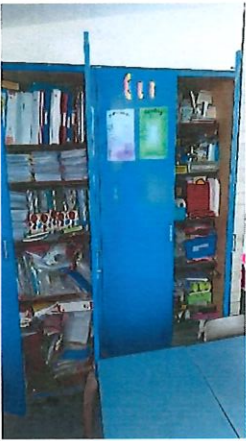
Material Assessment Ref	S246 –	
Building	Main	
Floor	First	
Room	109 Classroom Cupboards	
Position	Ceiling, Walls & Floor	
Component	Ceiling, Walls & Floor	
Accessibility	N/A	
Lab	In-House Database	
Next Inspection	No further action required	
Material Risk	0 (VL)	
Priority Risk	N/A	
Quantity	Num	
Survey Type	Management	
Action	No further action required	
Product Type	Not Selected	
Asbestos Type	Non suspect material	
Surface Treatment	Not Selected	
Condition	Not Selected	
Recommendations	No further action required	
Comments	Timber ceiling, walls and floor.

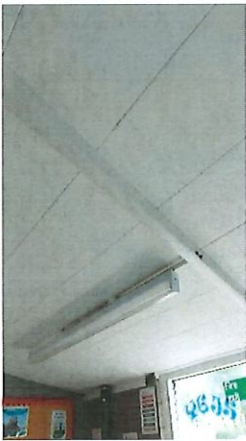
Material Assessment Ref	S247 – (As S223)	
Building	Main	
Floor	First	
Room	110 Cloaks	
Position	Ceiling	
Component	Ceiling	
Accessibility	N/A	
Lab	In-House Database	
Next Inspection	No Further Action Required	
Material Risk	0 (VL)	
Priority Risk	N/A	
Quantity	12 Sqr Mtrs	
Survey Type	Management	
Action	No Further Action Required	
Product Type	Not Selected	
Asbestos Type	Non suspect material	
Surface Treatment	Not Selected	
Condition	Not Selected	
Recommendations	No further action required	
Comments	Insulating boards to the ceiling.

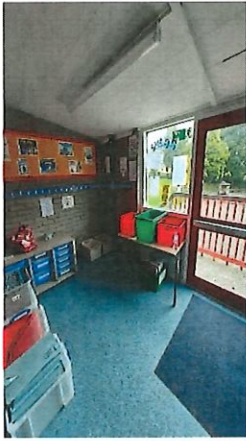
Material Assessment Ref	S248 –	
Building	Main	
Floor	First	
Room	110 Cloaks	
Position	Walls Internal	
Component	Walls Internal	
Accessibility	N/A	
Lab	In-House Database	
Next Inspection	No further action required	
Material Risk	0 (VL)	
Priority Risk	N/A	
Quantity	Num	
Survey Type	Management	
Action	No further action required	
Product Type	Not Selected	
Asbestos Type	Non suspect material	
Surface Treatment	Not Selected	
Condition	Not Selected	
Recommendations	No further action required	
Comments	Brick walls.

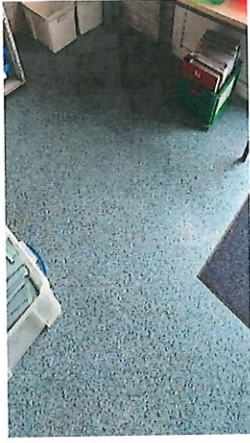
Material Assessment Ref	S249 –	
Building	Main	
Floor	First	
Room	110 Cloaks	
Position	Below Floor Covering	
Component	Below Floor Covering	
Accessibility	N/A	
Lab	In-House Database	
Next Inspection	No Access	
Material Risk	12 (H)	
Priority Risk	N/A	
Quantity	Num	
Survey Type	Management	
Action	Further investigation may be required.	
Product Type	No Access	
Asbestos Type	No Access	
Surface Treatment	No Access	
Condition	No Access	
Recommendations	Access was denied on the day of survey – see Inspection Comments (Material & Priority Assessment Records) for details.	
Comments	No access was possible beneath the modern vinyl without causing unnecessary damage.

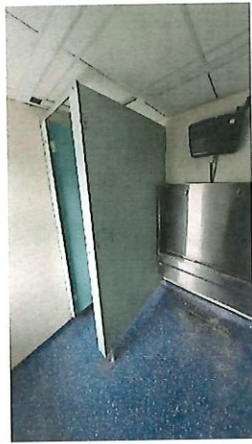
Material Assessment Ref	S250 –	
Building	Main	
Floor	First	
Room	111 Boys Toilets	
Position	Ceiling & Walls	
Component	Ceiling & Walls	
Accessibility	N/A	
Lab	In-House Database	
Next Inspection	No further action required	
Material Risk	0 (VL)	
Priority Risk	N/A	
Quantity	Num	
Survey Type	Management	
Action	No further action required	
Product Type	Not Selected	
Asbestos Type	Non suspect material	
Surface Treatment	Not Selected	
Condition	Not Selected	
Recommendations	No further action required	
Comments	Polystyrene tiles to ceiling above suspended ceiling and brick walls. Ceramic or modern black plastic toilet cisterns.

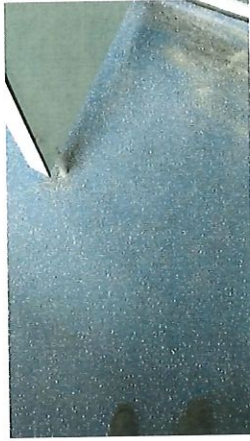
Material Assessment Ref	S251 –	
Building	Main	
Floor	First	
Room	111 Boys Toilets	
Position	Below Floor Covering	
Component	Below Floor Covering	
Accessibility	N/A	
Lab	In-House Database	
Next Inspection	No Access	
Material Risk	12 (H)	
Priority Risk	N/A	
Quantity	Num	
Survey Type	Management	
Action	Further investigation may be required.	
Product Type	No Access	
Asbestos Type	No Access	
Surface Treatment	No Access	
Condition	No Access	
Recommendations	Access was denied on the day of survey – see Inspection Comments (Material & Priority Assessment Records) for details.	
Comments	No access was possible beneath the modern vinyl without causing unnecessary damage.

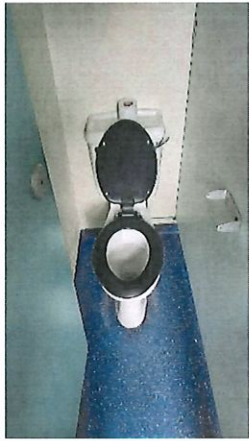
Material Assessment Ref	S252 – (As S230)	
Building	Main	
Floor	First	
Room	111 Boys Toilets	
Position	Toilet Seat	
Component	Toilet Seat	
Accessibility	N/A	
Lab	In-House Database	
Next Inspection	No Further Action Required	
Material Risk	0 (VL)	
Priority Risk	N/A	
Quantity	1 Num	
Survey Type	Management	
Action	No Further Action Required	
Product Type	Not Selected	
Asbestos Type	Non suspect material	
Surface Treatment	Not Selected	
Condition	Not Selected	
Recommendations	No further action required	
Comments	Black plastic toilet seats.

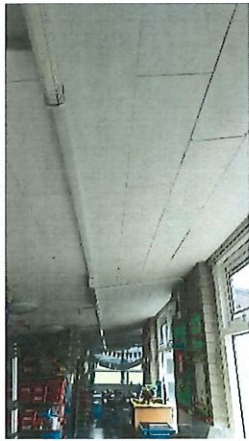
Material Assessment Ref	S253 – (As S223)	
Building	Main	
Floor	First	
Room	112 & 113 Resource Area	
Position	Ceiling	
Component	Ceiling	
Accessibility	N/A	
Lab	In-House Database	
Next Inspection	No Further Action Required	
Material Risk	0 (VL)	
Priority Risk	N/A	
Quantity	60 Sqr Mtrs	
Survey Type	Management	
Action	No Further Action Required	
Product Type	Not Selected	
Asbestos Type	Non suspect material	
Surface Treatment	Not Selected	
Condition	Not Selected	
Recommendations	No further action required	
Comments	Insulating boards to the ceiling.

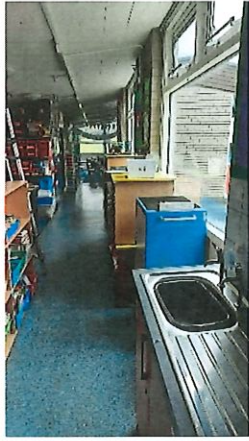
Material Assessment Ref	S254 –	
Building	Main	
Floor	First	
Room	112 & 113 Resource Area	
Position	Walls Internal	
Component	Walls Internal	
Accessibility	N/A	
Lab	In-House Database	
Next Inspection	No further action required	
Material Risk	0 (VL)	
Priority Risk	N/A	
Quantity	Num	
Survey Type	Management	
Action	No further action required	
Product Type	Not Selected	
Asbestos Type	Non suspect material	
Surface Treatment	Not Selected	
Condition	Not Selected	
Recommendations	No further action required	
Comments	Plaster skim to plasterboard or brick walls. Modern sink units.

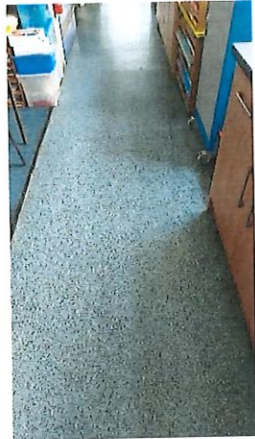
Material Assessment Ref	S255 –	
Building	Main	
Floor	First	
Room	112 & 113 Resource Area	
Position	Below Floor Covering	
Component	Below Floor Covering	
Accessibility	N/A	
Lab	In-House Database	
Next Inspection	No Access	
Material Risk	12 (H)	
Priority Risk	N/A	
Quantity	Num	
Survey Type	Management	
Action	Further investigation may be required.	
Product Type	No Access	
Asbestos Type	No Access	
Surface Treatment	No Access	
Condition	No Access	
Recommendations	Access was denied on the day of survey – see Inspection Comments (Material & Priority Assessment Records) for details.	
Comments	No access was possible beneath the modern vinyl without causing unnecessary damage.

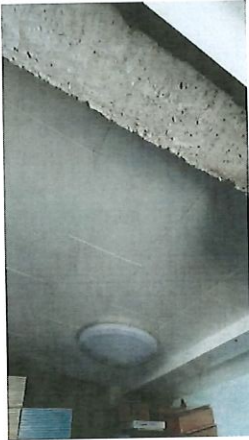
Material Assessment Ref	S256 – (As S223)	
Building	Main	
Floor	First	
Room	114 Store	
Position	Ceiling	
Component	Ceiling	
Accessibility	N/A	
Lab	In-House Database	
Next Inspection	No Further Action Required	
Material Risk	0 (VL)	
Priority Risk	N/A	
Quantity	6 Sqr Mtrs	
Survey Type	Management	
Action	No Further Action Required	
Product Type	Not Selected	
Asbestos Type	Non suspect material	
Surface Treatment	Not Selected	
Condition	Not Selected	
Recommendations	No further action required	
Comments	Insulating boards to the ceiling.

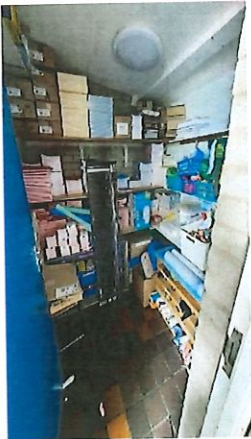
Material Assessment Ref	S257 –	
Building	Main	
Floor	First	
Room	114 Store	
Position	Walls & Floor	
Component	Walls & Floor	
Accessibility	N/A	
Lab	In-House Database	
Next Inspection	No further action required	
Material Risk	0 (VL)	
Priority Risk	N/A	
Quantity	Num	
Survey Type	Management	
Action	No further action required	
Product Type	Not Selected	
Asbestos Type	Non suspect material	
Surface Treatment	Not Selected	
Condition	Not Selected	
Recommendations	No further action required	
Comments	Brick walls and concrete floor beneath ceramic floor tiles.

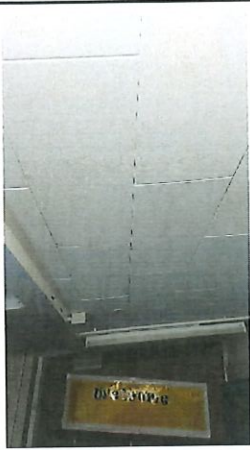
Material Assessment Ref	S258 – (As S223)	
Building	Main	
Floor	First	
Room	115 Lobby / Cloaks	
Position	Ceiling	
Component	Ceiling	
Accessibility	N/A	
Lab	In-House Database	
Next Inspection	No Further Action Required	
Material Risk	0 (VL)	
Priority Risk	N/A	
Quantity	10 Sqr Mtrs	
Survey Type	Management	
Action	No Further Action Required	
Product Type	Not Selected	
Asbestos Type	Non suspect material	
Surface Treatment	Not Selected	
Condition	Not Selected	
Recommendations	No further action required	
Comments	Insulating boards to the ceiling.

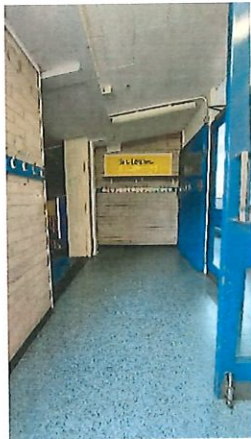
Material Assessment Ref	S259 –	
Building	Main	
Floor	First	
Room	115 Lobby / Cloaks	
Position	Walls Internal	
Component	Walls Internal	
Accessibility	N/A	
Lab	In-House Database	
Next Inspection	No further action required	
Material Risk	0 (VL)	
Priority Risk	N/A	
Quantity	Num	
Survey Type	Management	
Action	No further action required	
Product Type	Not Selected	
Asbestos Type	Non suspect material	
Surface Treatment	Not Selected	
Condition	Not Selected	
Recommendations	No further action required	
Comments	Plaster skim to plasterboard or brick walls. Glass door head panels.

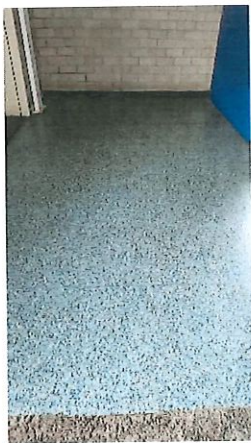
Material Assessment Ref	S260 –	
Building	Main	
Floor	First	
Room	115 Lobby / Cloaks	
Position	Below Floor Covering	
Component	Below Floor Covering	
Accessibility	N/A	
Lab	In-House Database	
Next Inspection	No Access	
Material Risk	12 (H)	
Priority Risk	N/A	
Quantity	Num	
Survey Type	Management	
Action	Further investigation may be required.	
Product Type	No Access	
Asbestos Type	No Access	
Surface Treatment	No Access	
Condition	No Access	
Recommendations	Access was denied on the day of survey – see Inspection Comments (Material & Priority Assessment Records) for details.	
Comments	No access was possible beneath the modern vinyl without causing unnecessary damage.

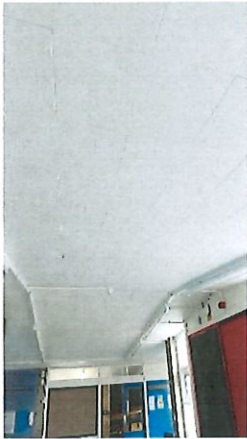
Material Assessment Ref	S261 – (As S223)	
Building	Main	
Floor	First	
Room	116 Resource Area	
Position	Ceiling	
Component	Ceiling	
Accessibility	N/A	
Lab	In-House Database	
Next Inspection	No Further Action Required	
Material Risk	0 (VL)	
Priority Risk	N/A	
Quantity	60 Sqr Mtrs	
Survey Type	Management	
Action	No Further Action Required	
Product Type	Not Selected	
Asbestos Type	Non suspect material	
Surface Treatment	Not Selected	
Condition	Not Selected	
Recommendations	No further action required	
Comments	Insulating boards to the ceiling.

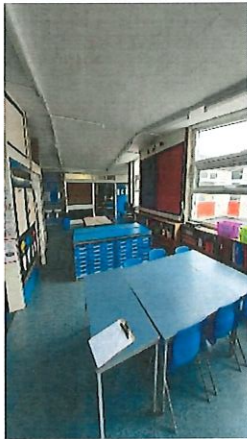
Material Assessment Ref	S262 –	
Building	Main	
Floor	First	
Room	116 Resource Area	
Position	Walls Internal	
Component	Walls Internal	
Accessibility	N/A	
Lab	In-House Database	
Next Inspection	No further action required	
Material Risk	0 (VL)	
Priority Risk	N/A	
Quantity	Num	
Survey Type	Management	
Action	No further action required	
Product Type	Not Selected	
Asbestos Type	Non suspect material	
Surface Treatment	Not Selected	
Condition	Not Selected	
Recommendations	No further action required	
Comments	Plaster skim to plasterboard or brick walls.

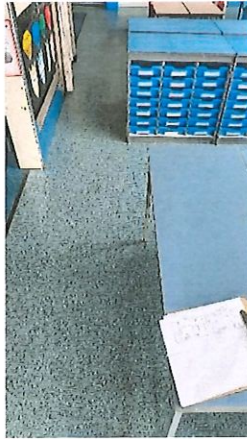
Material Assessment Ref	S263 –	
Building	Main	
Floor	First	
Room	116 Resource Area	
Position	Below Floor Covering	
Component	Below Floor Covering	
Accessibility	N/A	
Lab	In-House Database	
Next Inspection	No Access	
Material Risk	12 (H)	
Priority Risk	N/A	
Quantity	Num	
Survey Type	Management	
Action	Further investigation may be required.	
Product Type	No Access	
Asbestos Type	No Access	
Surface Treatment	No Access	
Condition	No Access	
Recommendations	Access was denied on the day of survey – see Inspection Comments (Material & Priority Assessment Records) for details.	
Comments	No access was possible beneath the modern vinyl without causing unnecessary damage.

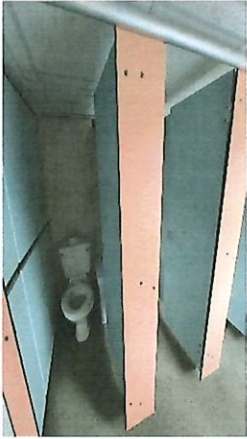
Material Assessment Ref	S264 –	
Building	Main	
Floor	First	
Room	117 Girls Toilets	
Position	Ceiling & Walls	
Component	Ceiling & Walls	
Accessibility	N/A	
Lab	In-House Database	
Next Inspection	No further action required	
Material Risk	0 (VL)	
Priority Risk	N/A	
Quantity	Num	
Survey Type	Management	
Action	No further action required	
Product Type	Not Selected	
Asbestos Type	Non suspect material	
Surface Treatment	Not Selected	
Condition	Not Selected	
Recommendations	No further action required	
Comments	Polystyrene tiles to ceiling above suspended ceiling and brick walls. Ceramic toilet cisterns and modern plastic seats.

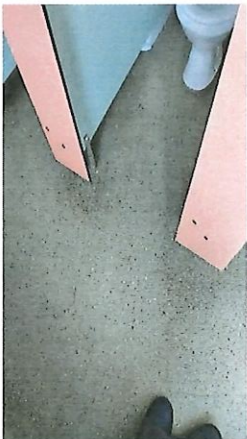
Material Assessment Ref	S265 –	
Building	Main	
Floor	First	
Room	117 Girls Toilets	
Position	Below Floor Covering	
Component	Below Floor Covering	
Accessibility	N/A	
Lab	In-House Database	
Next Inspection	No Access	
Material Risk	12 (H)	
Priority Risk	N/A	
Quantity	Num	
Survey Type	Management	
Action	Further investigation may be required.	
Product Type	No Access	
Asbestos Type	No Access	
Surface Treatment	No Access	
Condition	No Access	
Recommendations	Access was denied on the day of survey – see Inspection Comments (Material & Priority Assessment Records) for details.	
Comments	No access was possible beneath the modern vinyl without causing unnecessary damage.

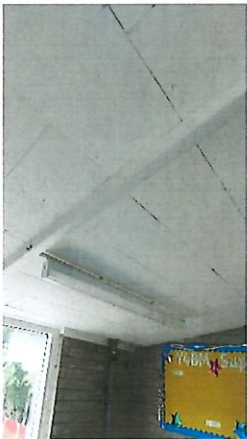
Material Assessment Ref	S266 – (As S223)	
Building	Main	
Floor	First	
Room	118 Cloaks	
Position	Ceiling	
Component	Ceiling	
Accessibility	N/A	
Lab	In-House Database	
Next Inspection	No Further Action Required	
Material Risk	0 (VL)	
Priority Risk	N/A	
Quantity	12 Sqr Mtrs	
Survey Type	Management	
Action	No Further Action Required	
Product Type	Not Selected	
Asbestos Type	Non suspect material	
Surface Treatment	Not Selected	
Condition	Not Selected	
Recommendations	No further action required	
Comments	Insulating boards to the ceiling.

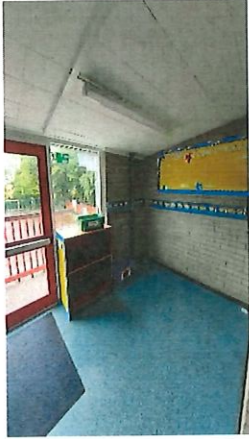
Material Assessment Ref	S267 –	
Building	Main	
Floor	First	
Room	118 Cloaks	
Position	Walls Internal	
Component	Walls Internal	
Accessibility	N/A	
Lab	In-House Database	
Next Inspection	No further action required	
Material Risk	0 (VL)	
Priority Risk	N/A	
Quantity	Num	
Survey Type	Management	
Action	No further action required	
Product Type	Not Selected	
Asbestos Type	Non suspect material	
Surface Treatment	Not Selected	
Condition	Not Selected	
Recommendations	No further action required	
Comments	Brick walls. Plastic downpipe.

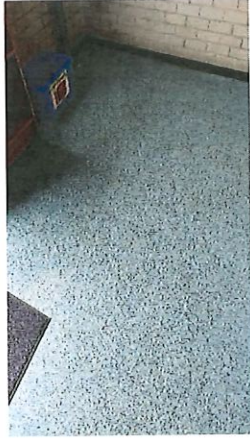
Material Assessment Ref	S268 –	
Building	Main	
Floor	First	
Room	118 Cloaks	
Position	Below Floor Covering	
Component	Below Floor Covering	
Accessibility	N/A	
Lab	In-House Database	
Next Inspection	No Access	
Material Risk	12 (H)	
Priority Risk	N/A	
Quantity	Num	
Survey Type	Management	
Action	Further investigation may be required.	
Product Type	No Access	
Asbestos Type	No Access	
Surface Treatment	No Access	
Condition	No Access	
Recommendations	Access was denied on the day of survey – see Inspection Comments (Material & Priority Assessment Records) for details.	
Comments	No access was possible beneath the modern vinyl without causing unnecessary damage.

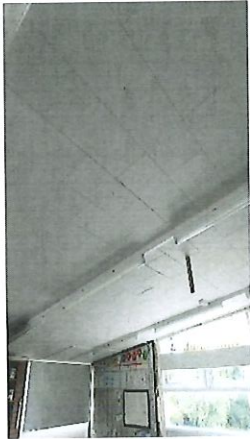
Material Assessment Ref	S269 – (As S223)	
Building	Main	
Floor	First	
Room	119 Classroom	
Position	Ceiling	
Component	Ceiling	
Accessibility	N/A	
Lab	In-House Database	
Next Inspection	No Further Action Required	
Material Risk	0 (VL)	
Priority Risk	N/A	
Quantity	60 Sqr Mtrs	
Survey Type	Management	
Action	No Further Action Required	
Product Type	Not Selected	
Asbestos Type	Non suspect material	
Surface Treatment	Not Selected	
Condition	Not Selected	
Recommendations	No further action required	
Comments	Insulating boards to the ceiling.

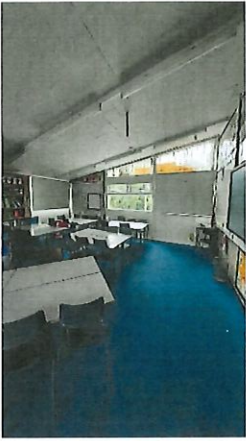
Material Assessment Ref	S270 –	
Building	Main	
Floor	First	
Room	119 Classroom	
Position	Walls Internal	
Component	Walls Internal	
Accessibility	N/A	
Lab	In-House Database	
Next Inspection	No further action required	
Material Risk	0 (VL)	
Priority Risk	N/A	
Quantity	Num	
Survey Type	Management	
Action	No further action required	
Product Type	Not Selected	
Asbestos Type	Non suspect material	
Surface Treatment	Not Selected	
Condition	Not Selected	
Recommendations	No further action required	
Comments	Brick walls.

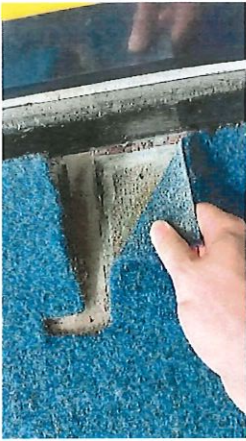
Material Assessment Ref	S271 – (As S239)	
Building	Main	
Floor	First	
Room	119 Classroom	
Position	Below Floor Covering	
Component	Floor Tiles & Adhesive	
Accessibility	Difficult	
Lab	In-House Database	
Next Inspection	17/08/2023	
Material Risk	3 (VL)	
Priority Risk	N/A	
Quantity	60 Sqr Mtrs	
Survey Type	Management	
Action	Manage	
Product Type	Thermo Plastic Floor Tiles	
Asbestos Type	Strongly Presumed Chrysotile	
Surface Treatment	Composite materials containing asbestos: reinforced plastics, resins, mastics, vinyl tiles, semi rigid paints or decorative finishes.	
Condition	Low damage: a few scratches or surface marks, broken edges on boards, tiles etc.	
Recommendations	Manage	
Comments	Green floor tiles and bitumen adhesive to concrete floor beneath carpet.

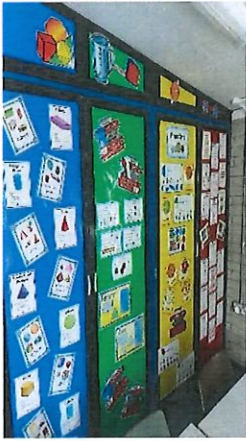
Material Assessment Ref	S272 –	
Building	Main	
Floor	First	
Room	120 Classroom Cupboards	
Position	Ceiling, Walls & Floor	
Component	Ceiling, Walls & Floor	
Accessibility	N/A	
Lab	In-House Database	
Next Inspection	No further action required	
Material Risk	0 (VL)	
Priority Risk	N/A	
Quantity	Num	
Survey Type	Management	
Action	No further action required	
Product Type	Not Selected	
Asbestos Type	Non suspect material	
Surface Treatment	Not Selected	
Condition	Not Selected	
Recommendations	No further action required	
Comments	Timber ceiling, walls and floor.

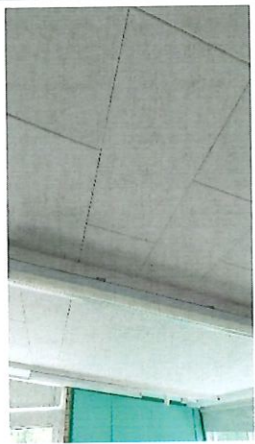
Material Assessment Ref	S273 – (As S223)	
Building	Main	
Floor	First	
Room	121 Classroom	
Position	Ceiling	
Component	Ceiling	
Accessibility	N/A	
Lab	In-House Database	
Next Inspection	No Further Action Required	
Material Risk	0 (VL)	
Priority Risk	N/A	
Quantity	60 Sqr Mtrs	
Survey Type	Management	
Action	No Further Action Required	
Product Type	Not Selected	
Asbestos Type	Non suspect material	
Surface Treatment	Not Selected	
Condition	Not Selected	
Recommendations	No further action required	
Comments	Insulating boards to the ceiling.

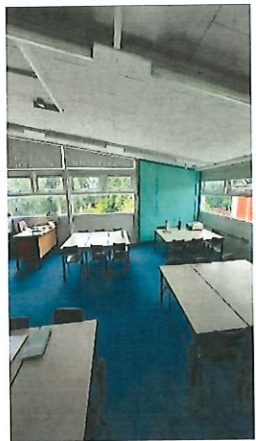
Material Assessment Ref	S274 –	
Building	Main	
Floor	First	
Room	121 Classroom	
Position	Walls Internal	
Component	Walls Internal	
Accessibility	N/A	
Lab	In-House Database	
Next Inspection	No further action required	
Material Risk	0 (VL)	
Priority Risk	N/A	
Quantity	Num	
Survey Type	Management	
Action	No further action required	
Product Type	Not Selected	
Asbestos Type	Non suspect material	
Surface Treatment	Not Selected	
Condition	Not Selected	
Recommendations	No further action required	
Comments	Brick walls.

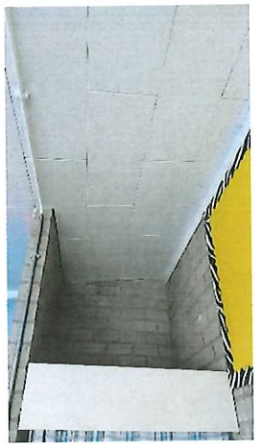
Material Assessment Ref	S276 – (As S223)	
Building	Main	
Floor	First	
Room	122 Classroom Store	
Position	Ceiling	
Component	Ceiling	
Accessibility	N/A	
Lab	In-House Database	
Next Inspection	No Further Action Required	
Material Risk	0 (VL)	
Priority Risk	N/A	
Quantity	1 Sqr Mtrs	
Survey Type	Management	
Action	No Further Action Required	
Product Type	Not Selected	
Asbestos Type	Non suspect material	
Surface Treatment	Not Selected	
Condition	Not Selected	
Recommendations	No further action required	
Comments	Insulating boards to the ceiling.

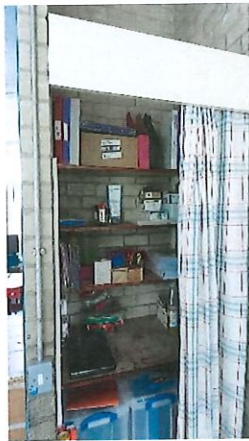
Material Assessment Ref	S277 –	
Building	Main	
Floor	First	
Room	122 Classroom Store	
Position	Walls Internal	
Component	Walls Internal	
Accessibility	N/A	
Lab	In-House Database	
Next Inspection	No further action required	
Material Risk	0 (VL)	
Priority Risk	N/A	
Quantity	Num	
Survey Type	Management	
Action	No further action required	
Product Type	Not Selected	
Asbestos Type	Non suspect material	
Surface Treatment	Not Selected	
Condition	Not Selected	
Recommendations	No further action required	
Comments	Brick walls.

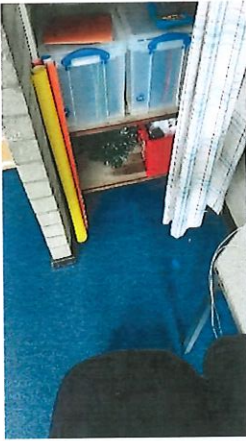
Material Assessment Ref	S278 – (As S239)	
Building	Main	
Floor	First	
Room	122 Classroom Store	
Position	Below Floor Covering	
Component	Floor Tiles & Adhesive	
Accessibility	Difficult	
Lab	In-House Database	
Next Inspection	17/08/2023	
Material Risk	3 (VL)	
Priority Risk	N/A	
Quantity	1 Sqr Mtrs	
Survey Type	Management	
Action	Manage	
Product Type	Thermo Plastic Floor Tiles	
Asbestos Type	Strongly Presumed Chrysotile	
Surface Treatment	Composite materials containing asbestos: reinforced plastics, resins, mastics, vinyl tiles, semi rigid paints or decorative finishes.	
Condition	Low damage: a few scratches or surface marks, broken edges on boards, tiles etc.	
Recommendations	Manage	
Comments	Green floor tiles and bitumen adhesive to concrete floor beneath carpet.

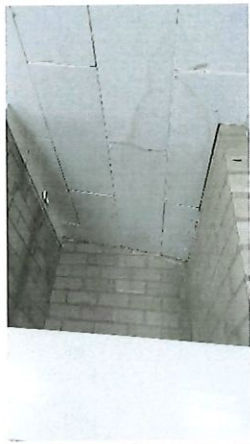
Material Assessment Ref	S279 – (As S223)	
Building	Main	
Floor	First	
Room	123 Small Store	
Position	Ceiling	
Component	Ceiling	
Accessibility	N/A	
Lab	In-House Database	
Next Inspection	No Further Action Required	
Material Risk	0 (VL)	
Priority Risk	N/A	
Quantity	1 Sqr Mtrs	
Survey Type	Management	
Action	No Further Action Required	
Product Type	Not Selected	
Asbestos Type	Non suspect material	
Surface Treatment	Not Selected	
Condition	Not Selected	
Recommendations	No further action required	
Comments	Insulating boards to the ceiling.

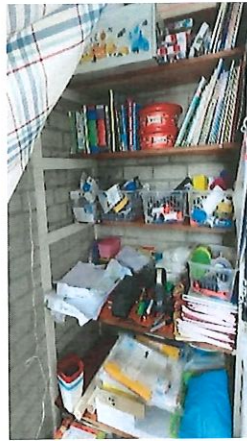
Material Assessment Ref	S280 –	
Building	Main	
Floor	First	
Room	123 Small Store	
Position	Walls Internal	
Component	Walls Internal	
Accessibility	N/A	
Lab	In-House Database	
Next Inspection	No further action required	
Material Risk	0 (VL)	
Priority Risk	N/A	
Quantity	Num	
Survey Type	Management	
Action	No further action required	
Product Type	Not Selected	
Asbestos Type	Non suspect material	
Surface Treatment	Not Selected	
Condition	Not Selected	
Recommendations	No further action required	
Comments	Brick walls.

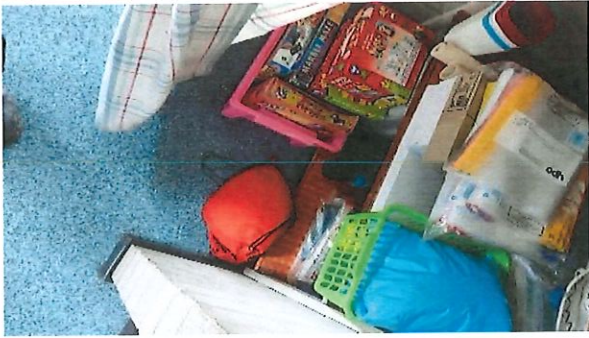
Material Assessment Ref	S281 –	
Building	Main	
Floor	First	
Room	123 Small Store	
Position	Below Floor Covering	
Component	Below Floor Covering	
Accessibility	N/A	
Lab	In-House Database	
Next Inspection	No Access	
Material Risk	12 (H)	
Priority Risk	N/A	
Quantity	Num	
Survey Type	Management	
Action	Further investigation may be required.	
Product Type	No Access	
Asbestos Type	No Access	
Surface Treatment	No Access	
Condition	No Access	
Recommendations	Access was denied on the day of survey – see Inspection Comments (Material & Priority Assessment Records) for details.	
Comments	No access was possible beneath the modern vinyl without causing unnecessary damage.

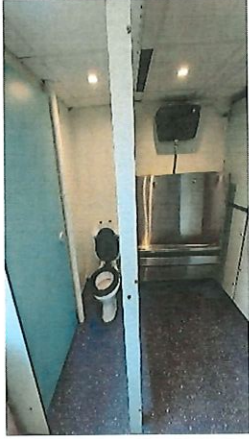
Material Assessment Ref	S282 –	
Building	Main	
Floor	First	
Room	124 Boys Toilets	
Position	Ceiling & Walls	
Component	Ceiling & Walls	
Accessibility	N/A	
Lab	In-House Database	
Next Inspection	No further action required	
Material Risk	0 (VL)	
Priority Risk	N/A	
Quantity	Num	
Survey Type	Management	
Action	No further action required	
Product Type	Not Selected	
Asbestos Type	Non suspect material	
Surface Treatment	Not Selected	
Condition	Not Selected	
Recommendations	No further action required	
Comments	Polystyrene tiles to ceiling above suspended ceiling and brick walls. Ceramic or modern black plastic toilet cisterns.

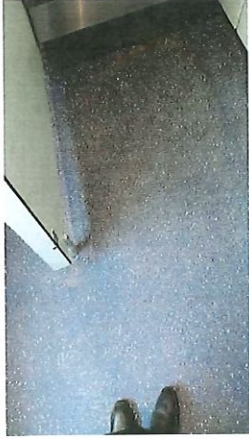
Material Assessment Ref	S283 –	
Building	Main	
Floor	First	
Room	124 Boys Toilets	
Position	Below Floor Covering	
Component	Below Floor Covering	
Accessibility	N/A	
Lab	In-House Database	
Next Inspection	No Access	
Material Risk	12 (H)	
Priority Risk	N/A	
Quantity	Num	
Survey Type	Management	
Action	Further investigation may be required.	
Product Type	No Access	
Asbestos Type	No Access	
Surface Treatment	No Access	
Condition	No Access	
Recommendations	Access was denied on the day of survey – see Inspection Comments (Material & Priority Assessment Records) for details.	
Comments	No access was possible beneath the modern vinyl without causing unnecessary damage.

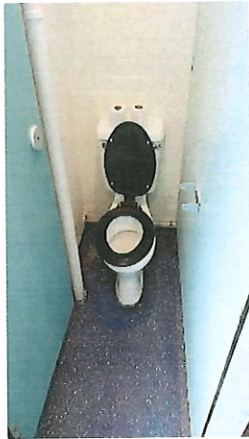
Material Assessment Ref	S284 – (As S230)	
Building	Main	
Floor	First	
Room	124 Boys Toilets	
Position	Toilet Seat	
Component	Toilet Seat	
Accessibility	N/A	
Lab	In-House Database	
Next Inspection	No Further Action Required	
Material Risk	0 (VL)	
Priority Risk	N/A	
Quantity	1 Num	
Survey Type	Management	
Action	No Further Action Required	
Product Type	Not Selected	
Asbestos Type	Non suspect material	
Surface Treatment	Not Selected	
Condition	Not Selected	
Recommendations	No further action required	
Comments	Black plastic toilet seats.

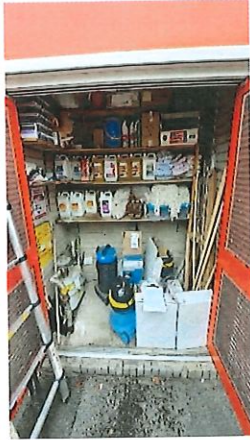
Material Assessment Ref	S286 –	
Building	Main	
Floor	Ground	
Room	007 Gas Meter Cupboard	
Position	Walls & Floor	
Component	Walls & Floor	
Accessibility	N/A	
Lab	In-House Database	
Next Inspection	No further action required	
Material Risk	0 (VL)	
Priority Risk	N/A	
Quantity	Num	
Survey Type	Management	
Action	No further action required	
Product Type	Not Selected	
Asbestos Type	Non suspect material	
Surface Treatment	Not Selected	
Condition	Not Selected	
Recommendations	No further action required	
Comments	Brick walls and concrete floor. Modern gas meter.

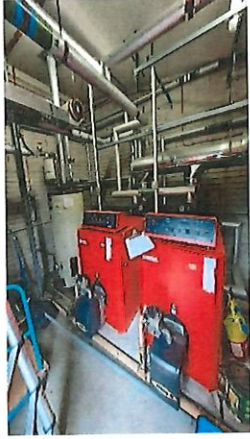
Material Assessment Ref	S288 –	
Building	Main	
Floor	Ground	
Room	008 Boiler Room	
Position	Walls & Floor	
Component	Walls & Floor	
Accessibility	N/A	
Lab	In-House Database	
Next Inspection	No further action required	
Material Risk	0 (VL)	
Priority Risk	N/A	
Quantity	Num	
Survey Type	Management	
Action	No further action required	
Product Type	Not Selected	
Asbestos Type	Non suspect material	
Surface Treatment	Not Selected	
Condition	Not Selected	
Recommendations	No further action required	
Comments	Brick walls and concrete floor.

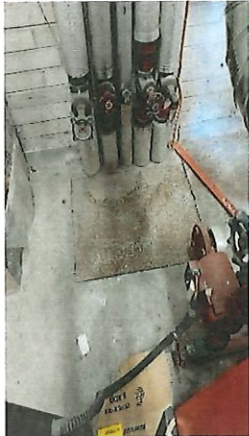
Material Assessment Ref	S291 –	
Building	Main	
Floor	Ground	
Room	008 Boiler Room	
Position	Floor Void	
Component	Floor Void	
Accessibility	N/A	
Lab	In-House Database	
Next Inspection	No Access	
Material Risk	12 (H)	
Priority Risk	N/A	
Quantity	Num	
Survey Type	Management	
Action	Further investigation may be required.	
Product Type	No Access	
Asbestos Type	No Access	
Surface Treatment	No Access	
Condition	No Access	
Recommendations	Access was denied on the day of survey – see Inspection Comments (Material & Priority Assessment Records) for details.	
Comments	No access was possible beneath the metal grid to floor (possible floor trench for pipework).

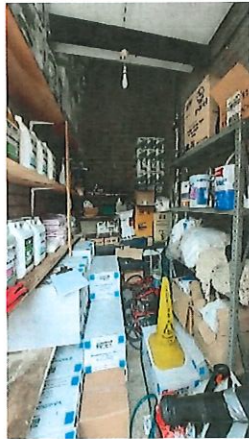
Material Assessment Ref	S292 –	
Building	Main	
Floor	Ground	
Room	043 External Store	
Position	Ceiling, Walls & Floor	
Component	Ceiling, Walls & Floor	
Accessibility	N/A	
Lab	In-House Database	
Next Inspection	No further action required	
Material Risk	0 (VL)	
Priority Risk	N/A	
Quantity	Num	
Survey Type	Management	
Action	No further action required	
Product Type	Not Selected	
Asbestos Type	Non suspect material	
Surface Treatment	Not Selected	
Condition	Not Selected	
Recommendations	No further action required	
Comments	Plaster skim to plasterboard ceiling, brick walls and concrete floor. Limited access was only possible throughout the area due to stored items.

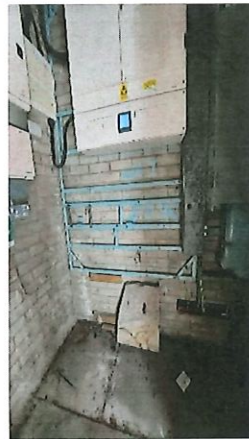
Material Assessment Ref	S293 –	
Building	Main	
Floor	Ground	
Room	047 Main Switch Room	
Position	Ceiling, Walls & Floor	
Component	Ceiling, Walls & Floor	
Accessibility	N/A	
Lab	In-House Database	
Next Inspection	No further action required	
Material Risk	0 (VL)	
Priority Risk	N/A	
Quantity	Num	
Survey Type	Management	
Action	No further action required	
Product Type	Not Selected	
Asbestos Type	Non suspect material	
Surface Treatment	Not Selected	
Condition	Not Selected	
Recommendations	No further action required	
Comments	Timber ceiling, brick walls and concrete floor.

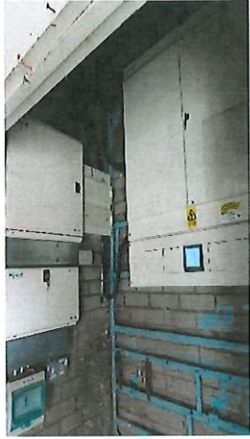
Material Assessment Ref	S294 –	
Building	Main	
Floor	Ground	
Room	047 Main Switch Room	
Position	Electric Meter & Consumer Unit	
Component	Electric Meter & Consumer Unit	
Accessibility	N/A	
Lab	In-House Database	
Next Inspection	No further action required	
Material Risk	0 (VL)	
Priority Risk	N/A	
Quantity	Num	
Survey Type	Management	
Action	No further action required	
Product Type	Not Selected	
Asbestos Type	Non suspect material	
Surface Treatment	Not Selected	
Condition	Not Selected	
Recommendations	No further action required	
Comments	Modern electrics.

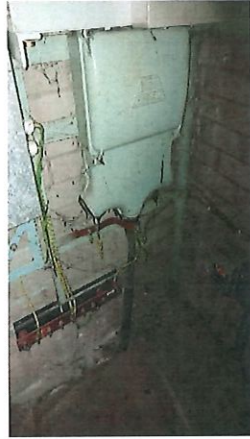
Material Assessment Ref	S295 –	
Building	Main	
Floor	Ground	
Room	047 Main Switch Room	
Position	Cable Wrap	
Component	Cable Wrap	
Accessibility	Medium	
Lab	In-House Database	
Next Inspection	17/08/2023	
Material Risk	6 (L)	
Priority Risk	N/A	
Quantity	1 Num	
Survey Type	Management	
Action	Manage	
Product Type	Textiles	
Asbestos Type	Strongly Presumed Crocidolite Amosite	
Surface Treatment	Enclosed sprays and lagging, AIB (with exposed face painted or encapsulated) asbestos cement sheets.	
Condition	Good condition: no visible damage.	
Recommendations	Manage	
Comments	Suspect main breaker and bitumen wrap to hv cable.

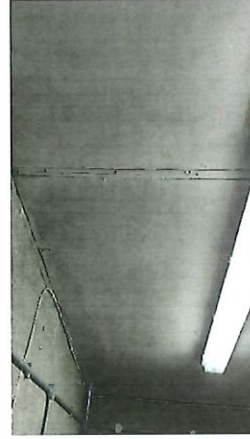
Material Assessment Ref	S296 –	
Building	Main	
Floor	Ground	
Room	049 Boiler Room 2	
Position	Ceiling	
Component	Ceiling	
Accessibility	N/A	
Lab	The Testing Lab PLC	
Next Inspection	No Further Action Required	
Material Risk	0 (VL)	
Priority Risk	N/A	
Quantity	15 Sqr Mtrs	
Survey Type	Management	
Action	No Further Action Required	
Product Type	Not Selected	
Asbestos Type	NADIS	
Surface Treatment	Not Selected	
Condition	Not Selected	
Recommendations	No further action required	
Comments	Insulating boards to the ceiling.

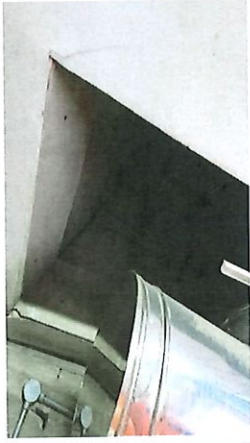
Material Assessment Ref	S297 –	
Building	Main	
Floor	Ground	
Room	049 Boiler Room 2	
Position	Ceiling	
Component	Ceiling	
Accessibility	Medium	
Lab	The Testing Lab PLC	
Next Inspection	17/08/2023	
Material Risk	4 (VL)	
Priority Risk	N/A	
Quantity	15 Sqr Mtrs	
Survey Type	Management	
Action	Encapsulate and Label	
Product Type	Cement	
Asbestos Type	Chrysotile	
Surface Treatment	Enclosed sprays and lagging, AIB (with exposed face painted or encapsulated) asbestos cement sheets.	
Condition	Low damage: a few scratches or surface marks, broken edges on boards, tiles etc.	
Recommendations	Encapsulate and label	
Comments	Insulating boards to ceiling around metal flue pipe.

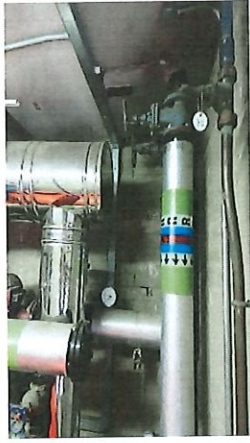
Material Assessment Ref	S298 – (As S289)	
Building	Main	
Floor	Ground	
Room	049 Boiler Room 2	
Position	Pipework	
Component	Gaskets	
Accessibility	N/A	
Lab	In-House Database	
Next Inspection	No Further Action Required	
Material Risk	0 (VL)	
Priority Risk	N/A	
Quantity	10 Num	
Survey Type	Management	
Action	No Further Action Required	
Product Type	Not Selected	
Asbestos Type	Non suspect material	
Surface Treatment	Not Selected	
Condition	Not Selected	
Recommendations	No further action required	
Comments	Gaskets to pipework.

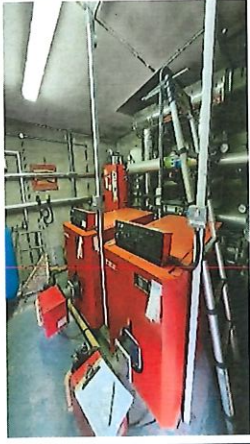
Material Assessment Ref	S299 –	
Building	Main	
Floor	Ground	
Room	049 Boiler Room 2	
Position	Live Plant	
Component	Plant Equipment	
Accessibility	N/A	
Lab	In-House Database	
Next Inspection	No further action required	
Material Risk	0 (VL)	
Priority Risk	N/A	
Quantity	Num	
Survey Type	Management	
Action	No further action required	
Product Type	Not Selected	
Asbestos Type	Non suspect material	
Surface Treatment	Not Selected	
Condition	Not Selected	
Recommendations	No further action required	
Comments	Modern boilers x 2 and mmmf insulation to pipework beneath metal cladding. Modern metal flue pipe.

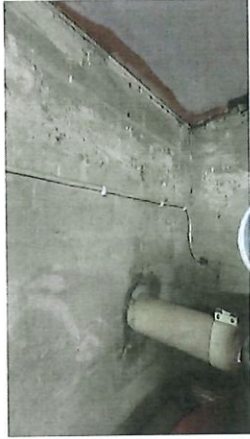
Material Assessment Ref	S300 –	
Building	Main	
Floor	Ground	
Room	049 Boiler Room 2	
Position	Insulation Debris / Residues	
Component	All Surfaces	
Accessibility	N/A	
Lab	The Testing Lab PLC	
Next Inspection	No Further Action Required	
Material Risk	0 (VL)	
Priority Risk	N/A	
Quantity	40 Sqr Mtrs	
Survey Type	Management	
Action	No Further Action Required	
Product Type	Not Selected	
Asbestos Type	NADIS	
Surface Treatment	Not Selected	
Condition	Not Selected	
Recommendations	No further action required	
Comments	Insulation debris / residues to all surfaces throughout the area.

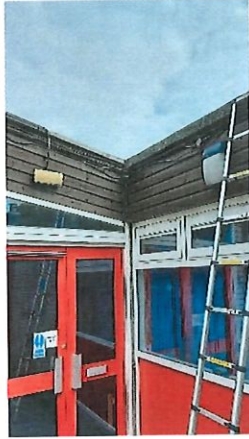
Material Assessment Ref	S301 –	
Building	Main	
Floor	External	
Room	All Elevations	
Position	Behind Fascias	
Component	Behind Fascias	
Accessibility	N/A	
Lab	In-House Database	
Next Inspection	No Access	
Material Risk	12 (H)	
Priority Risk	N/A	
Quantity	Num	
Survey Type	Management	
Action	Further investigation may be required.	
Product Type	No Access	
Asbestos Type	No Access	
Surface Treatment	No Access	
Condition	No Access	
Recommendations	Access was denied on the day of survey – see Inspection Comments (Material & Priority Assessment Records) for details.	
Comments	No access was possible behind the wooden fascias boards without causing unnecessary damage.

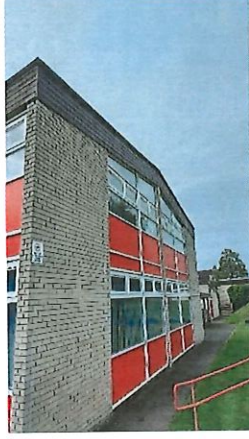
Material Assessment Ref	S302 –	
Building	Main	
Floor	External	
Room	Roof	
Position	No Access	
Component	No Access	
Accessibility	N/A	
Lab	In-House Database	
Next Inspection	No Access	
Material Risk	12 (H)	
Priority Risk	N/A	
Quantity	Num	
Survey Type	Management	
Action	Further investigation may be required.	
Product Type	No Access	
Asbestos Type	No Access	
Surface Treatment	No Access	
Condition	No Access	
Recommendations	A risk assessment identified high risk exposure to the surveyor, normally due to high voltage, height or other hazardous risks being present.	
Comments	No safe access was possible to the high level roof.

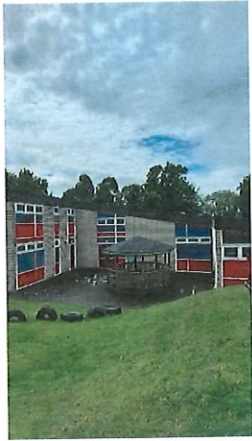
Material Assessment Ref	S303 –	
Building	Main	
Floor	External	
Room	All Elevations	
Position	Roof, Walls External & Rain Water Goods	
Component	Roof, Walls External & Rain Water Goods	
Accessibility	N/A	
Lab	In-House Database	
Next Inspection	No further action required	
Material Risk	0 (VL)	
Priority Risk	N/A	
Quantity	Num	
Survey Type	Management	
Action	No further action required	
Product Type	Not Selected	
Asbestos Type	Non suspect material	
Surface Treatment	Not Selected	
Condition	Not Selected	
Recommendations	No further action required	
Comments	Modern felt lined roof, brick walls, wooden or plastic fenestration and plastic or metal rainwater goods.
