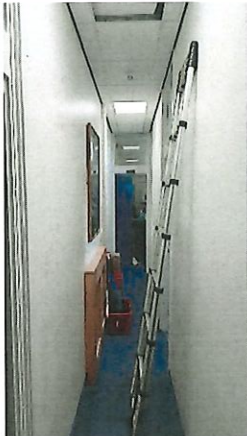
Material Assessment Ref	S086 –	
Building	Main	
Floor	Ground	
Room	031A Passage	
Position	Walls & Floor	
Component	Walls & Floor	
Accessibility	N/A	
Lab	In-House Database	
Next Inspection	No further action required	
Material Risk	0 (VL)	
Priority Risk	N/A	
Quantity	Num	
Survey Type	Management	
Action	No further action required	
Product Type	Not Selected	
Asbestos Type	Non suspect material	
Surface Treatment	Not Selected	
Condition	Not Selected	
Recommendations	No further action required	
Comments	Plaster skim to plasterboard and brick walls and concrete floor beneath carpet. Glass door head panels.

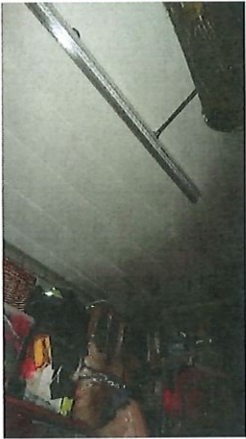
Material Assessment Ref	S105 – (As S085)	
Building	Main	
Floor	Ground	
Room	075 PE Store	
Position	Ceiling	
Component	Ceiling	
Accessibility	N/A	
Lab	In-House Database	
Next Inspection	No Further Action Required	
Material Risk	0 (VL)	
Priority Risk	N/A	
Quantity	16 Sqr Mtrs	
Survey Type	Management	
Action	No Further Action Required	
Product Type	Not Selected	
Asbestos Type	Non suspect material	
Surface Treatment	Not Selected	
Condition	Not Selected	
Recommendations	No further action required	
Comments	Insulating boards to the ceiling.

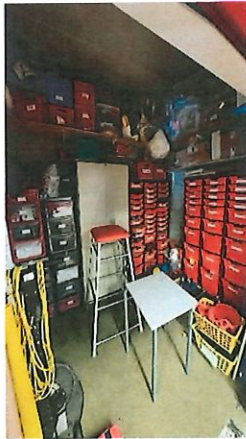
Material Assessment Ref	S106 –	
Building	Main	
Floor	Ground	
Room	075 PE Store	
Position	Walls Internal	
Component	Walls Internal	
Accessibility	N/A	
Lab	In-House Database	
Next Inspection	No further action required	
Material Risk	0 (VL)	
Priority Risk	N/A	
Quantity	Num	
Survey Type	Management	
Action	No further action required	
Product Type	Not Selected	
Asbestos Type	Non suspect material	
Surface Treatment	Not Selected	
Condition	Not Selected	
Recommendations	No further action required	
Comments	Brick walls.

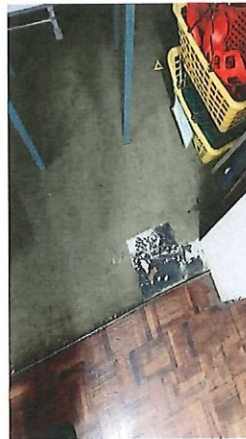
Material Assessment Ref	S107 –	
Building	Main	
Floor	Ground	
Room	075 PE Store	
Position	Floor	
Component	Floor Tiles & Adhesive	
Accessibility	Easy	
Lab	The Testing Lab PLC	
Next Inspection	16/08/2023	
Material Risk	3 (VL)	
Priority Risk	N/A	
Quantity	16 Sqr Mtrs	
Survey Type	Management	
Action	Manage	
Product Type	Thermo Plastic Floor Tiles	
Asbestos Type	Chrysotile	
Surface Treatment	Composite materials containing asbestos: reinforced plastics, resins, mastics, vinyl tiles, semi rigid paints or decorative finishes.	
Condition	Low damage: a few scratches or surface marks, broken edges on boards, tiles etc.	
Recommendations	Manage	
Comments	Green floor tiles and bitumen adhesive to concrete floor.
