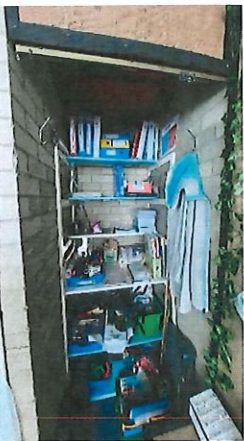
Material Assessment Ref	S157 –	
Building	Main	
Floor	Ground	
Room	060 Classroom Store	
Position	Walls Internal	
Component	Walls Internal	
Accessibility	N/A	
Lab	In-House Database	
Next Inspection	No further action required	
Material Risk	0 (VL)	
Priority Risk	N/A	
Quantity	Num	
Survey Type	Management	
Action	No further action required	
Product Type	Not Selected	
Asbestos Type	Non suspect material	
Surface Treatment	Not Selected	
Condition	Not Selected	
Recommendations	No further action required	
Comments	Brick walls. Wood door head panel.

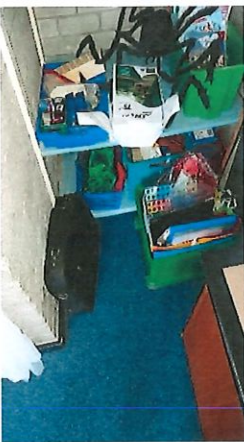
Material Assessment Ref	S158 – (As S146)	
Building	Main	
Floor	Ground	
Room	060 Classroom Store	
Position	Below Floor Covering	
Component	Floor Tiles & Adhesive	
Accessibility	Difficult	
Lab	In-House Database	
Next Inspection	16/08/2023	
Material Risk	3 (VL)	
Priority Risk	N/A	
Quantity	1 Sqr Mtrs	
Survey Type	Management	
Action	Manage	
Product Type	Thermo Plastic Floor Tiles	
Asbestos Type	Strongly Presumed Chrysotile	
Surface Treatment	Composite materials containing asbestos: reinforced plastics, resins, mastics, vinyl tiles, semi rigid paints or decorative finishes.	
Condition	Low damage: a few scratches or surface marks, broken edges on boards, tiles etc.	
Recommendations	Manage	
Comments	Green floor tiles and bitumen adhesive to concrete floor beneath carpet.

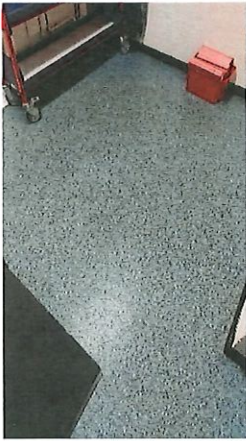
Material Assessment Ref	S175 –	
Building	Main	
Floor	Ground	
Room	067 Cloaks	
Position	Below Floor Covering	
Component	Below Floor Covering	
Accessibility	N/A	
Lab	In-House Database	
Next Inspection	No Access	
Material Risk	12 (H)	
Priority Risk	N/A	
Quantity	Num	
Survey Type	Management	
Action	Further investigation may be required.	
Product Type	No Access	
Asbestos Type	No Access	
Surface Treatment	No Access	
Condition	No Access	
Recommendations	Access was denied on the day of survey – see Inspection Comments (Material & Priority Assessment Records) for details.	
Comments	No access was possible beneath the modern vinyl without causing unnecessary damage.

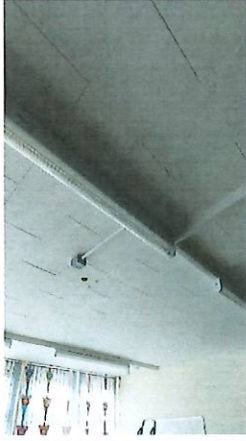
Material Assessment Ref	S176 – (As S138)	
Building	Main	
Floor	Ground	
Room	068 Classroom	
Position	Ceiling	
Component	Ceiling	
Accessibility	N/A	
Lab	In-House Database	
Next Inspection	No Further Action Required	
Material Risk	0 (VL)	
Priority Risk	N/A	
Quantity	60 Sqr Mtrs	
Survey Type	Management	
Action	No Further Action Required	
Product Type	Not Selected	
Asbestos Type	Non suspect material	
Surface Treatment	Not Selected	
Condition	Not Selected	
Recommendations	No further action required	
Comments	Insulating boards to the ceiling.

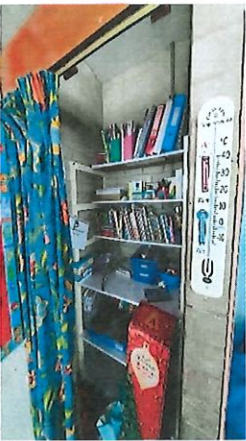
Material Assessment Ref	S180 –	
Building	Main	
Floor	Ground	
Room	069 Classroom Store	
Position	Walls Internal	
Component	Walls Internal	
Accessibility	N/A	
Lab	In-House Database	
Next Inspection	No further action required	
Material Risk	0 (VL)	
Priority Risk	N/A	
Quantity	Num	
Survey Type	Management	
Action	No further action required	
Product Type	Not Selected	
Asbestos Type	Non suspect material	
Surface Treatment	Not Selected	
Condition	Not Selected	
Recommendations	No further action required	
Comments	Brick walls. Wood door head panel.

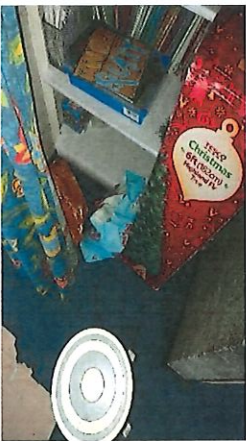
Material Assessment Ref	S181 – (As S146)	
Building	Main	
Floor	Ground	
Room	069 Classroom Store	
Position	Below Floor Covering	
Component	Floor Tiles & Adhesive	
Accessibility	Difficult	
Lab	In-House Database	
Next Inspection	16/08/2023	
Material Risk	3 (VL)	
Priority Risk	N/A	
Quantity	1 Sqr Mtrs	
Survey Type	Management	
Action	Manage	
Product Type	Thermo Plastic Floor Tiles	
Asbestos Type	Strongly Presumed Chrysotile	
Surface Treatment	Composite materials containing asbestos: reinforced plastics, resins, mastics, vinyl tiles, semi rigid paints or decorative finishes.	
Condition	Low damage: a few scratches or surface marks, broken edges on boards, tiles etc.	
Recommendations	Manage	
Comments	Green floor tiles and bitumen adhesive to concrete floor beneath carpet.

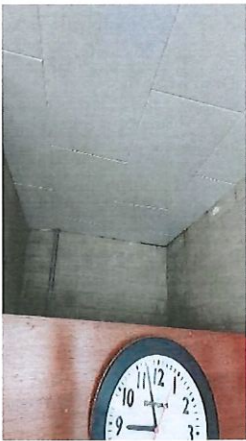
Material Assessment Ref	S182 – (As S138)	
Building	Main	
Floor	Ground	
Room	070 Classroom Store	
Position	Ceiling	
Component	Ceiling	
Accessibility	N/A	
Lab	In-House Database	
Next Inspection	No Further Action Required	
Material Risk	0 (VL)	
Priority Risk	N/A	
Quantity	1 Sqr Mtrs	
Survey Type	Management	
Action	No Further Action Required	
Product Type	Not Selected	
Asbestos Type	Non suspect material	
Surface Treatment	Not Selected	
Condition	Not Selected	
Recommendations	No further action required	
Comments	Insulating boards to the ceiling.

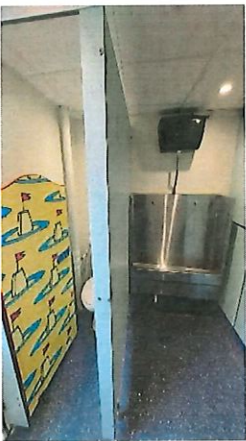
Material Assessment Ref	S189 –	
Building	Main	
Floor	Ground	
Room	072 Boys Toilets	
Position	Walls Internal	
Component	Walls Internal	
Accessibility	N/A	
Lab	In-House Database	
Next Inspection	No further action required	
Material Risk	0 (VL)	
Priority Risk	N/A	
Quantity	Num	
Survey Type	Management	
Action	No further action required	
Product Type	Not Selected	
Asbestos Type	Non suspect material	
Surface Treatment	Not Selected	
Condition	Not Selected	
Recommendations	No further action required	
Comments	Brick walls. Ceramic toilet cisterns and modern seats. Modern black plastic cistern to urinals. Plastic downpipe.

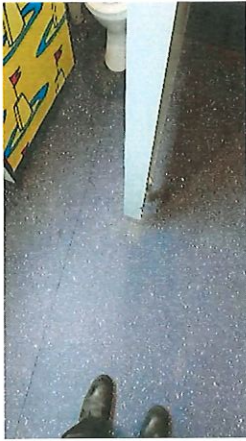
Material Assessment Ref	S190 –	
Building	Main	
Floor	Ground	
Room	072 Boys Toilets	
Position	Below Floor Covering	
Component	Below Floor Covering	
Accessibility	N/A	
Lab	In-House Database	
Next Inspection	No Access	
Material Risk	12 (H)	
Priority Risk	N/A	
Quantity	Num	
Survey Type	Management	
Action	Further investigation may be required.	
Product Type	No Access	
Asbestos Type	No Access	
Surface Treatment	No Access	
Condition	No Access	
Recommendations	Access was denied on the day of survey – see Inspection Comments (Material & Priority Assessment Records) for details.	
Comments	No access was possible beneath the modern vinyl without causing unnecessary damage.

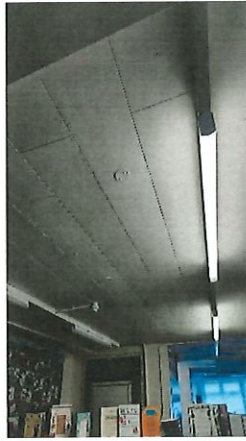
Material Assessment Ref	S191 – (As S138)	
Building	Main	
Floor	Ground	
Room	073 & 074 Reading Area	
Position	Ceiling	
Component	Ceiling	
Accessibility	N/A	
Lab	In-House Database	
Next Inspection	No Further Action Required	
Material Risk	0 (VL)	
Priority Risk	N/A	
Quantity	60 Sqr Mtrs	
Survey Type	Management	
Action	No Further Action Required	
Product Type	Not Selected	
Asbestos Type	Non suspect material	
Surface Treatment	Not Selected	
Condition	Not Selected	
Recommendations	No further action required	
Comments	Insulating boards to the ceiling.

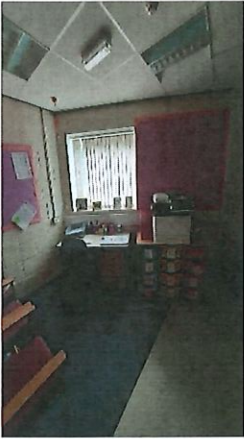
Material Assessment Ref	S195 –	
Building	Main	
Floor	Ground	
Room	069 Office	
Position	Ceiling, Walls & Floor	
Component	Ceiling, Walls & Floor	
Accessibility	N/A	
Lab	In-House Database	
Next Inspection	No further action required	
Material Risk	0 (VL)	
Priority Risk	N/A	
Quantity	Num	
Survey Type	Management	
Action	No further action required	
Product Type	Not Selected	
Asbestos Type	Non suspect material	
Surface Treatment	Not Selected	
Condition	Not Selected	
Recommendations	No further action required	
Comments	Timber roof decking boards above suspended ceiling, block walls and concrete floor beneath carpet and modern vinyl.

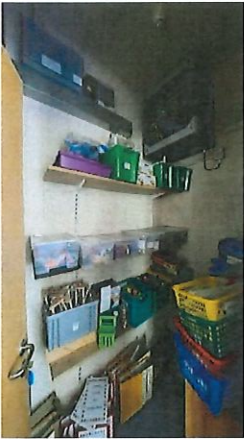
Material Assessment Ref	S196 –	
Building	Main	
Floor	Ground	
Room	080 Server Room	
Position	Ceiling, Walls & Floor	
Component	Ceiling, Walls & Floor	
Accessibility	N/A	
Lab	In-House Database	
Next Inspection	No further action required	
Material Risk	0 (VL)	
Priority Risk	N/A	
Quantity	Num	
Survey Type	Management	
Action	No further action required	
Product Type	Not Selected	
Asbestos Type	Non suspect material	
Surface Treatment	Not Selected	
Condition	Not Selected	
Recommendations	No further action required	
Comments	Plaster skim to plasterboard ceiling, block walls and concrete floor beneath carpet. Modern consumer unit.

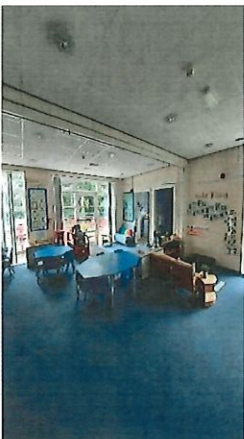
Material Assessment Ref	S197 –	
Building	Main	
Floor	Ground	
Room	081 Classroom	
Position	Ceiling, Walls & Floor	
Component	Ceiling, Walls & Floor	
Accessibility	N/A	
Lab	In-House Database	
Next Inspection	No further action required	
Material Risk	0 (VL)	
Priority Risk	N/A	
Quantity	Num	
Survey Type	Management	
Action	No further action required	
Product Type	Not Selected	
Asbestos Type	Non suspect material	
Surface Treatment	Not Selected	
Condition	Not Selected	
Recommendations	No further action required	
Comments	Timber roof decking boards above suspended ceiling, block walls and concrete floor beneath carpet.

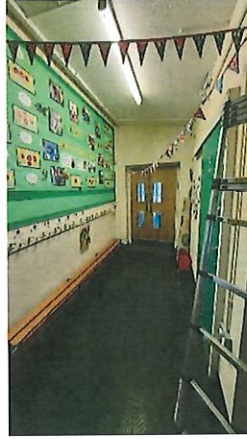
Material Assessment Ref	S205 –	
Building	Main	
Floor	Ground	
Room	N001 Cloakroom	
Position	Walls Internal	
Component	Walls Internal	
Accessibility	N/A	
Lab	In-House Database	
Next Inspection	No further action required	
Material Risk	0 (VL)	
Priority Risk	N/A	
Quantity	Num	
Survey Type	Management	
Action	No further action required	
Product Type	Not Selected	
Asbestos Type	Non suspect material	
Surface Treatment	Not Selected	
Condition	Not Selected	
Recommendations	No further action required	
Comments	Plaster skim to plasterboard and brick walls.

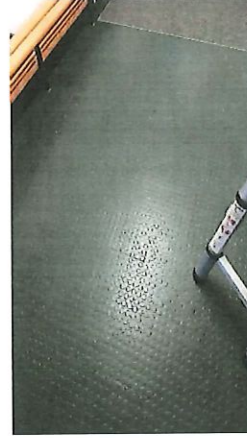
Material Assessment Ref	S206 –	
Building	Main	
Floor	Ground	
Room	N001 Cloakroom	
Position	Below Floor Covering	
Component	Below Floor Covering	
Accessibility	N/A	
Lab	In-House Database	
Next Inspection	No Access	
Material Risk	12 (H)	
Priority Risk	N/A	
Quantity	Num	
Survey Type	Management	
Action	Further investigation may be required.	
Product Type	No Access	
Asbestos Type	No Access	
Surface Treatment	No Access	
Condition	No Access	
Recommendations	Access was denied on the day of survey – see Inspection Comments (Material & Priority Assessment Records) for details.	
Comments	No access was possible beneath the modern vinyl without causing unnecessary damage.

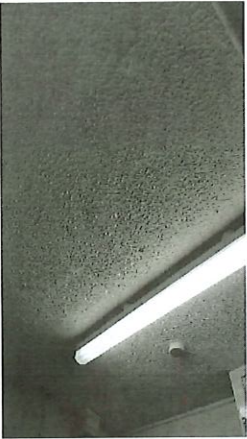
Material Assessment Ref	S207 – (As S204)	
Building	Main	
Floor	Ground	
Room	N001A Disabled Toilet	
Position	Ceiling	
Component	Textured Coating To Ceiling	
Accessibility	Medium	
Lab	In-House Database	
Next Inspection	17/08/2023	
Material Risk	3 (VL)	
Priority Risk	N/A	
Quantity	7 Sqr Mtrs	
Survey Type	Management	
Action	Manage	
Product Type	Textured Coating	
Asbestos Type	Strongly Presumed Chrysotile	
Surface Treatment	Composite materials containing asbestos: reinforced plastics, resins, mastics, vinyl tiles, semi rigid paints or decorative finishes.	
Condition	Low damage: a few scratches or surface marks, broken edges on boards, tiles etc.	
Recommendations	Manage	
Comments	Textured coating to plasterboard ceiling.

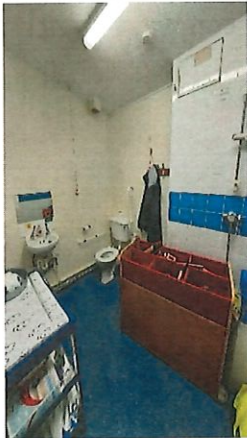
Material Assessment Ref	S208 –	
Building	Main	
Floor	Ground	
Room	N001A Disabled Toilet	
Position	Walls Internal	
Component	Walls Internal	
Accessibility	N/A	
Lab	In-House Database	
Next Inspection	No further action required	
Material Risk	0 (VL)	
Priority Risk	N/A	
Quantity	Num	
Survey Type	Management	
Action	No further action required	
Product Type	Not Selected	
Asbestos Type	Non suspect material	
Surface Treatment	Not Selected	
Condition	Not Selected	
Recommendations	No further action required	
Comments	Plaster skim to plasterboard and brick walls partly ceramic tiled. Ceramic toilet cistern and plastic seat.

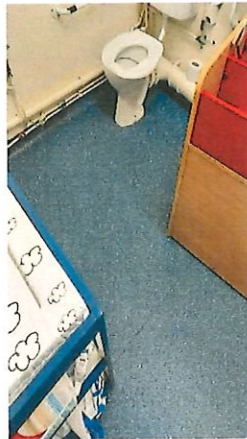
Material Assessment Ref	S209 –	
Building	Main	
Floor	Ground	
Room	N001A Disabled Toilet	
Position	Below Floor Covering	
Component	Below Floor Covering	
Accessibility	N/A	
Lab	In-House Database	
Next Inspection	No Access	
Material Risk	12 (H)	
Priority Risk	N/A	
Quantity	Num	
Survey Type	Management	
Action	Further investigation may be required.	
Product Type	No Access	
Asbestos Type	No Access	
Surface Treatment	No Access	
Condition	No Access	
Recommendations	Access was denied on the day of survey – see Inspection Comments (Material & Priority Assessment Records) for details.	
Comments	No access was possible beneath the modern vinyl without causing unnecessary damage.

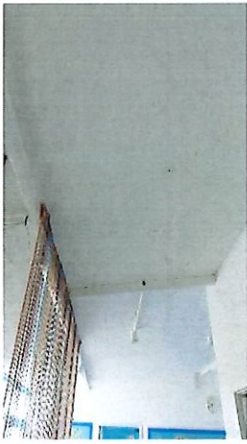
Material Assessment Ref	S210 – (As S204)	
Building	Main	
Floor	Ground	
Room	N002 Nursery Classroom	
Position	Ceiling	
Component	Textured Coating To Ceiling	
Accessibility	Medium	
Lab	In-House Database	
Next Inspection	17/08/2023	
Material Risk	3 (VL)	
Priority Risk	N/A	
Quantity	30 Sqr Mtrs	
Survey Type	Management	
Action	Manage	
Product Type	Textured Coating	
Asbestos Type	Strongly Presumed Chrysotile	
Surface Treatment	Composite materials containing asbestos: reinforced plastics, resins, mastics, vinyl tiles, semi rigid paints or decorative finishes.	
Condition	Low damage: a few scratches or surface marks, broken edges on boards, tiles etc.	
Recommendations	Manage	
Comments	Textured coating to plasterboard ceiling.

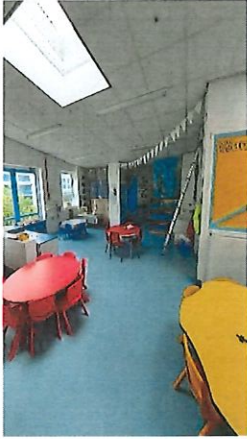
Material Assessment Ref	S211 –	
Building	Main	
Floor	Ground	
Room	N002 Nursery Classroom	
Position	Walls & Floor	
Component	Walls & Floor	
Accessibility	N/A	
Lab	In-House Database	
Next Inspection	No further action required	
Material Risk	0 (VL)	
Priority Risk	N/A	
Quantity	Num	
Survey Type	Management	
Action	No further action required	
Product Type	Not Selected	
Asbestos Type	Non suspect material	
Surface Treatment	Not Selected	
Condition	Not Selected	
Recommendations	No further action required	
Comments	Plaster skim to plasterboard and brick walls and concrete floor beneath modern vinyl and carpet.

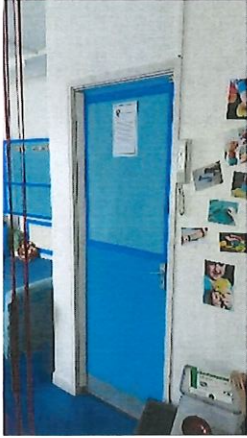
Material Assessment Ref	S212 –	
Building	Main	
Floor	Ground	
Room	N003 Store Room	
Position	No Access	
Component	No Access	
Accessibility	N/A	
Lab	In-House Database	
Next Inspection	No Access	
Material Risk	12 (H)	
Priority Risk	N/A	
Quantity	Num	
Survey Type	Management	
Action	Further investigation may be required.	
Product Type	No Access	
Asbestos Type	No Access	
Surface Treatment	No Access	
Condition	No Access	
Recommendations	Access was denied on the day of survey – see Inspection Comments (Material & Priority Assessment Records) for details.	
Comments	No keys were made available.
